Building Survey Report
on
23 Ingersoll Road, London W2 7BE
for
Ms V Davison
as at
11 November 2015

James Ross & Co Chartered Surveyors

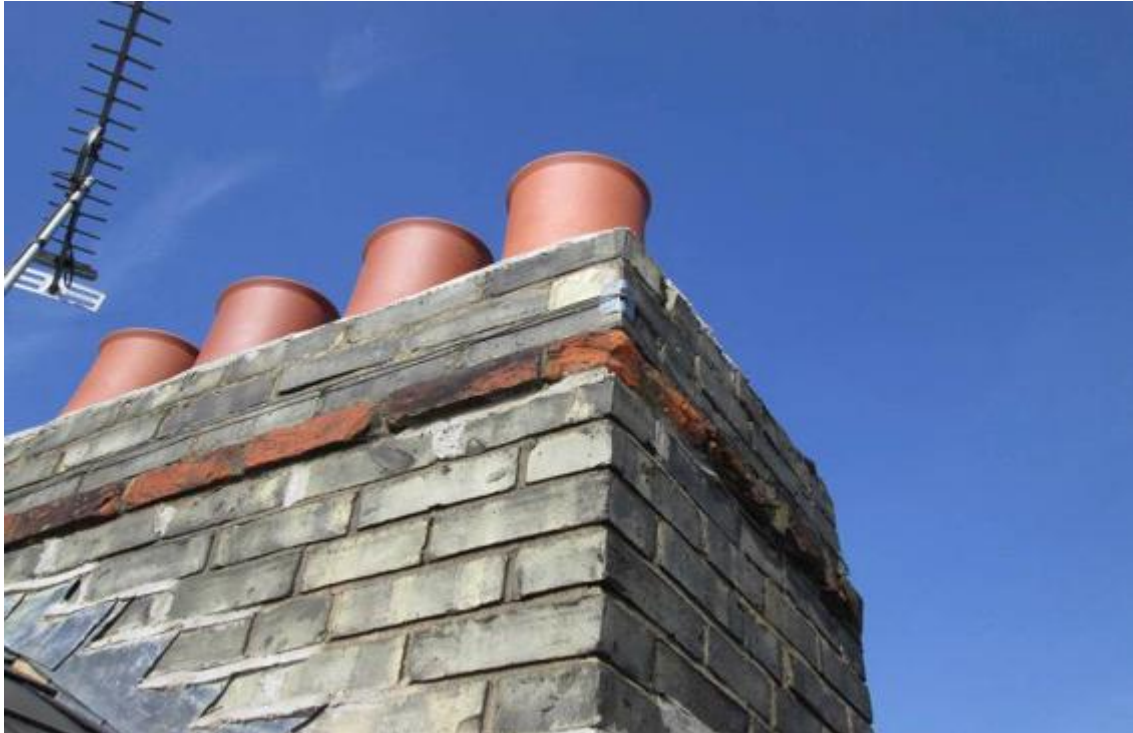
There are the first signs of spalling to a number of the faces to the red bricks that form the horizontal ornamental band. Although, the point has not yet been reached at which the bricks need to be cut out and replaced to preserve the structural integrity of the stack, they will continue to weather at the same incremental rate as has taken place in the past.

Chimney stack to main roof with bricks to ornamental red band starting to spall (1).

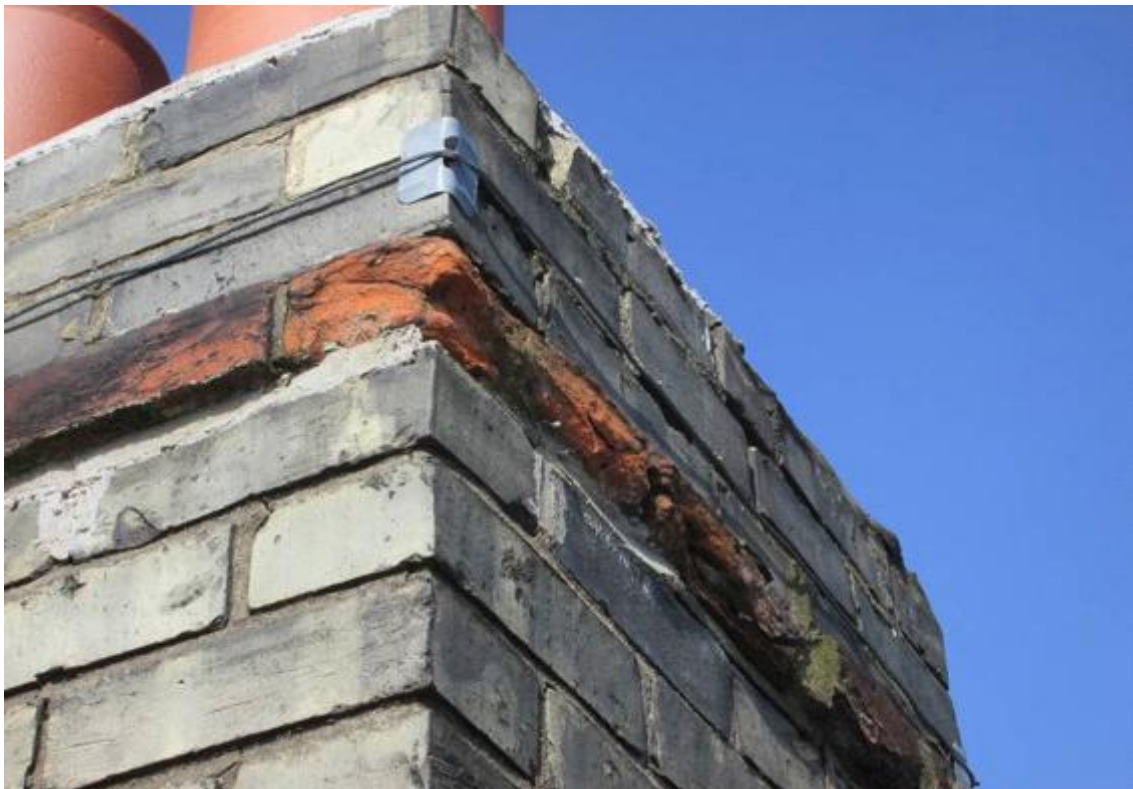
Chimney stack to main roof with bricks to ornamental red band starting to spall (2).

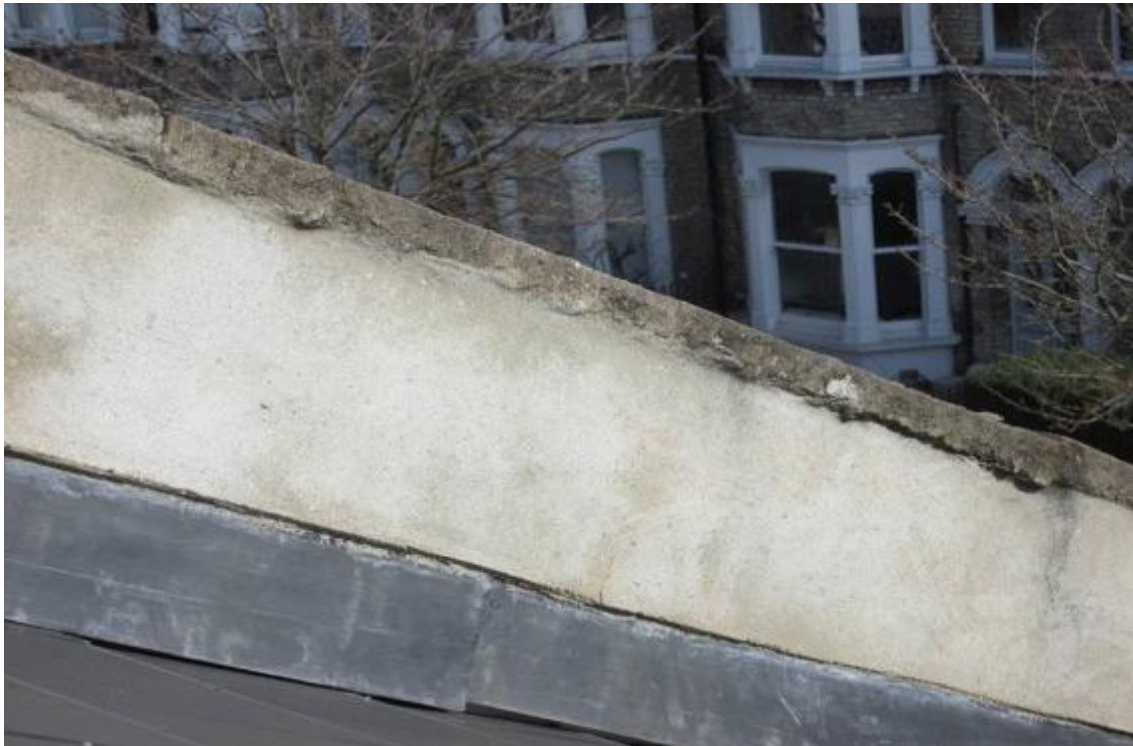
The condition of the parapet walls forms one of the few disappointing features of the property. Parapet walls of this type rely on the integrity of the render, plus the provision of good quality capping stones on top, in order to adequately resist water penetration.

To the parapet wall to the right side of the main roof, the cappings are in poor condition and finished flush with the render. This means that any water landing on top of the existing capping stones will simply wash down the render, posing a potential theoretical risk of water penetrating internally.

Parapet wall to right side of main roof with no oversailing capping detail.

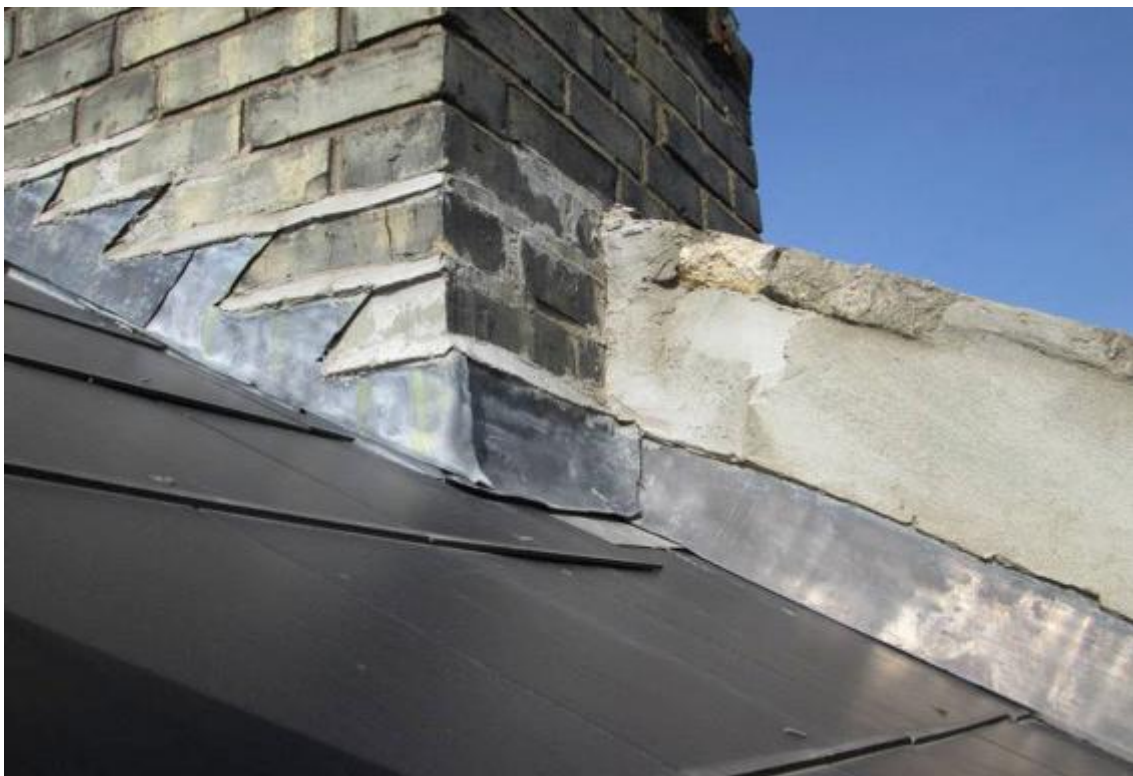
The abutment detail between the slates to the main roof and the adjacent chimney stacks/parapet walls are sealed with sheet metal flashings, which is good building practice, with the flashings and corresponding soakers in satisfactory condition.

Correct flashing detail between slates and stack/parapet wall to right side of main roof.

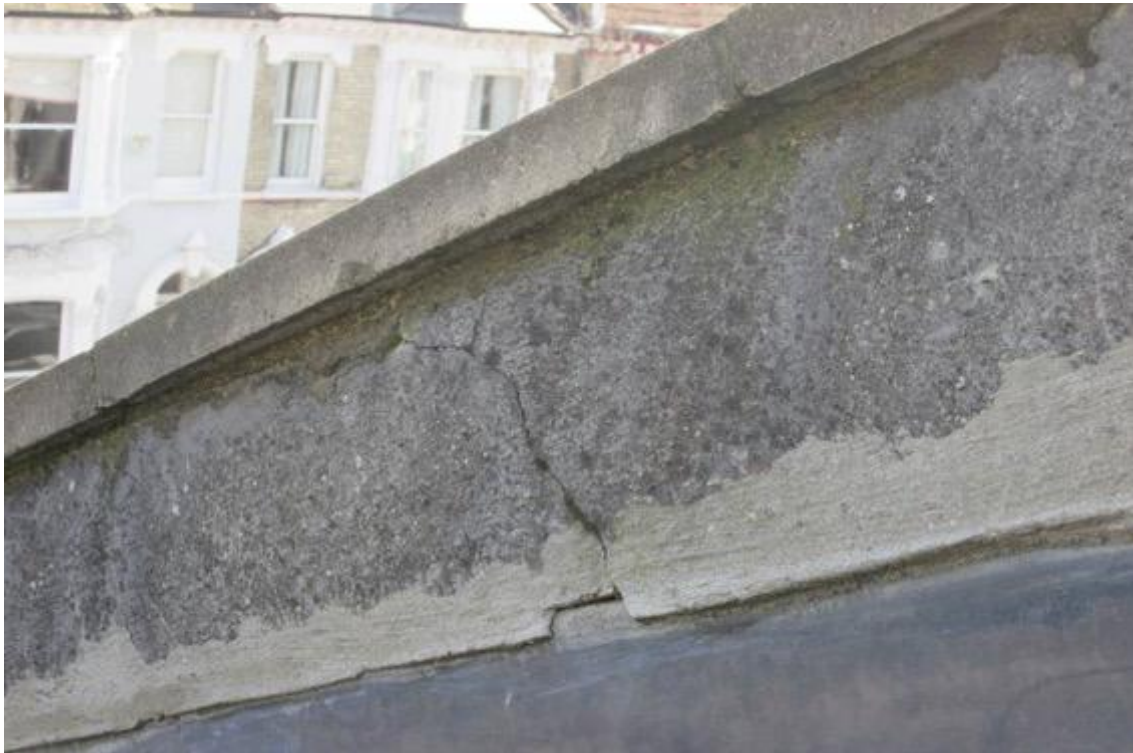
There is also one crack passing through the render forming an isolated weak spot.

Crack through render to parapet wall to left side of main roof.

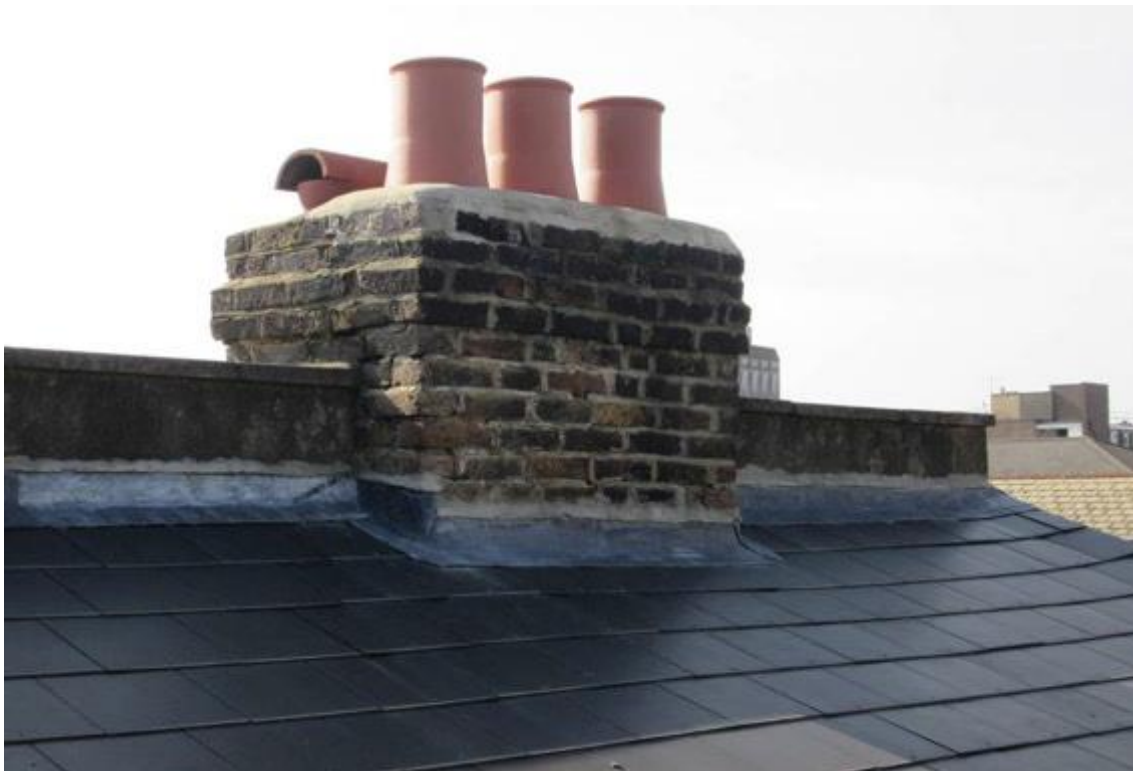
The chimney stack to the left side of the upper back addition roof has brickwork that is untidy in appearance, although it is not specifically defective.

There are a few spots of missing pointing to the front face of the stack, but this isolated lack of pointing has not invalidated the overall stability.

Untidy brickwork to chimney stack to left side of upper back addition roof.

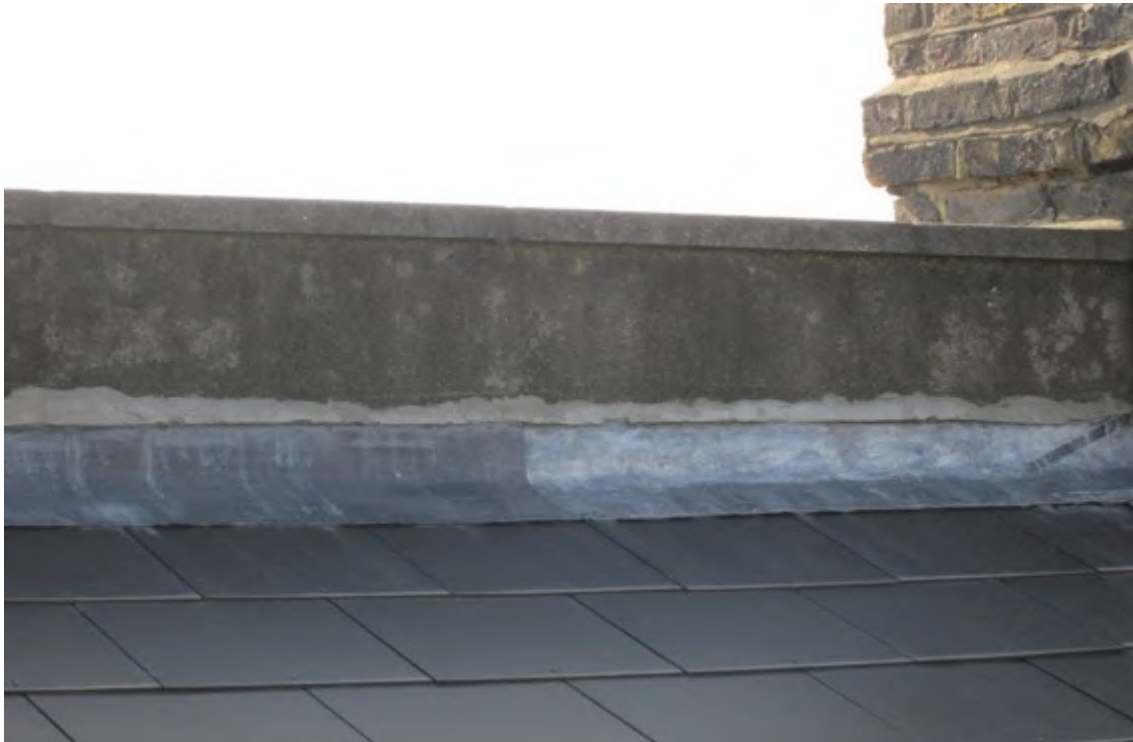
Viewed from the window of the first floor centre bedroom, the parapet wall is not fundamentally defective, but again the capping detail appears inadequate, and comments made previously in respect of possible damp penetration in the future, also apply here.

The abutment detail between the head of the slates and the parapet wall/chimney stack is formed with lead flashings, in satisfactory condition, as viewed from the first floor centre bedroom window.

Parapet wall to upper back addition roof with poor capping detail but correct flashing detail.

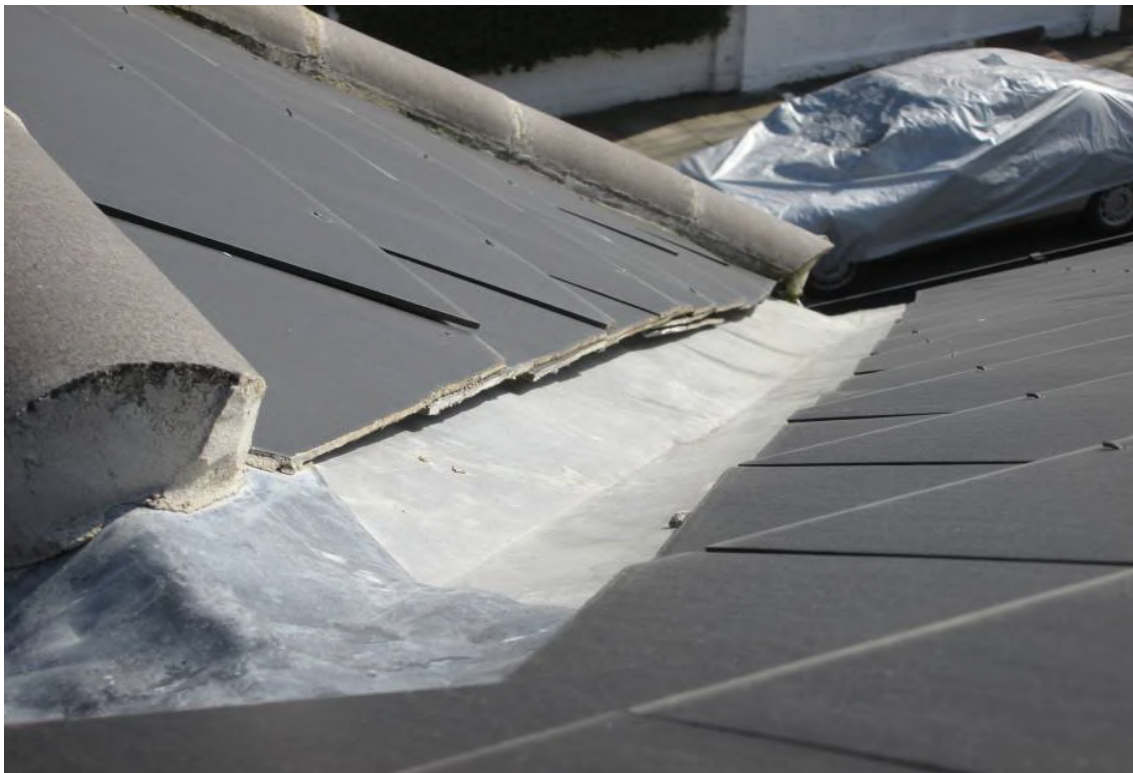
At the abutment where the front slope meets the various slated slopes to the front bay, constructional details known as valley gutters are in position, which to the subject property are covered with sheet lead. As viewed from the two skylights to the second floor bedroom, the leadwork is in satisfactory condition.

Valley gutter to front of main roof covered with leadwork.

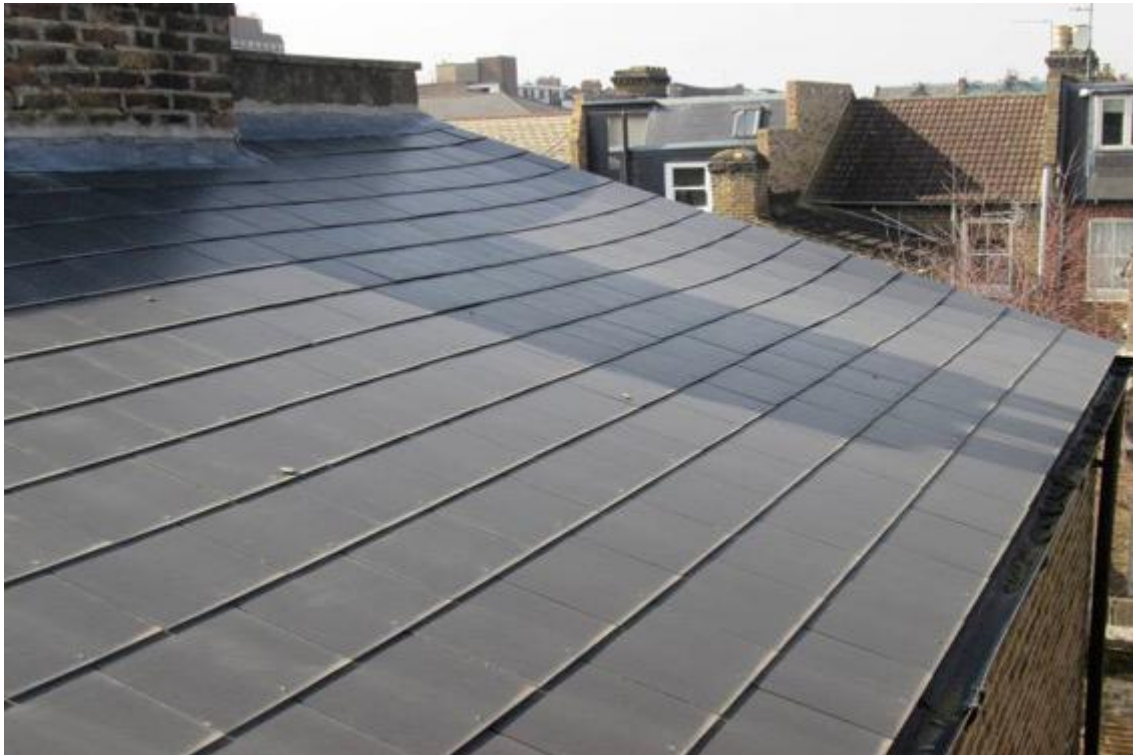
Our inspection of the roof above the two-storey back addition from the first floor centre bedroom did reveal an amount of unevenness to the roof slope. The distortion is almost certainly caused by unevenness in the rafters beneath. On a property of this age and type, this is not an unusual phenomenon, and certainly we do not recommend that any significant works are required at the present time. However, the situation should be monitored, and if there is any further distortion from the existing profile, it might be necessary to carry out some works to strengthen the roof timbers beneath.

Uneven profile to slating to upper back addition roof.

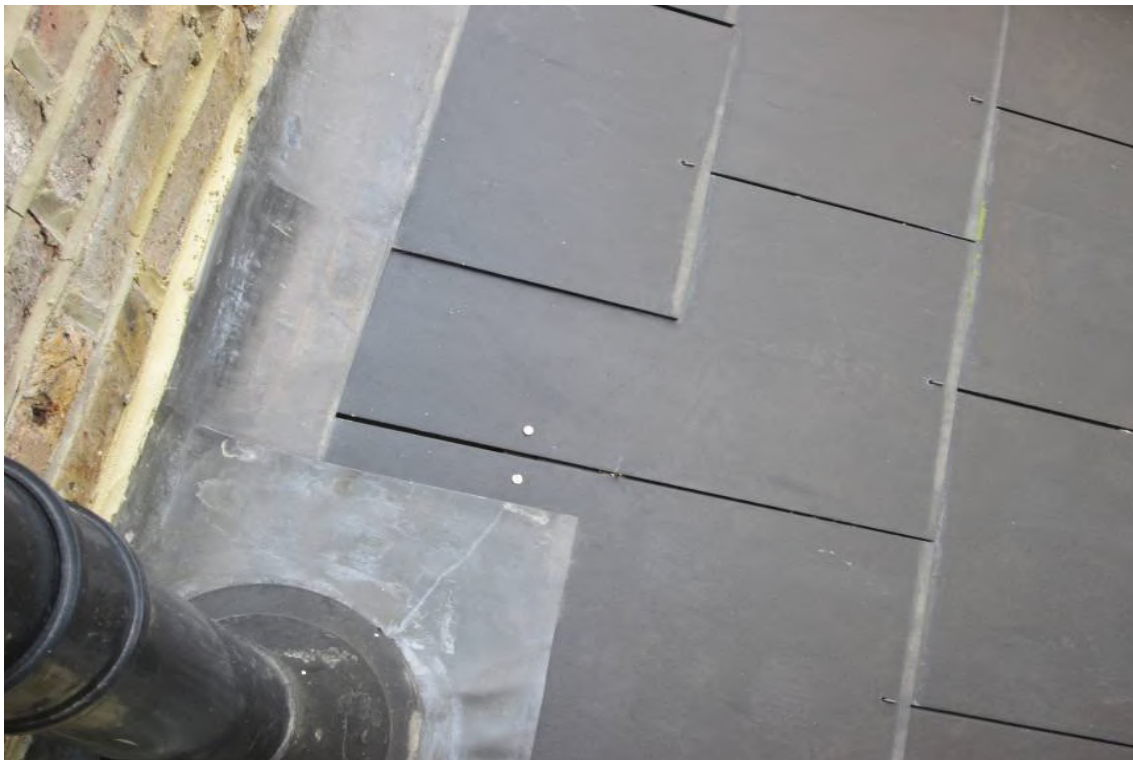
It appears that one slate is missing to the front left corner of the roof above the single-storey extension, adjacent to the soil pipe. It needs to be replaced.

Missing slate to lower rear subsidiary roof.

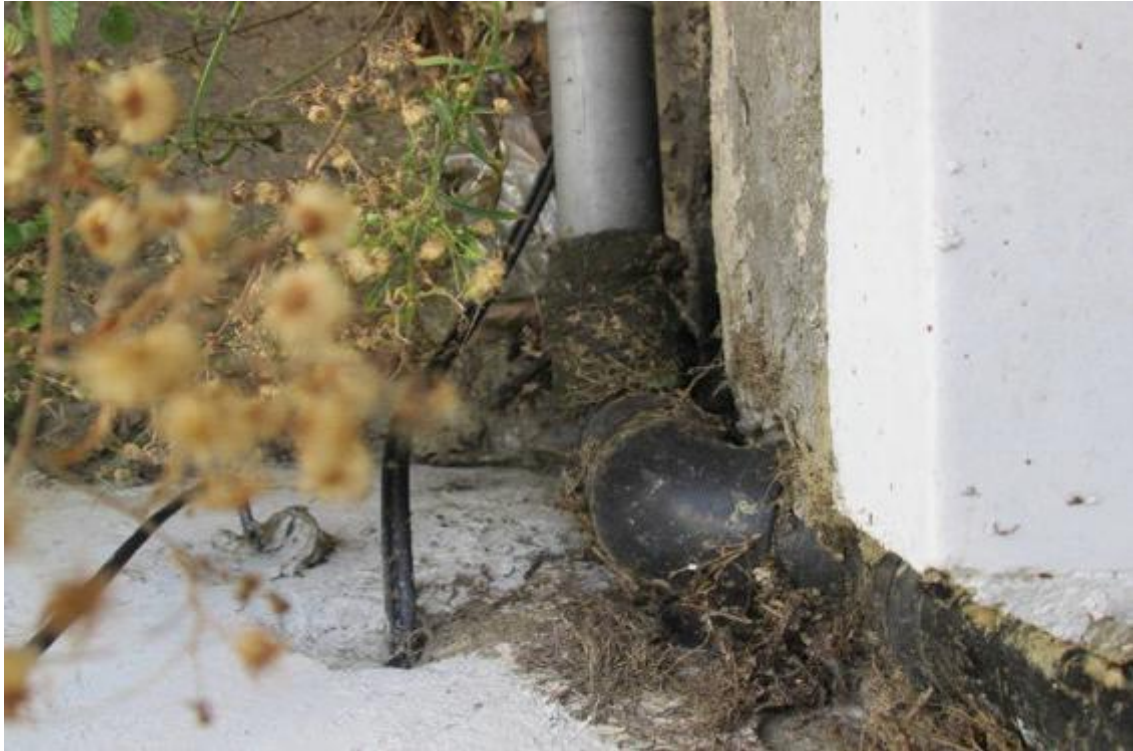
This particular downpipe discharges onto the pavement, after running through the front garden to the right side adjacent property. The main bend to the downpipe adjacent to ground level in the neighbouring garden appears to be wrapped with a waterproof bandage. This is probably in position to deal with a leak but in a temporary and unsatisfactory manner. We assume that this would be the adopted repairing responsibility of the right side adjacent property, but even if they do ask for 50% of the cost of repair, this would be an insignificant sum.

Bandaged joint at low level to downpipe to right side of front elevation.

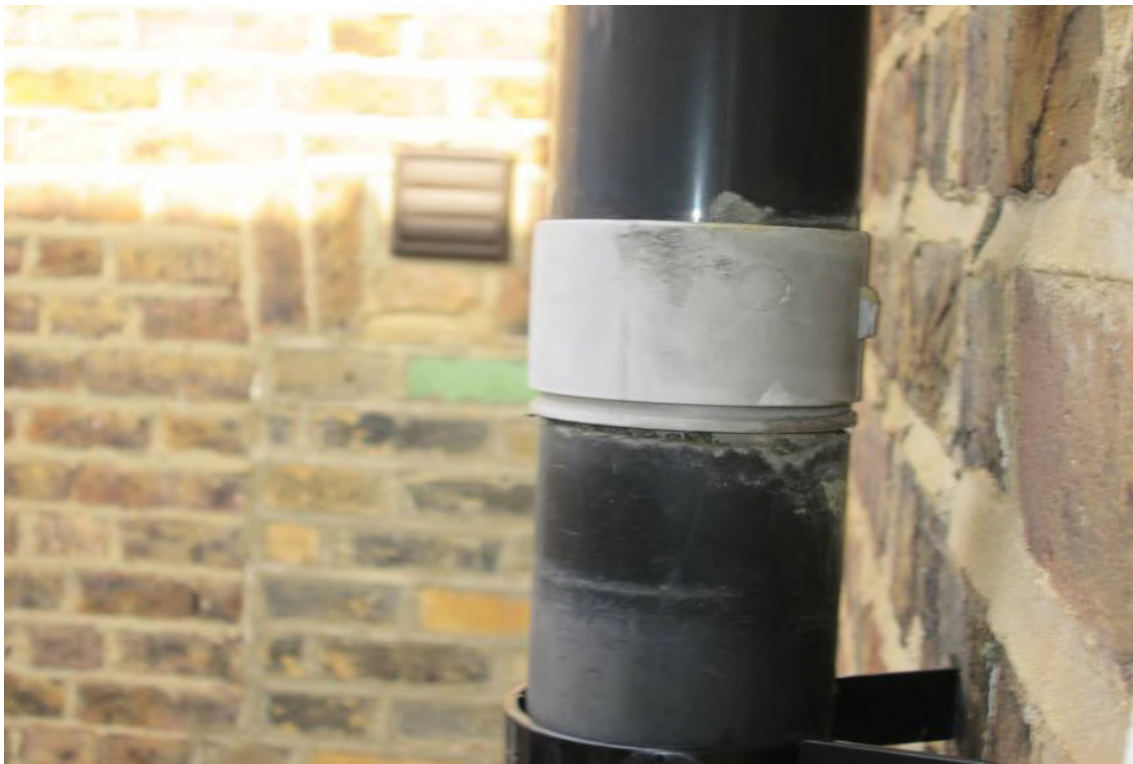
There was evidence of slight weeping to several of the gutter/downpipe joints and you should anticipate having to carry out the re-sealing of individual, defective joints in the interests of routine maintenance.

Weeping rear downpipe joint.

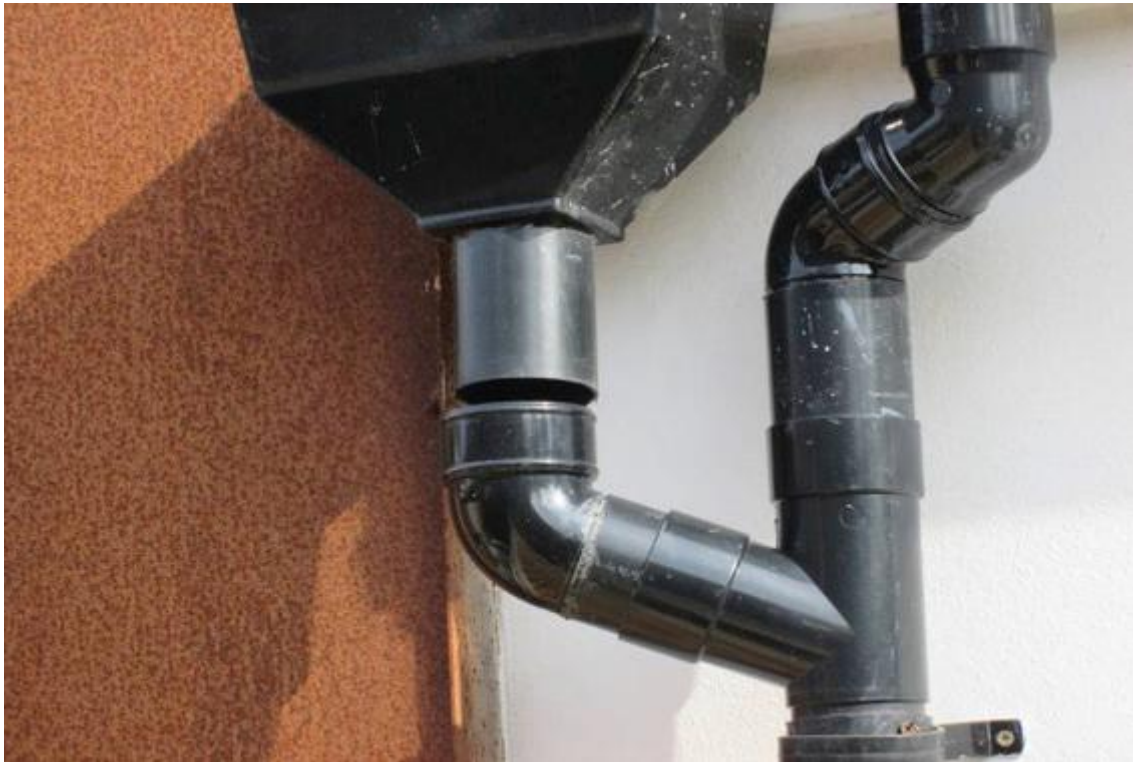
To the rear of the property, the joint between the hopper draining the box gutter to the subsidiary roof and the associated downpipe beneath has come loose, and the downpipe/hopper need to be re-connected.

Separated joint between rear hopper and downpipe beneath.

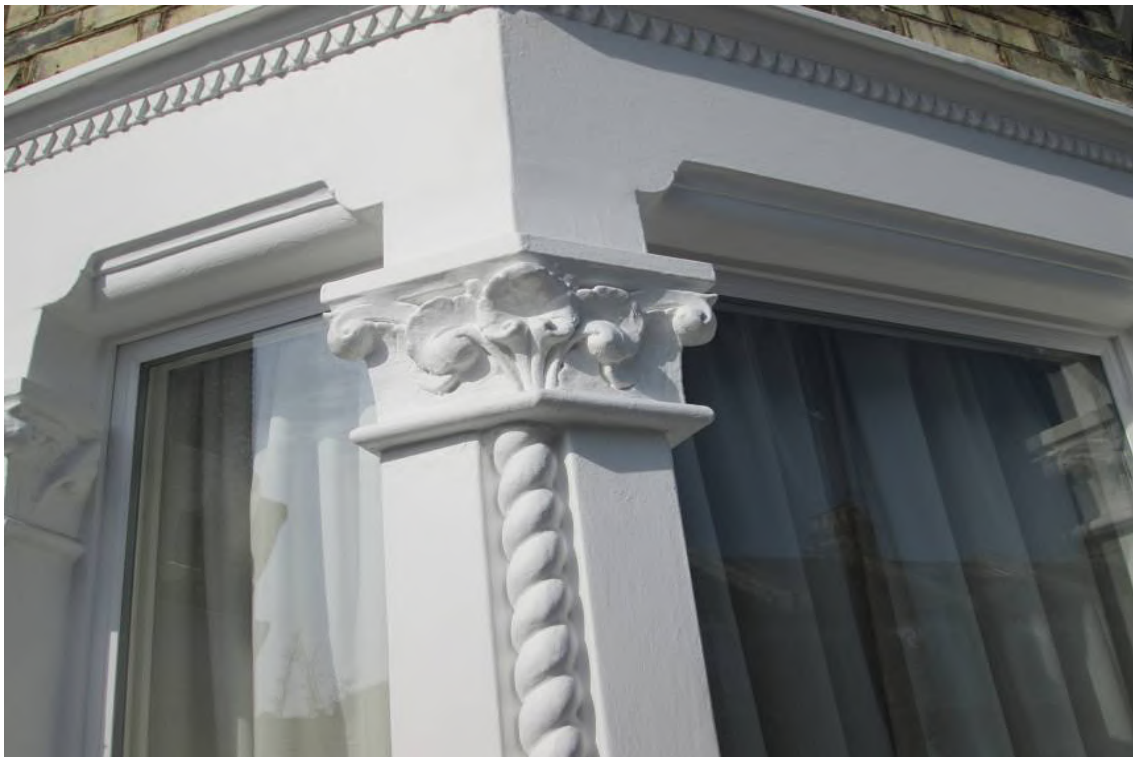
To the front elevation, the brickwork incorporates an amount of ornamental render detailing as part of the bay construction and over the door/window heads. The ornamental render is in surprisingly good condition, and has retained much of its crisp, original profile, which is a positive factor.

Ornamental render to front bay retaining its sharp detailing (1).

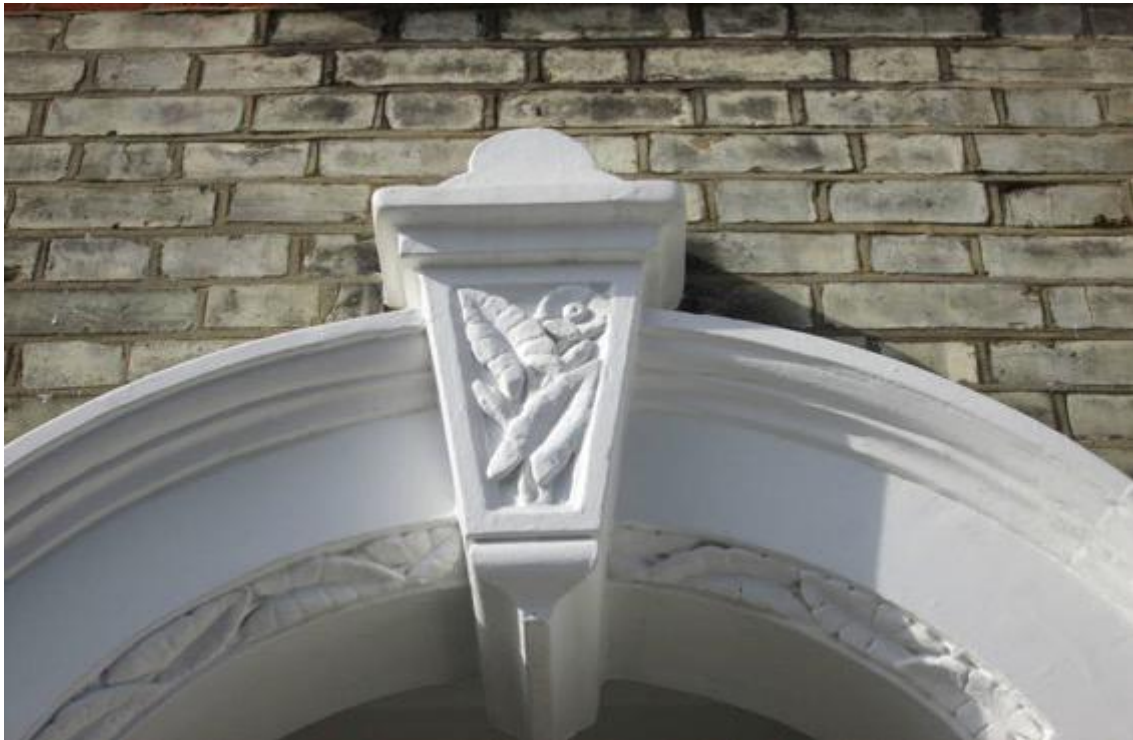
Ornamental render to front bay retaining its sharp detailing (2).

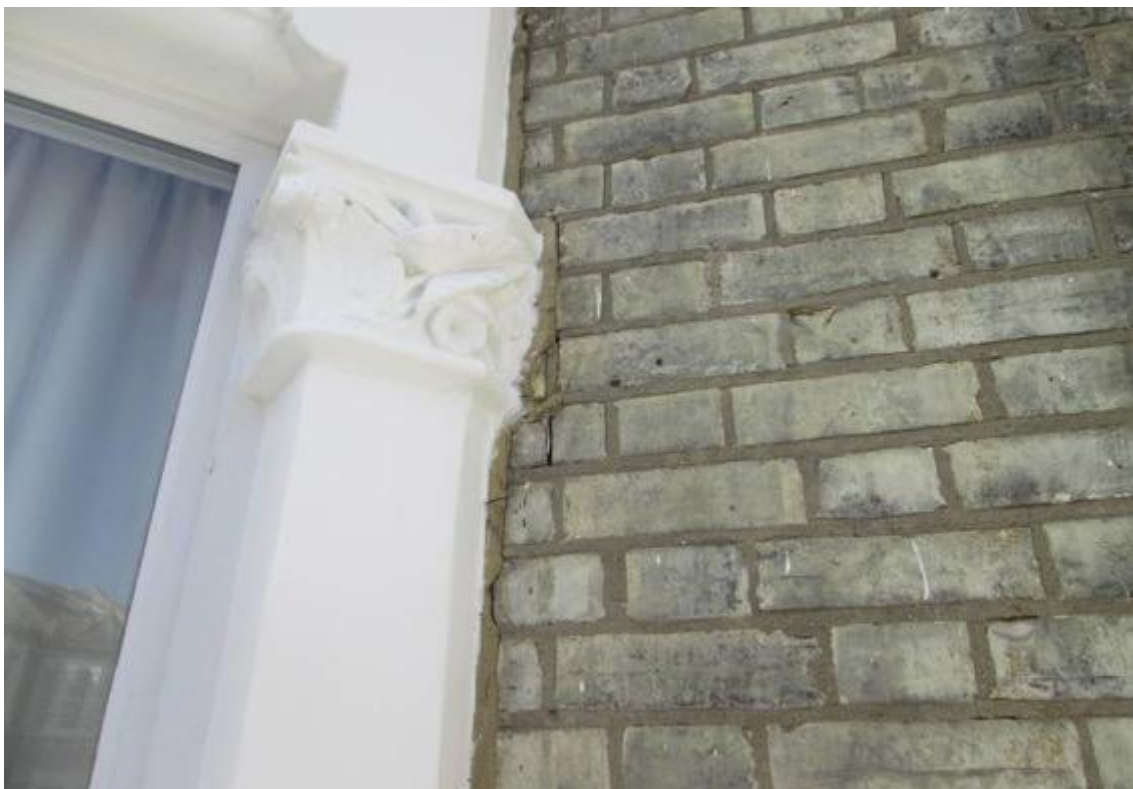
No separation between bay and front elevation.

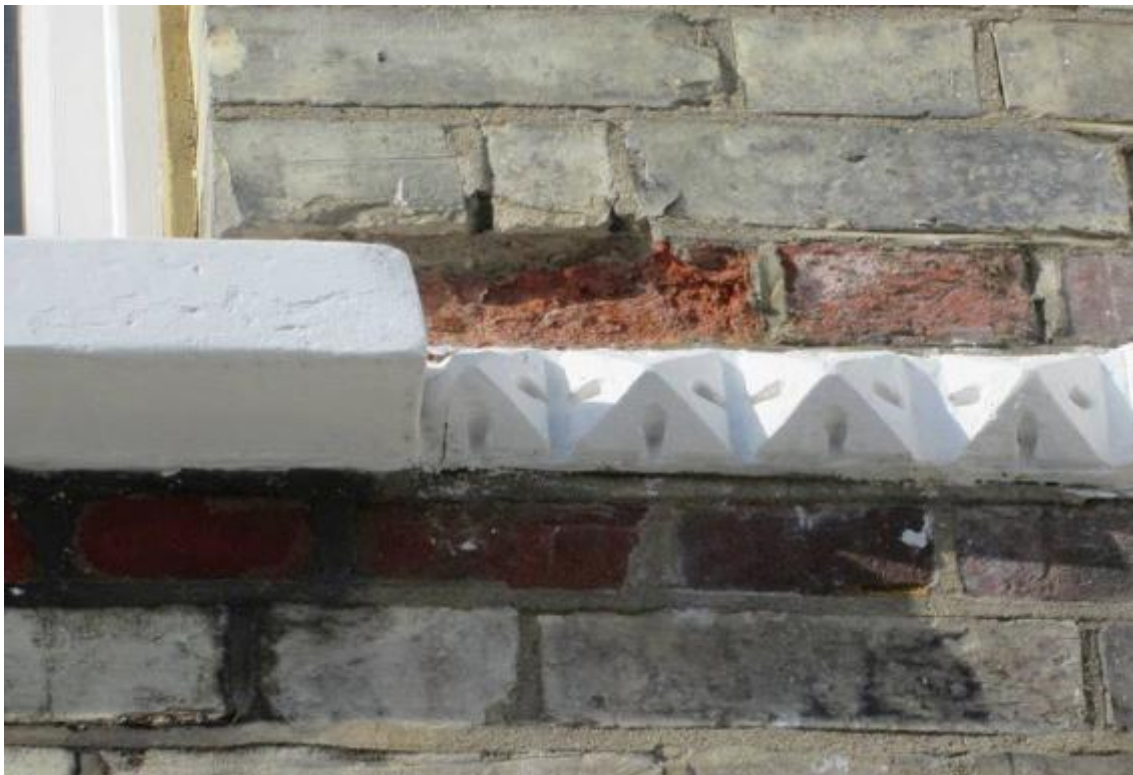
One individual brick is spalled to the right side of the window sill to the first floor left window, but this is an insignificant matter.

Single spalled brick at first floor level to front elevation.

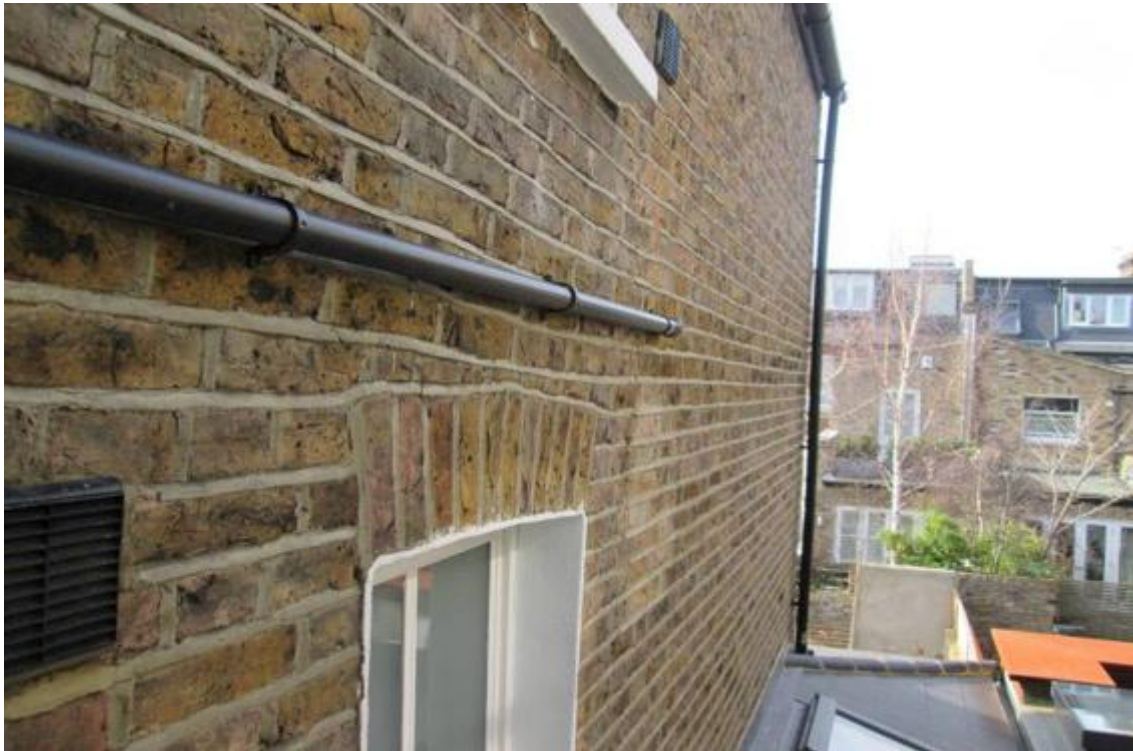
To the rear of the property, there is some slight distortion of the brickwork around the head of the window to the first floor main bathroom, with further slight disturbance above the window arches to the second floor rear bedroom and the first floor rear bedroom. Any movement that has caused the distortion appears to have stabilised, and there is no current need for any repair works to take place. Should the distortion adjacent to the arches start to develop again in the future, it might be necessary to carry out some limited repair works to the arches and associated brickwork, but on current evidence this is unlikely.

Brickwork slightly twisted over first floor bathroom window.

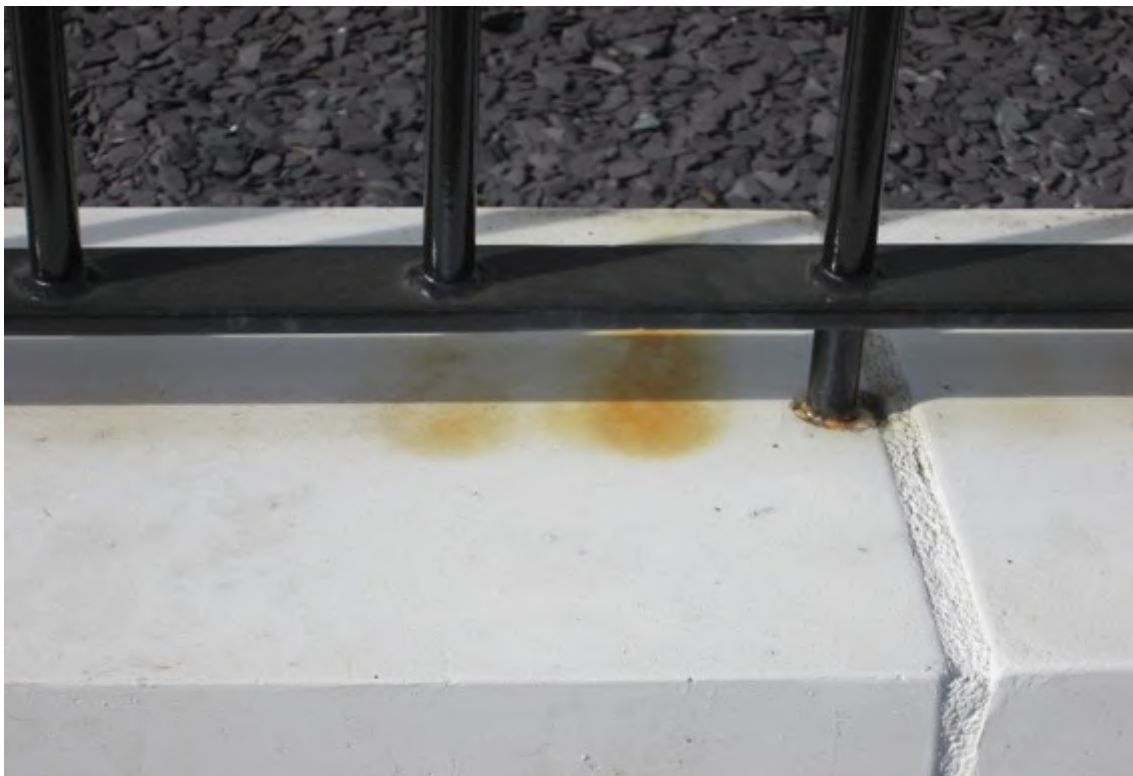
The underside of the bottom rail to the metal railings to the front of the property is not painted, and this has led to rust staining developing on the front boundary wall.

Rust staining to front boundary wall, due to bottom rail to front railings being unpainted.

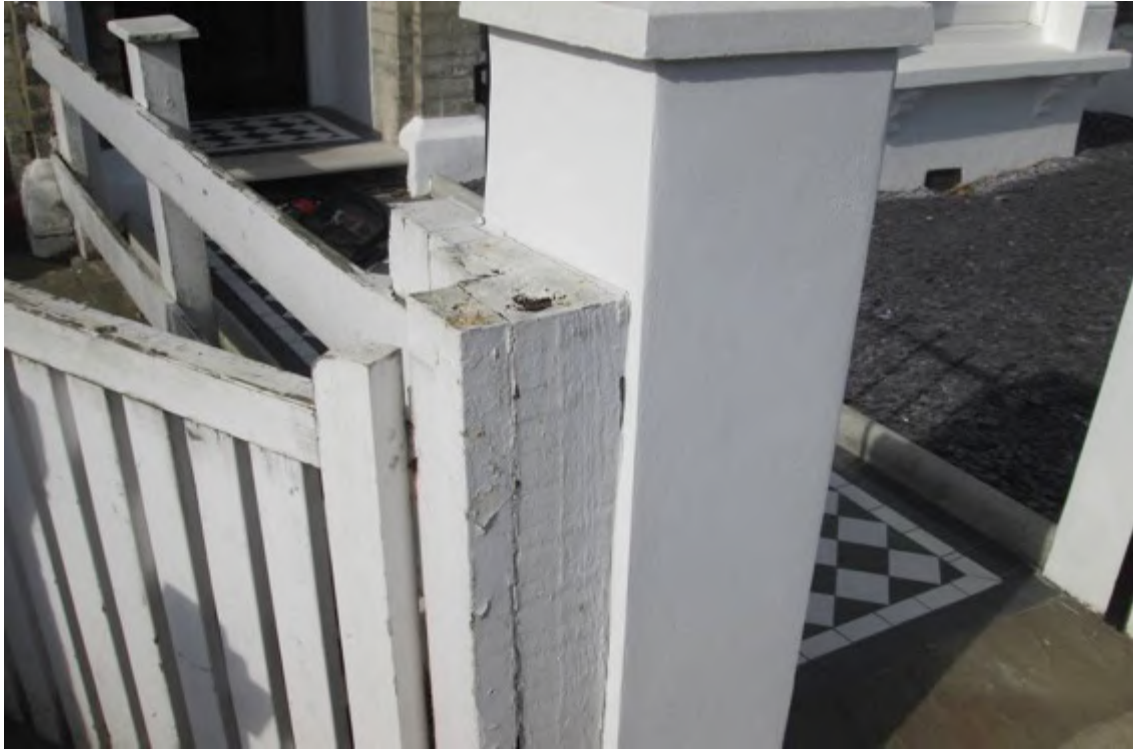
Render to garden gate pier will be unfinished behind timber post.

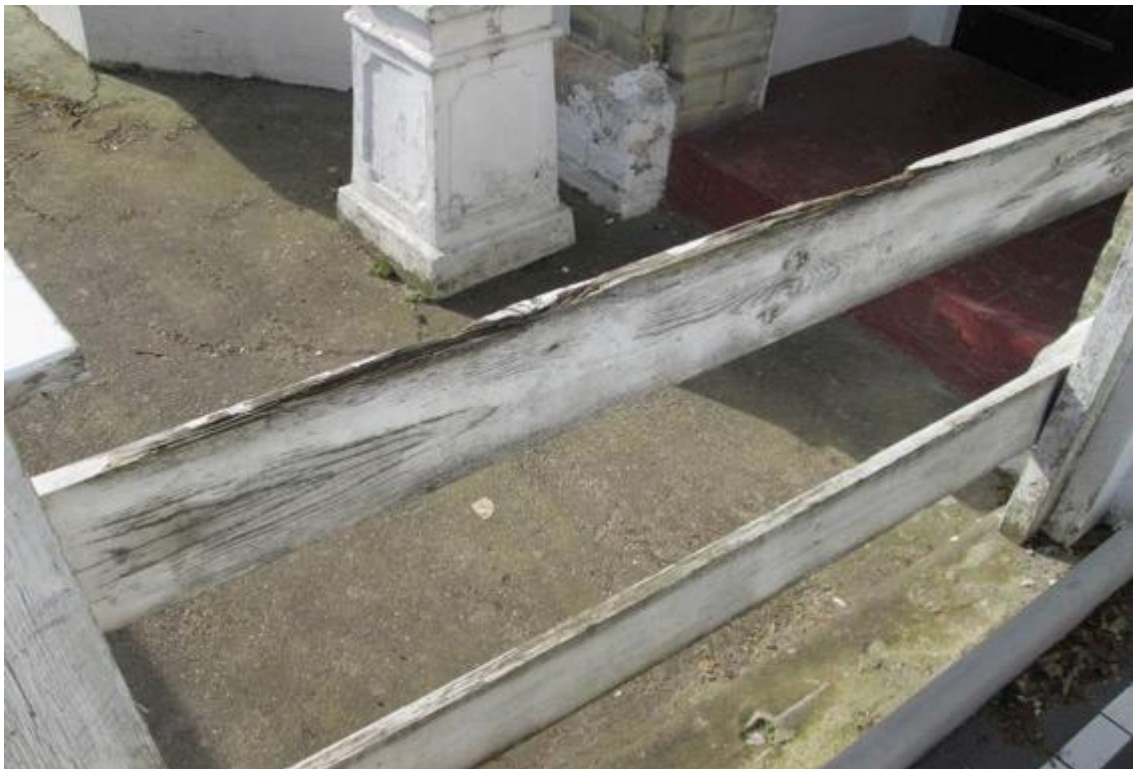
The timber fence to the left side of the front garden is badly decayed and needs to be replaced, although we cannot confirm as to whether the repairing responsibility lies with the subject property or the left side adjacent property.

Timber fence to left side of front garden in poor condition.

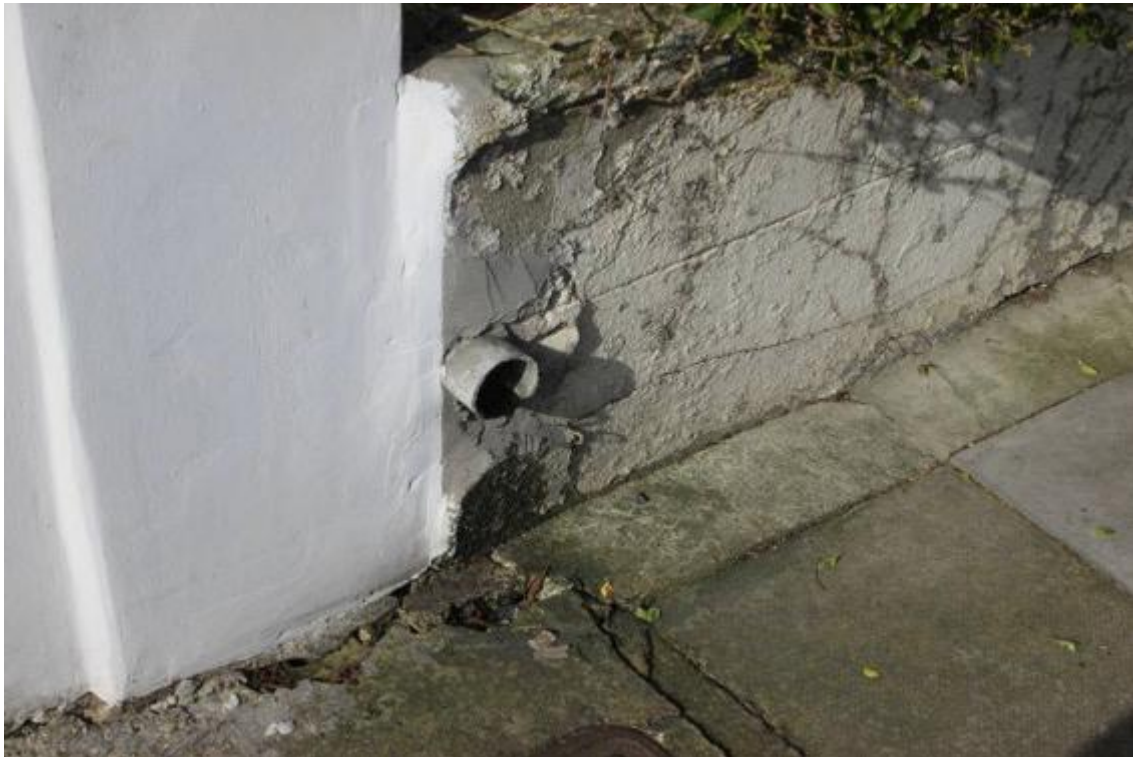
Rainwater downpipe discharging onto pavement.

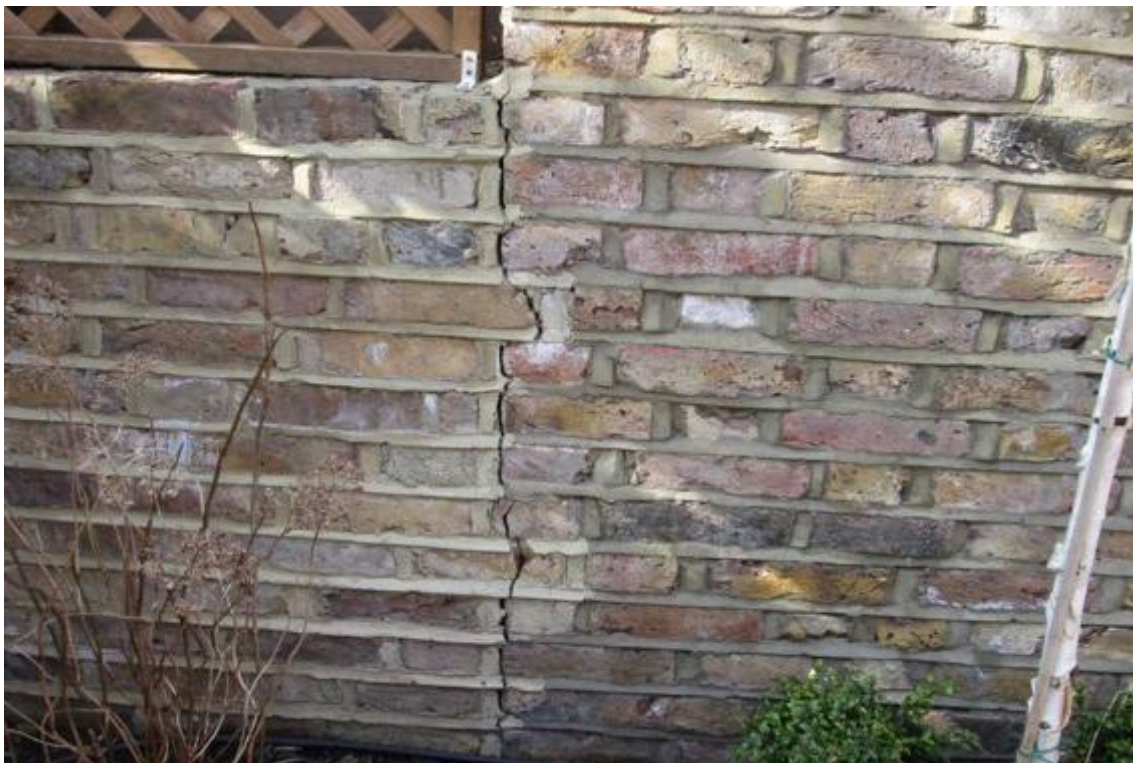
The brick walls surrounding the rear garden are in fair condition only. They are untidy, but generally sound, apart from the rear boundary wall, where there is a vertical crack on the left side and also an area of untidy brickwork in one isolated spot at high level. Limited repairs to the brickwork to these areas should be anticipated.

Crack to rear boundary wall.

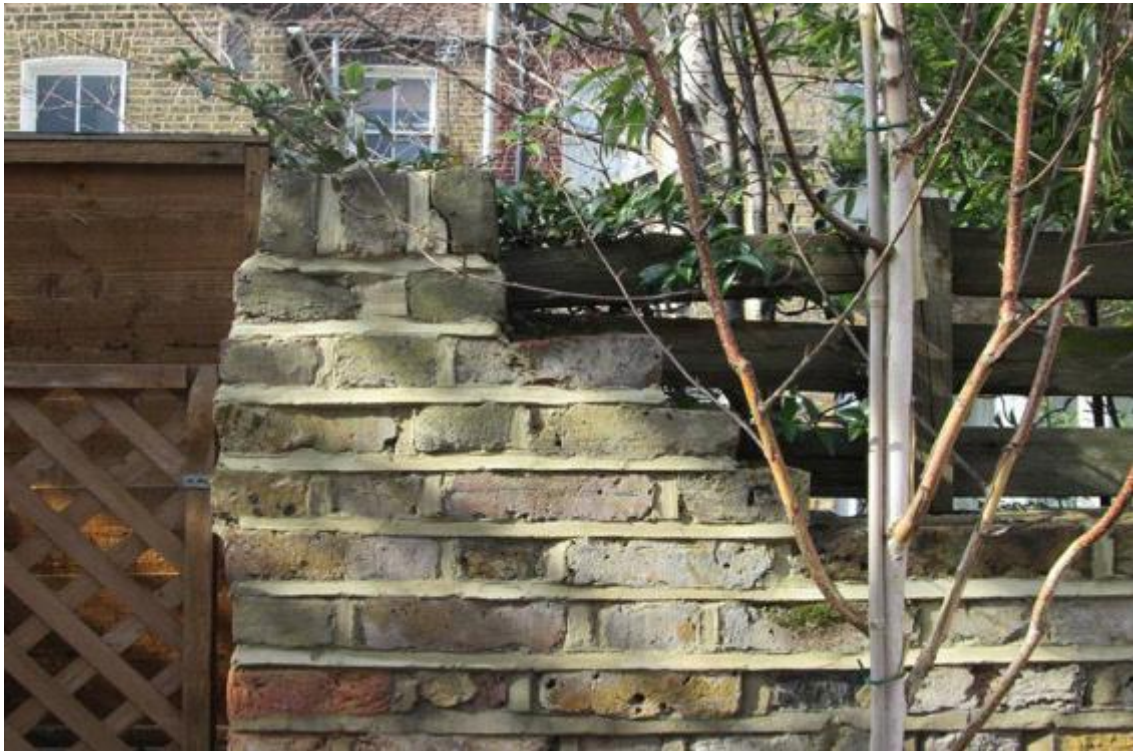
Incomplete high-level brickwork to rear boundary wall.
