Building Survey Report
on
23 Ingersoll Road, London W2 7BE
for
Ms V Davison
as at
11 November 2015

James Ross & Co Chartered Surveyors

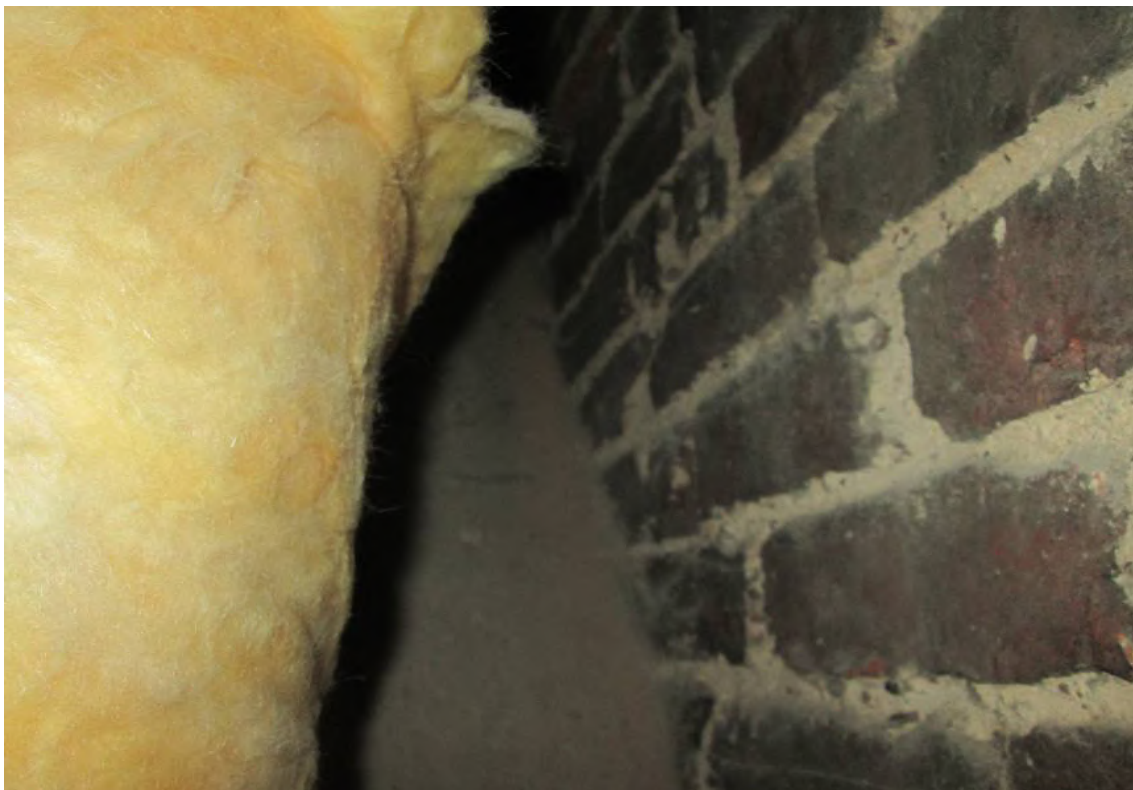
Open gap to right side of second floor bedroom.

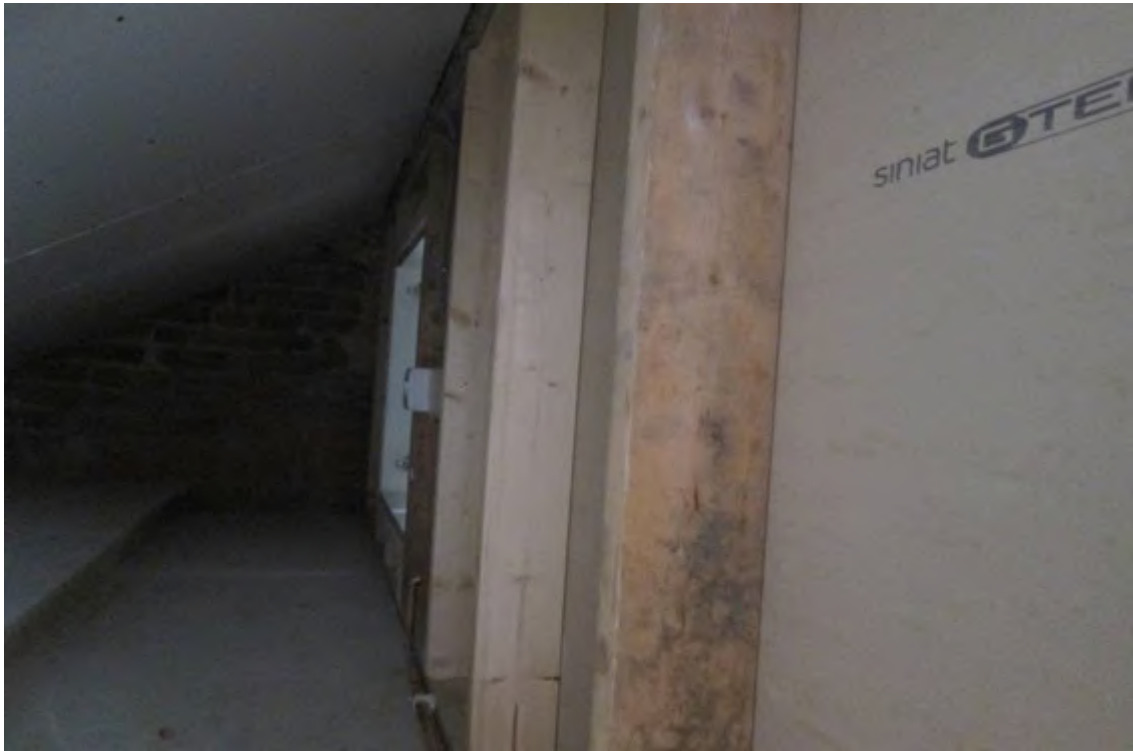
No insulation in stud wall to front of second floor bedroom.

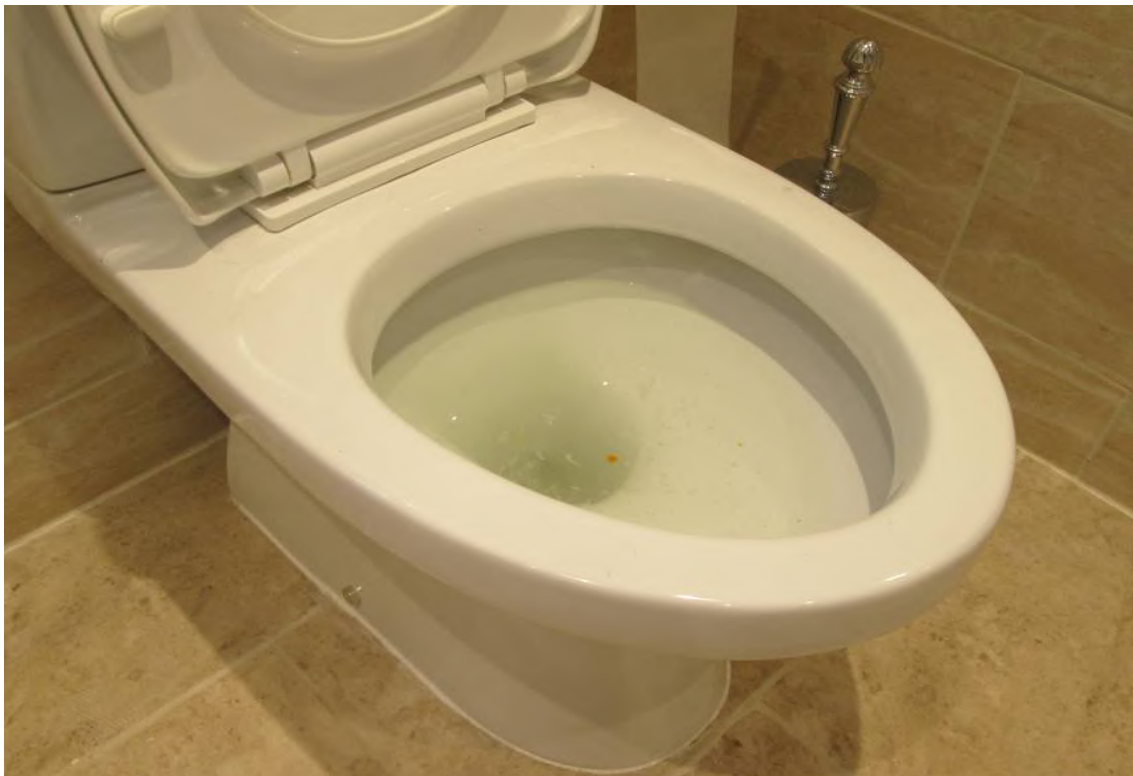
Water at top of bowl to first floor WC pan.

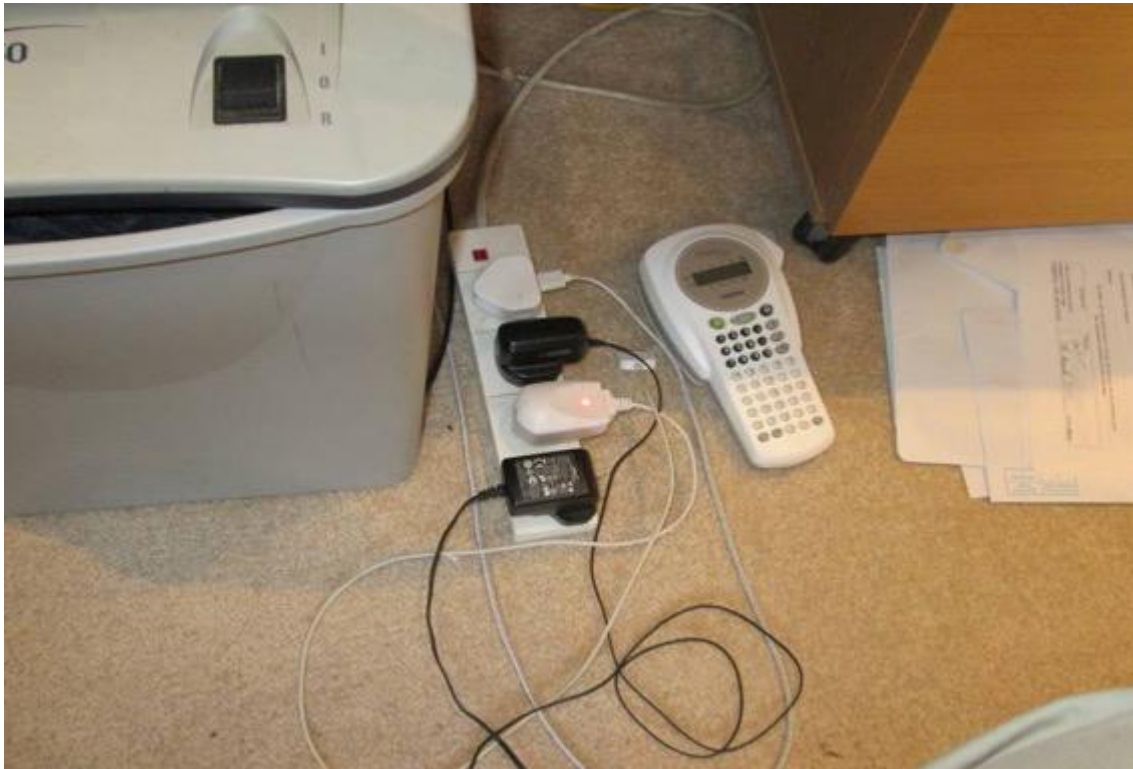
Extension cords to first floor centre bedroom suggesting inadequate power supply.
