Building Survey Report
on
Sunfield House, Townsend Road, Streatley
Berkshire RG8 9LH
for
Ms A White
as at
3 July 2025

James Ross & Co Limited
Chartered Building Surveyors

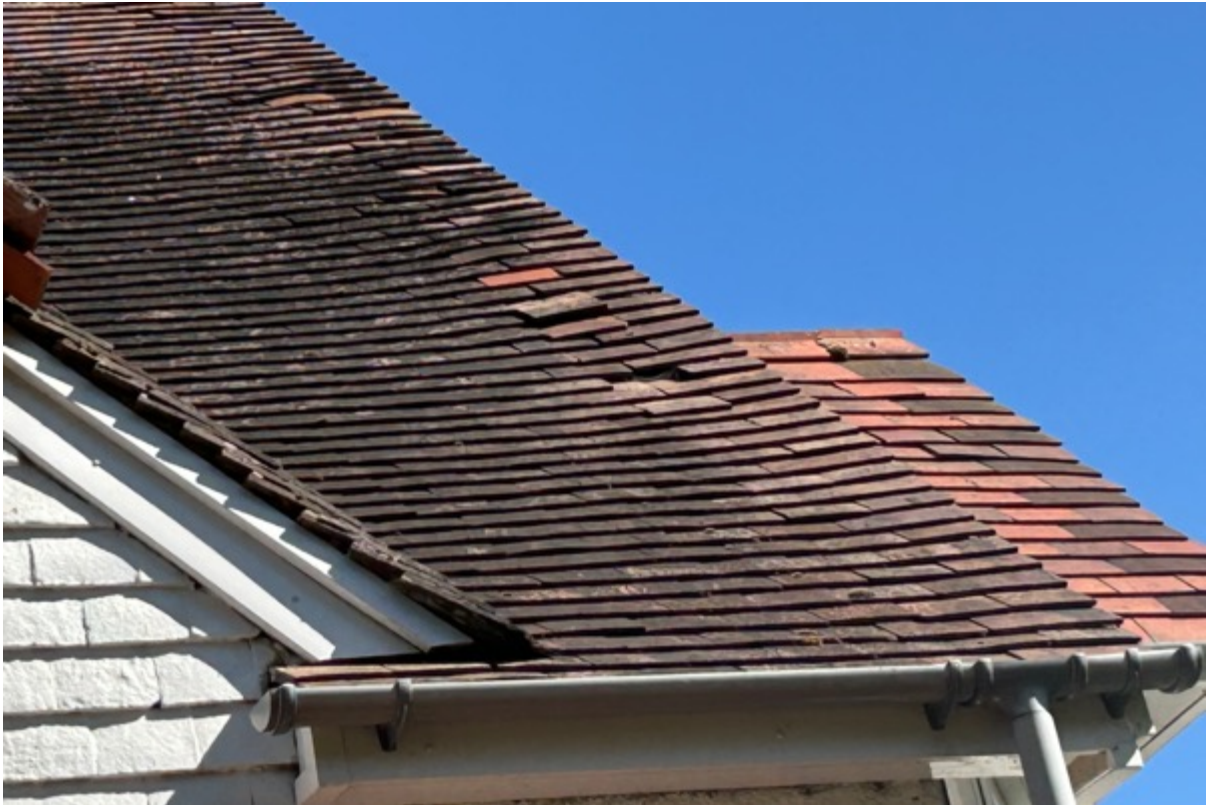
Missing tiling to the right side of the front slope to the main roof.

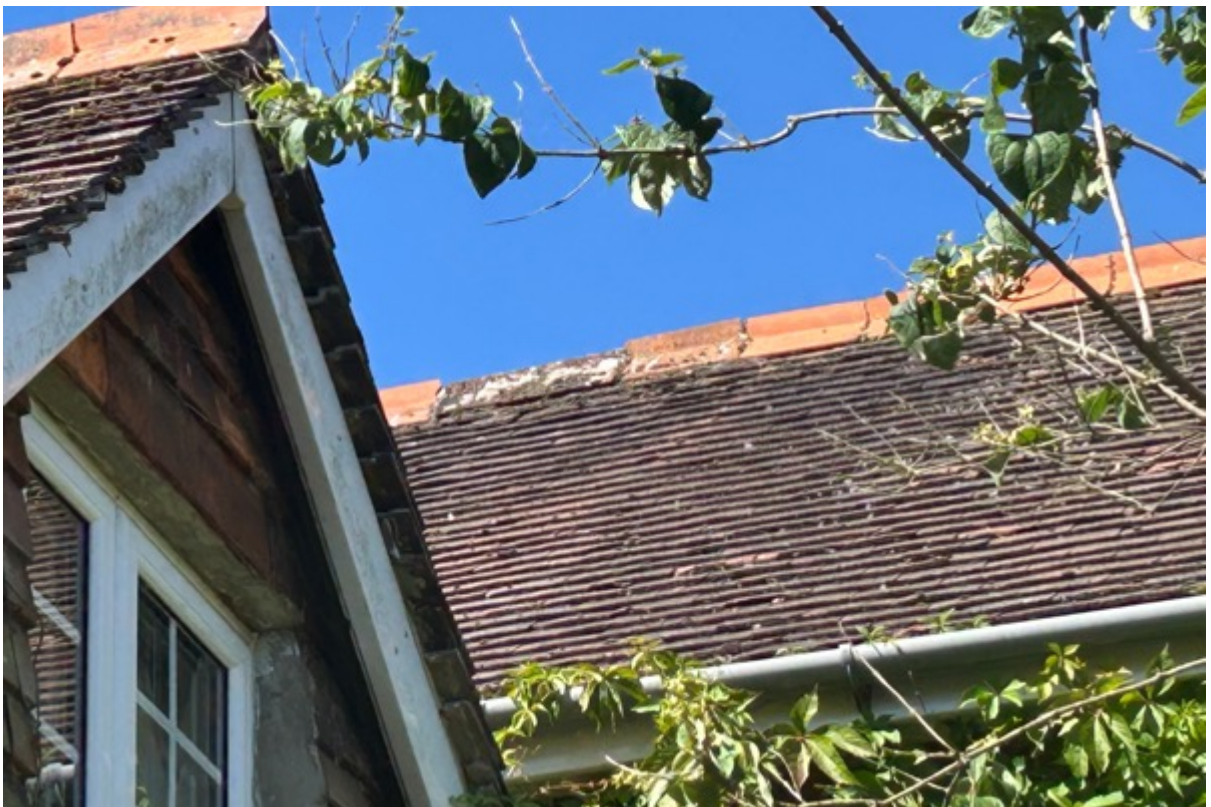
Several badly weathered, non-matching ridge tiles to the rear of the main roof.

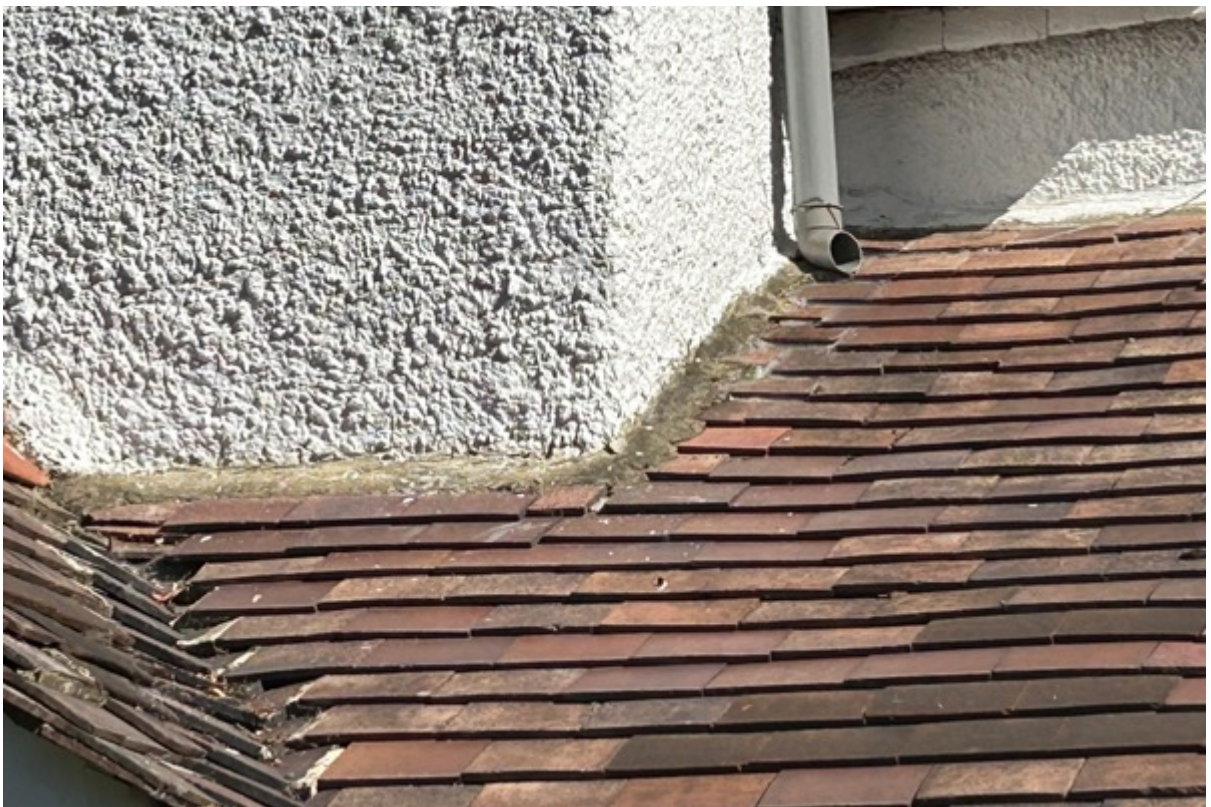
Inadequate cement fillet waterproofing the perimeter of the same roof (1).

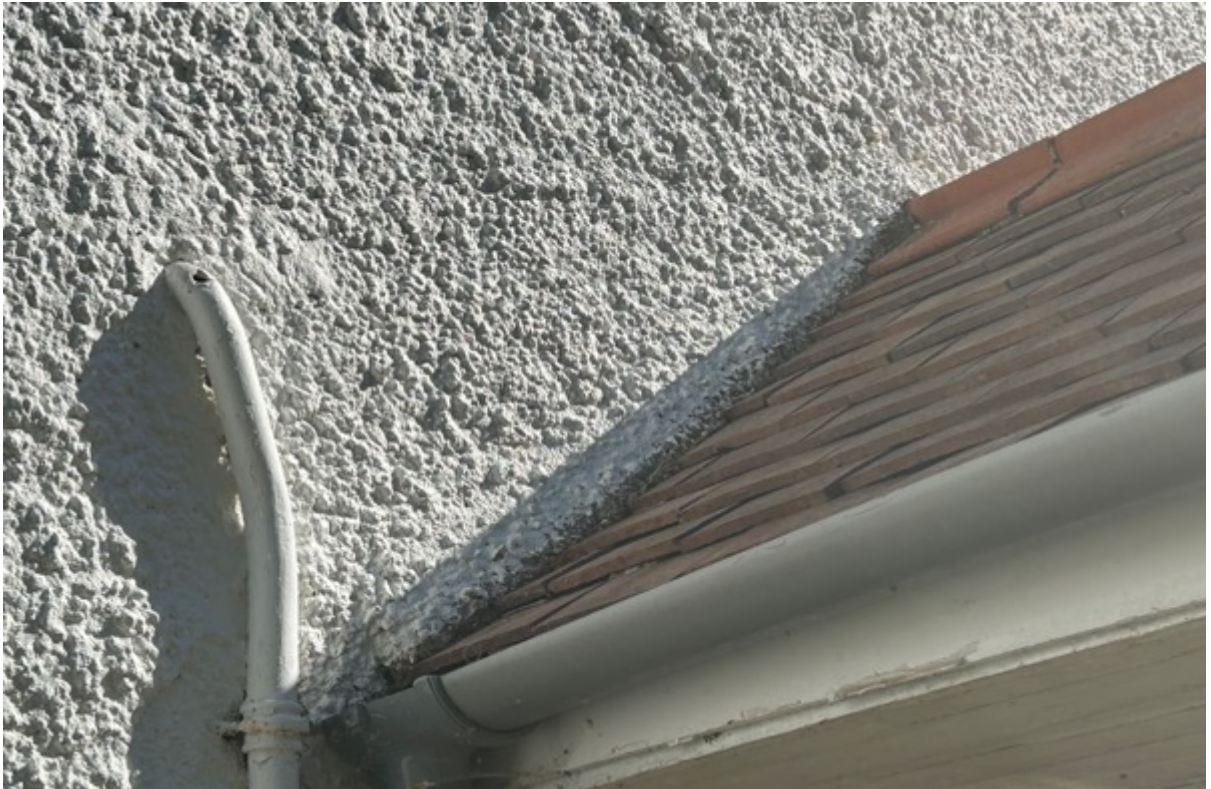
Inadequate cement fillet waterproofing the perimeter of the same roof (2).

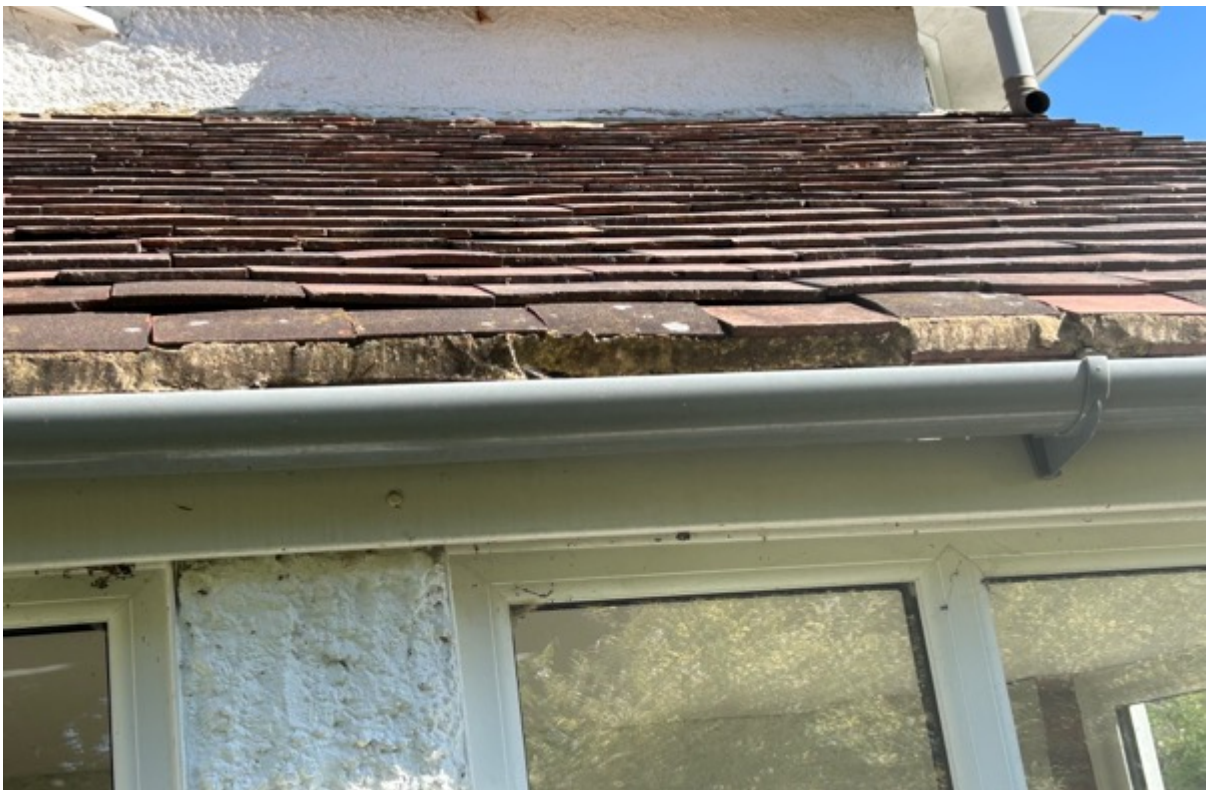
Bizarre arrangement to the bottom of the tiles, with a mortar infill rather than a projecting strip of sarking felt.

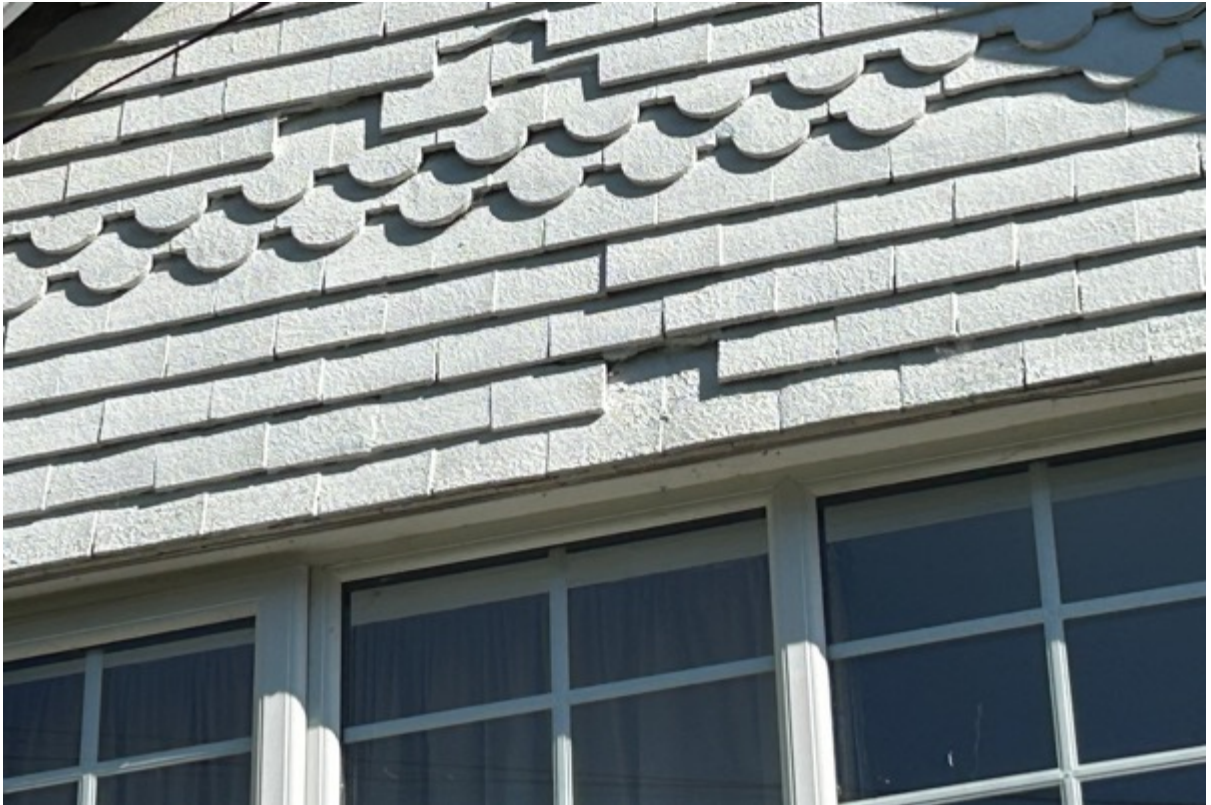
Missing tile at high level to the front gable tile hanging.

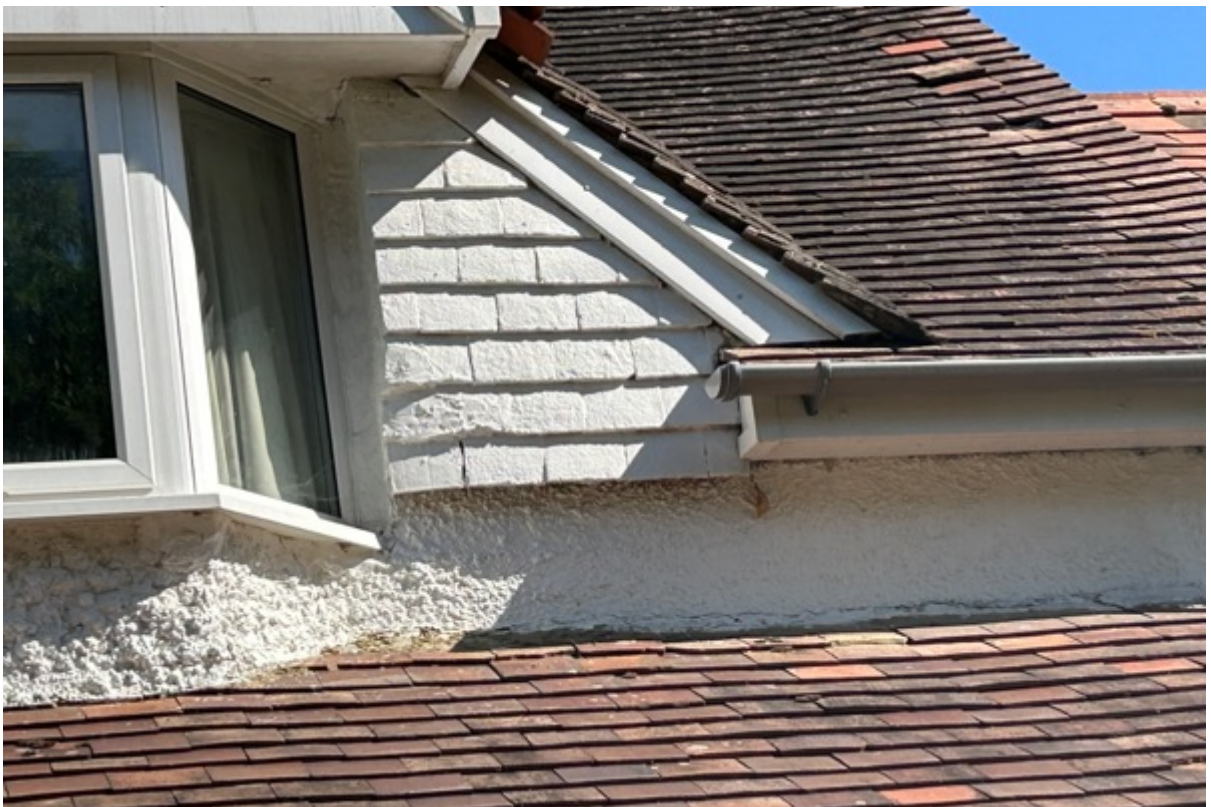
Several tiles to the area of painted file hanging badly profiled and needing replacement.

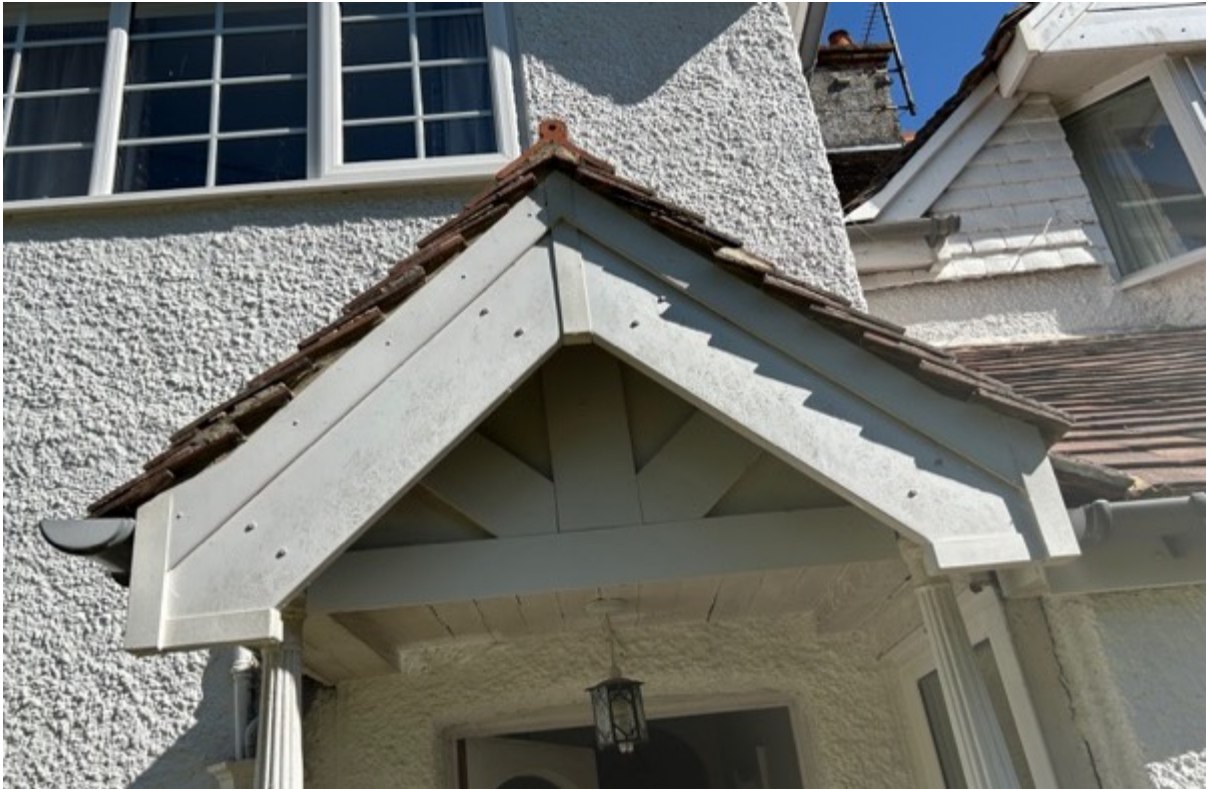
Perimeter PVC boarding to the roof immediately above the front entrance door in satisfactory condition.

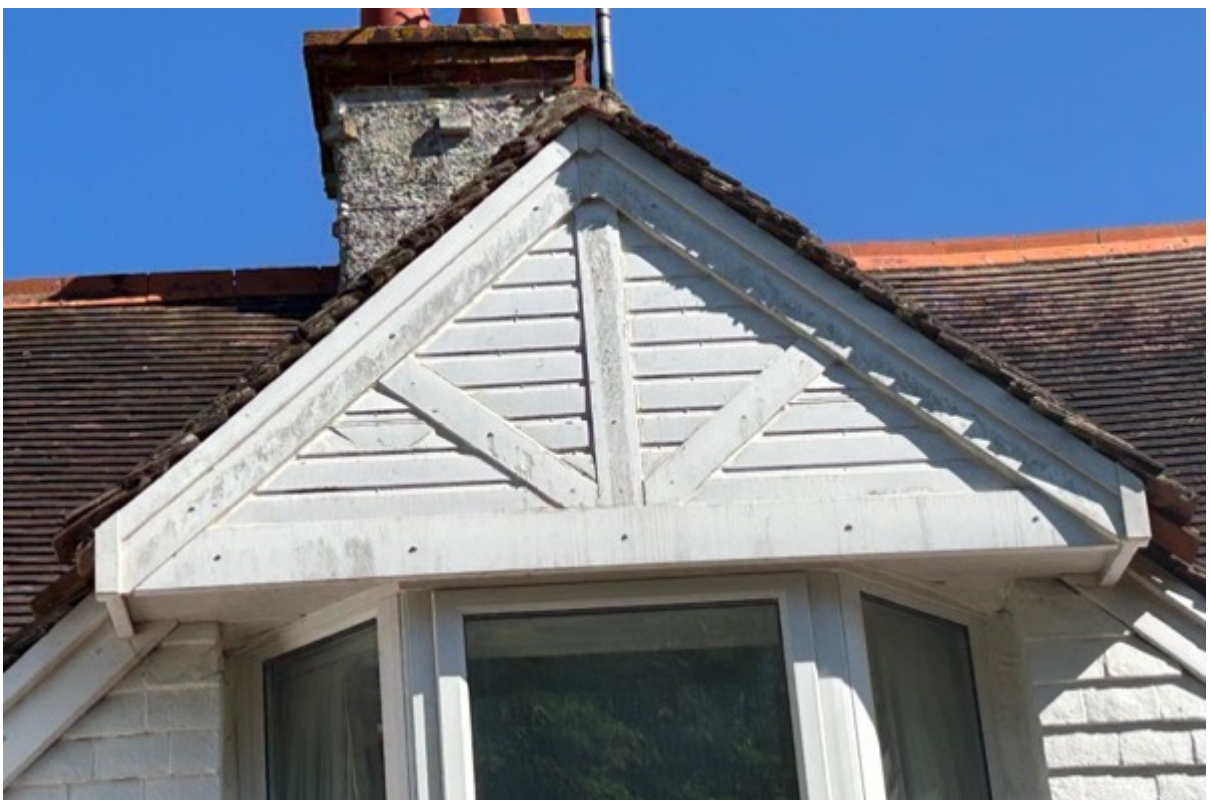
Front gable covered with PVC boarding in satisfactory condition.

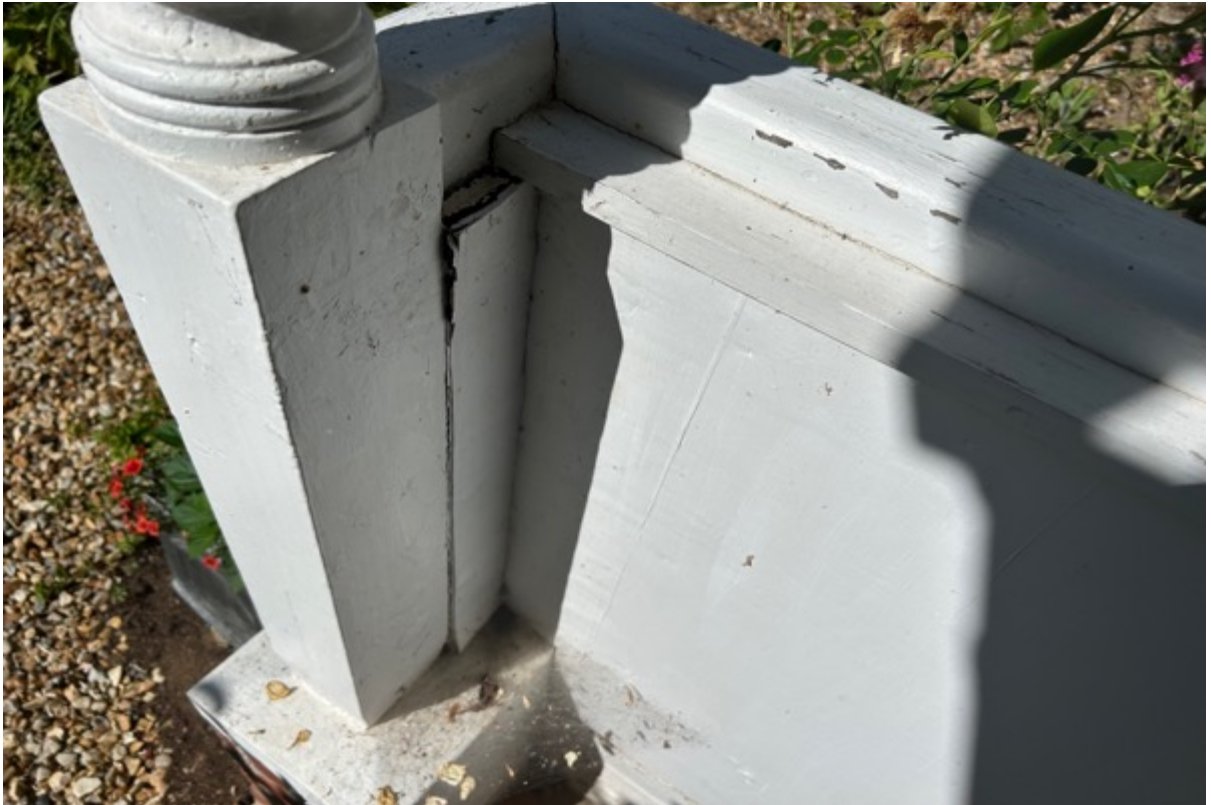
Timber decay to the front porch joinery (1).

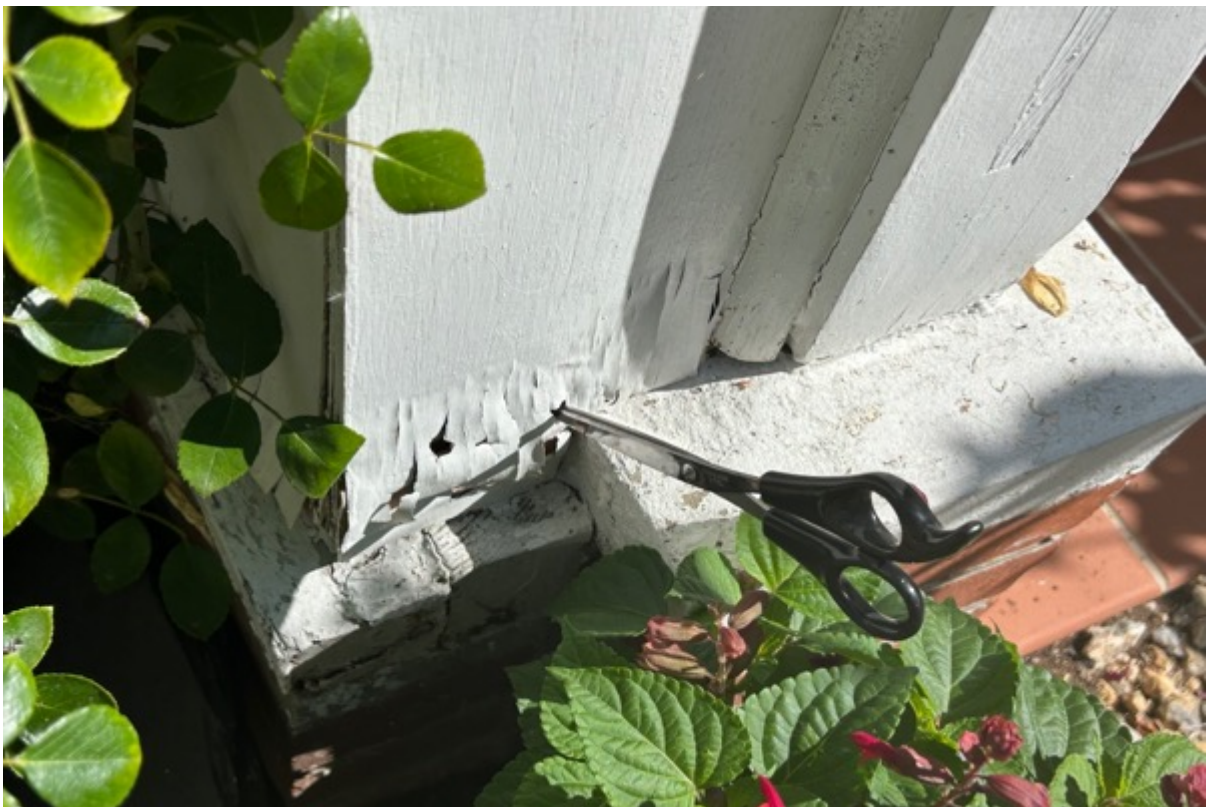
Timber decay to the front porch joinery (2).

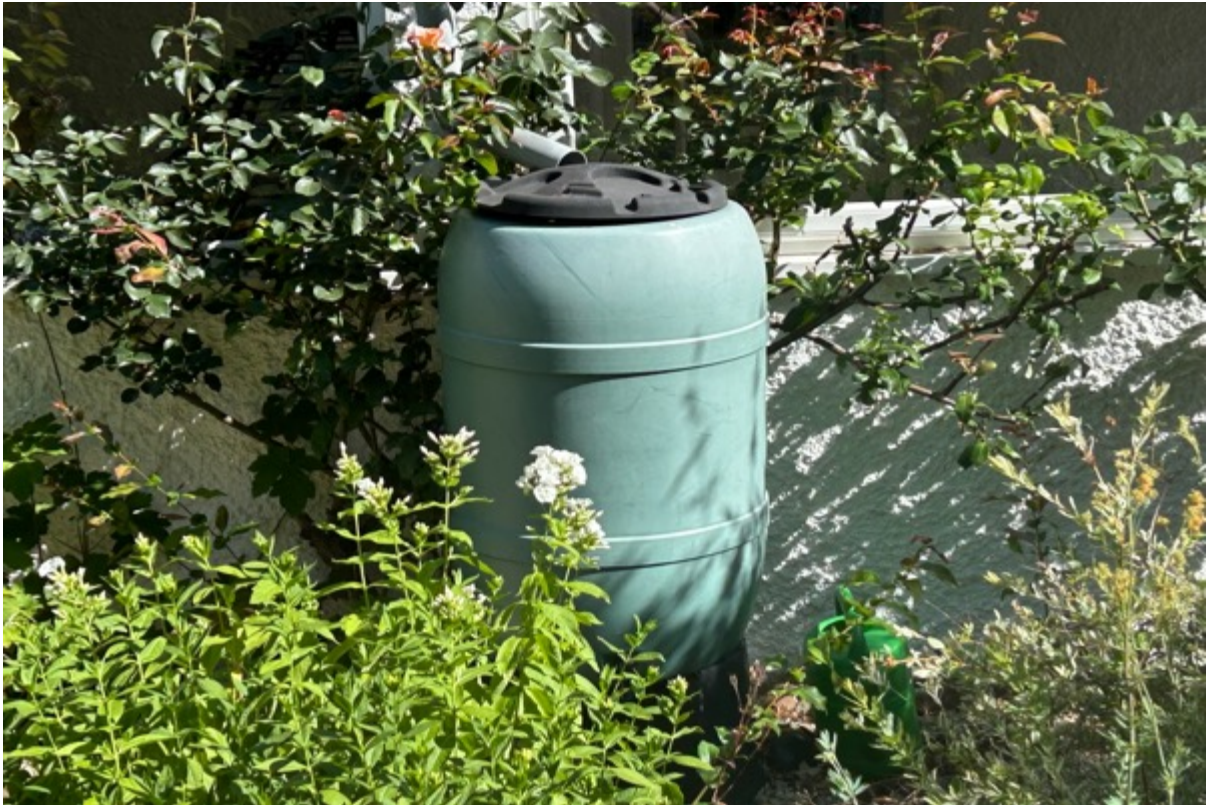
An example of the all-pervading water butts around the property.

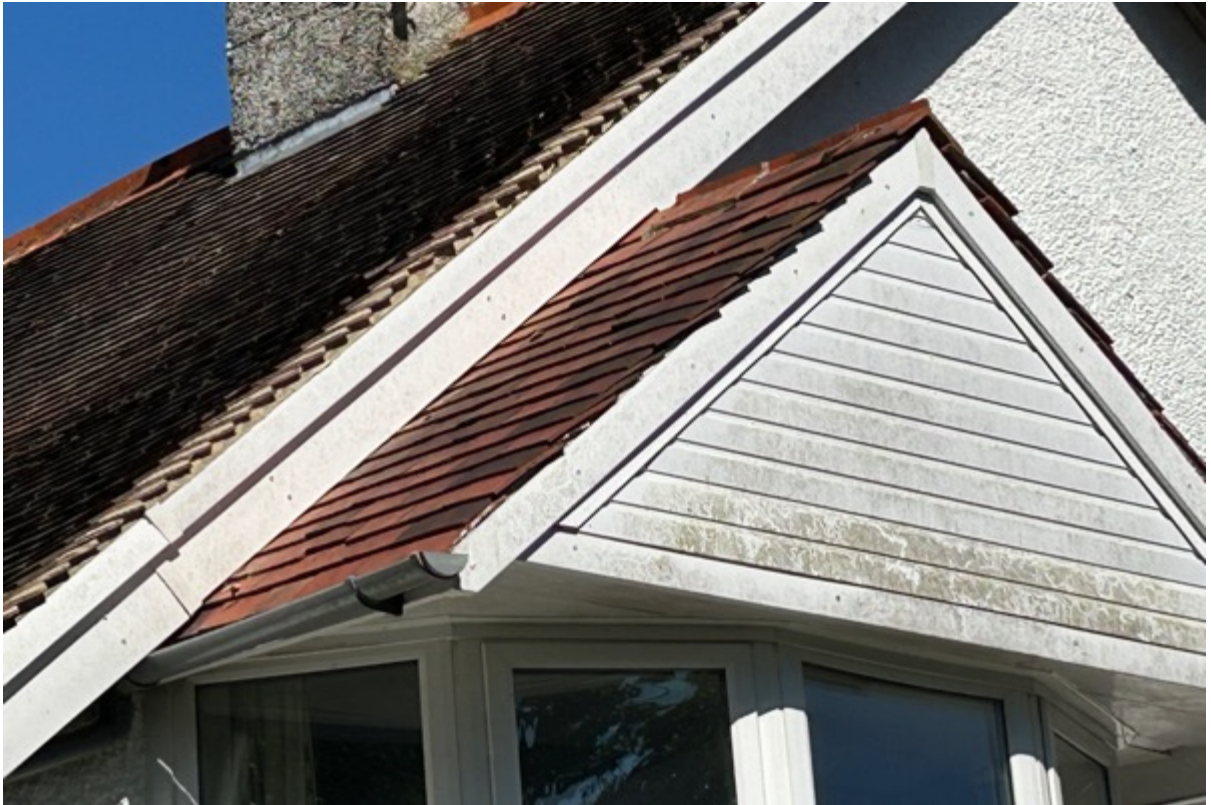
Front slope to the right side upper subsidiary roof in satisfactory condition.

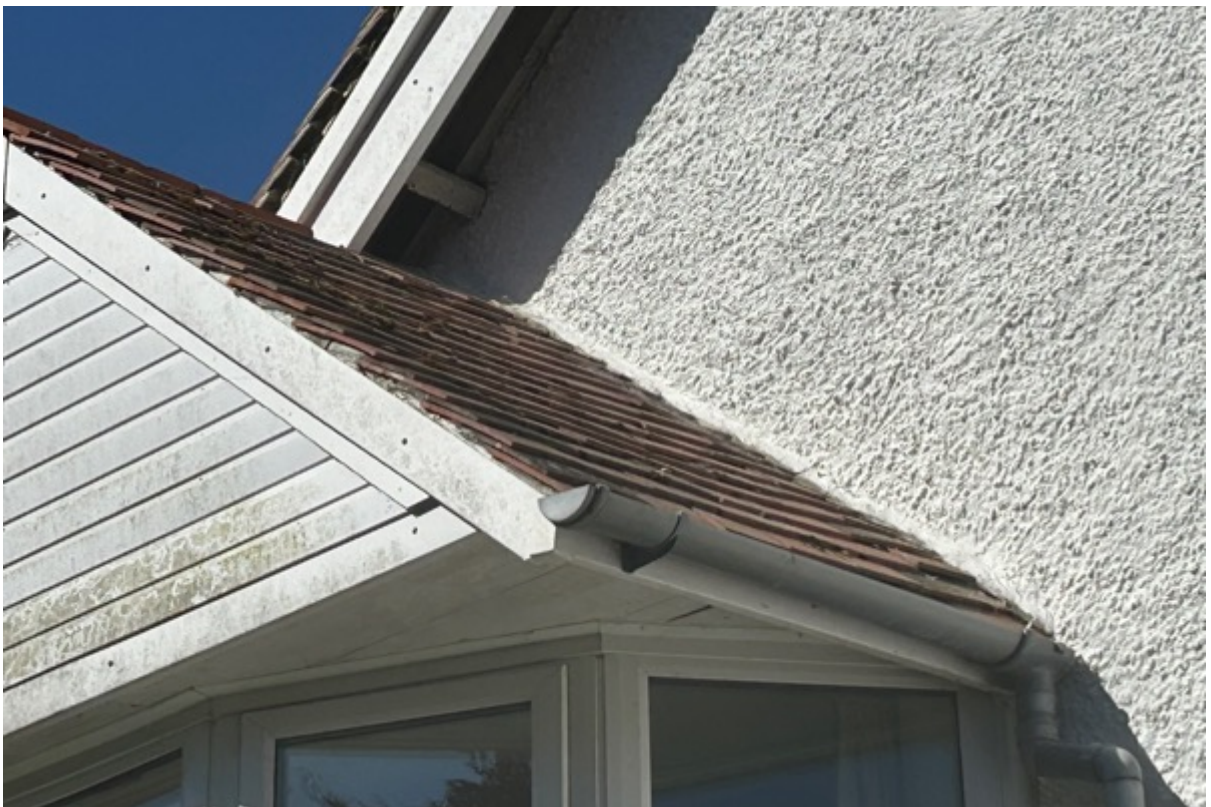
Poor quality waterproofing arrangement to the left side of the rear slope to the same roof.

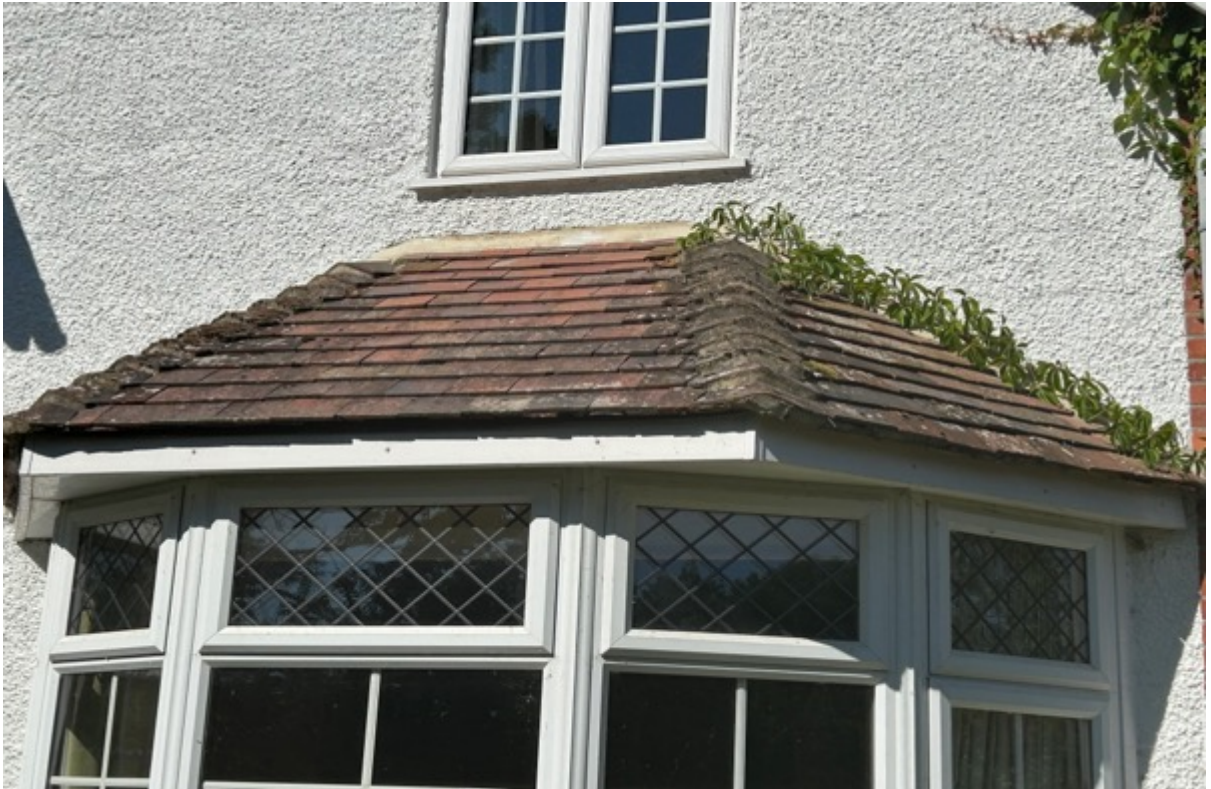
General view of the lower subsidiary bay roof, with no significant defects observed to the tiling.

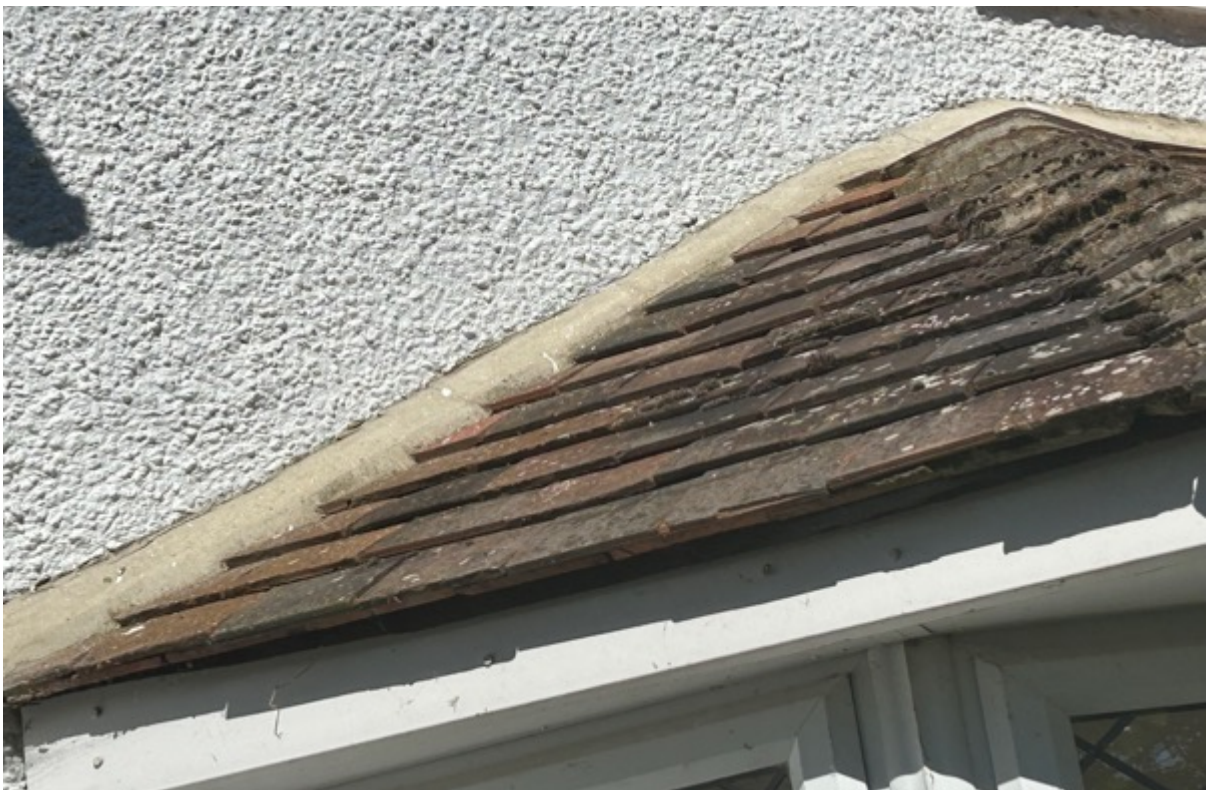
Poor quality cement fillet waterproofing the joint between the same roof and the right side elevation roughcast render.

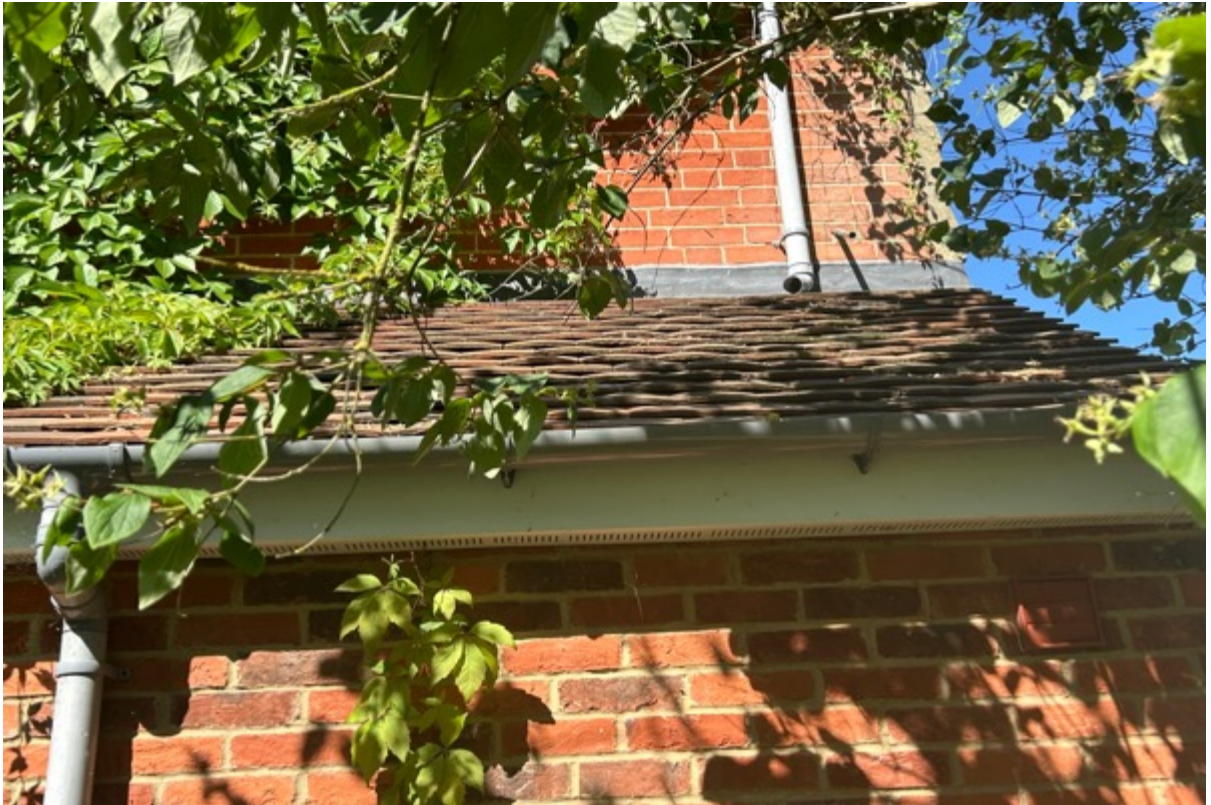
No significant defects noted to the tiling to the rear right subsidiary roof.

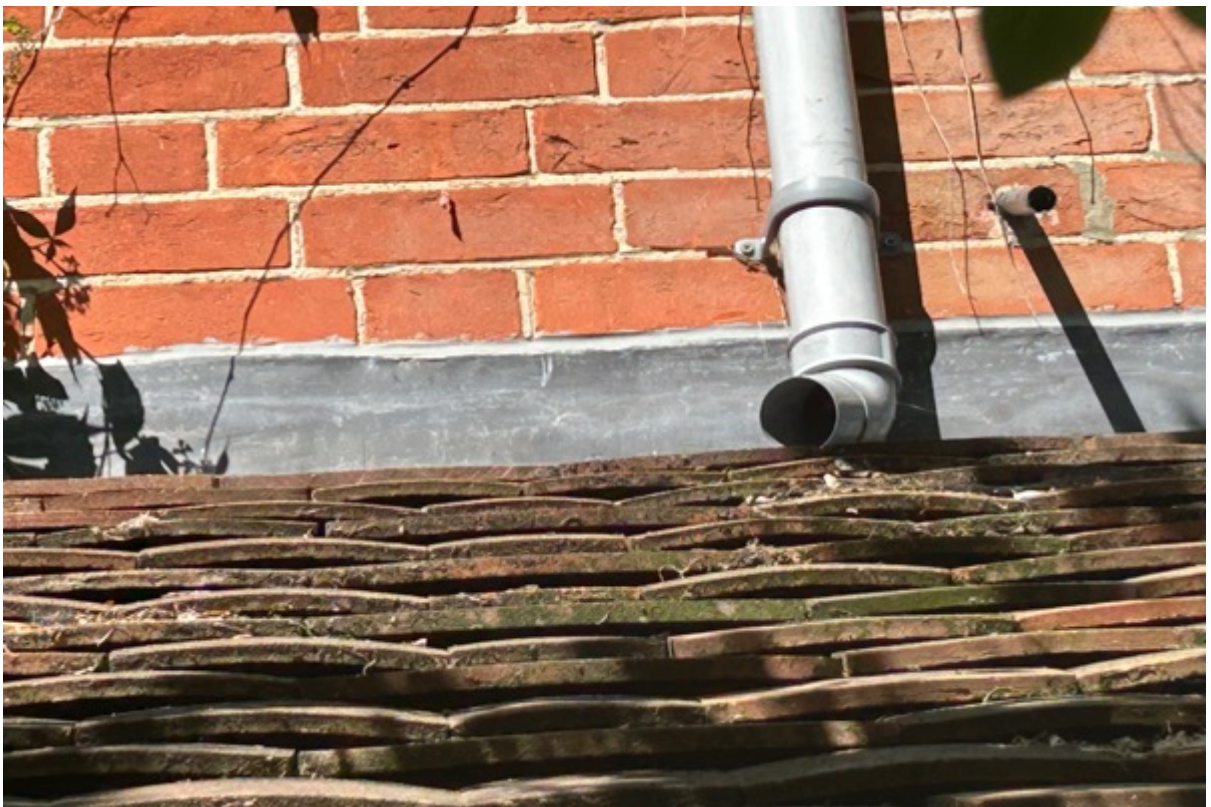
Flashing to the same subsidiary roof in satisfactory condition.

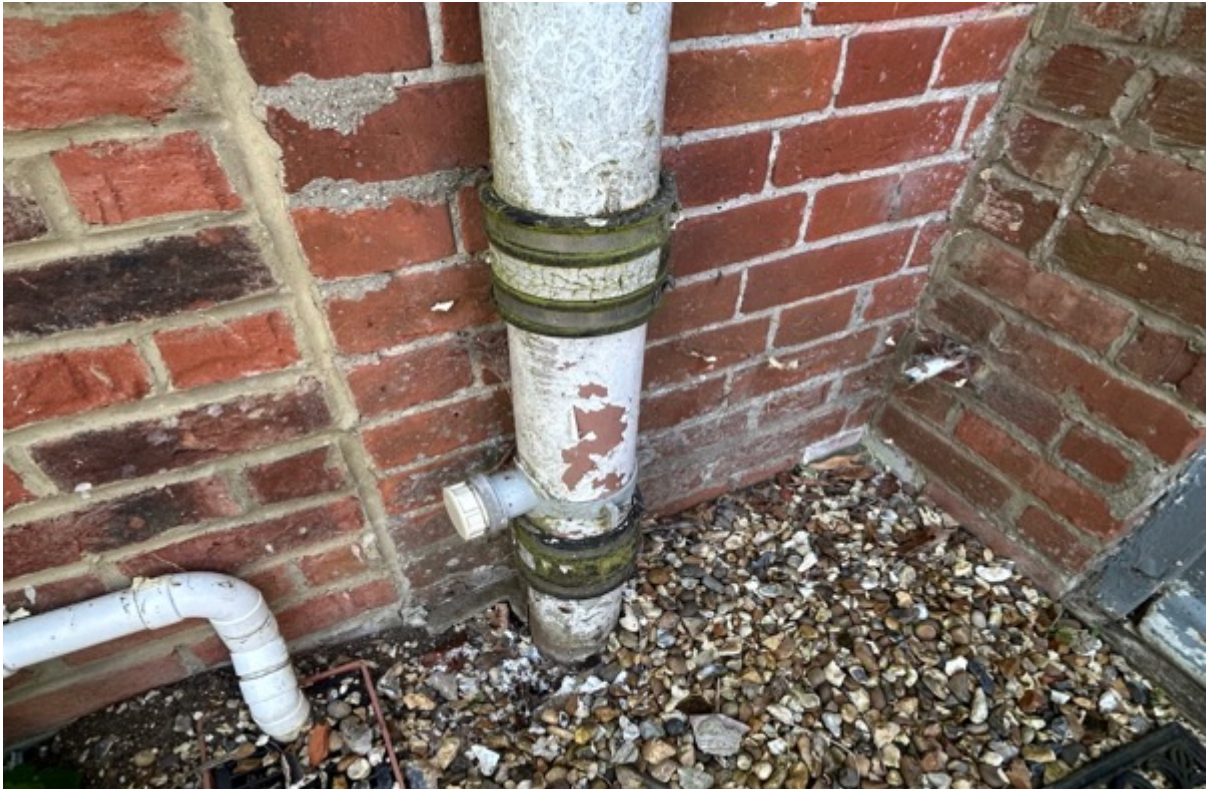
Perishing jubilee clips to the rear soil stack.

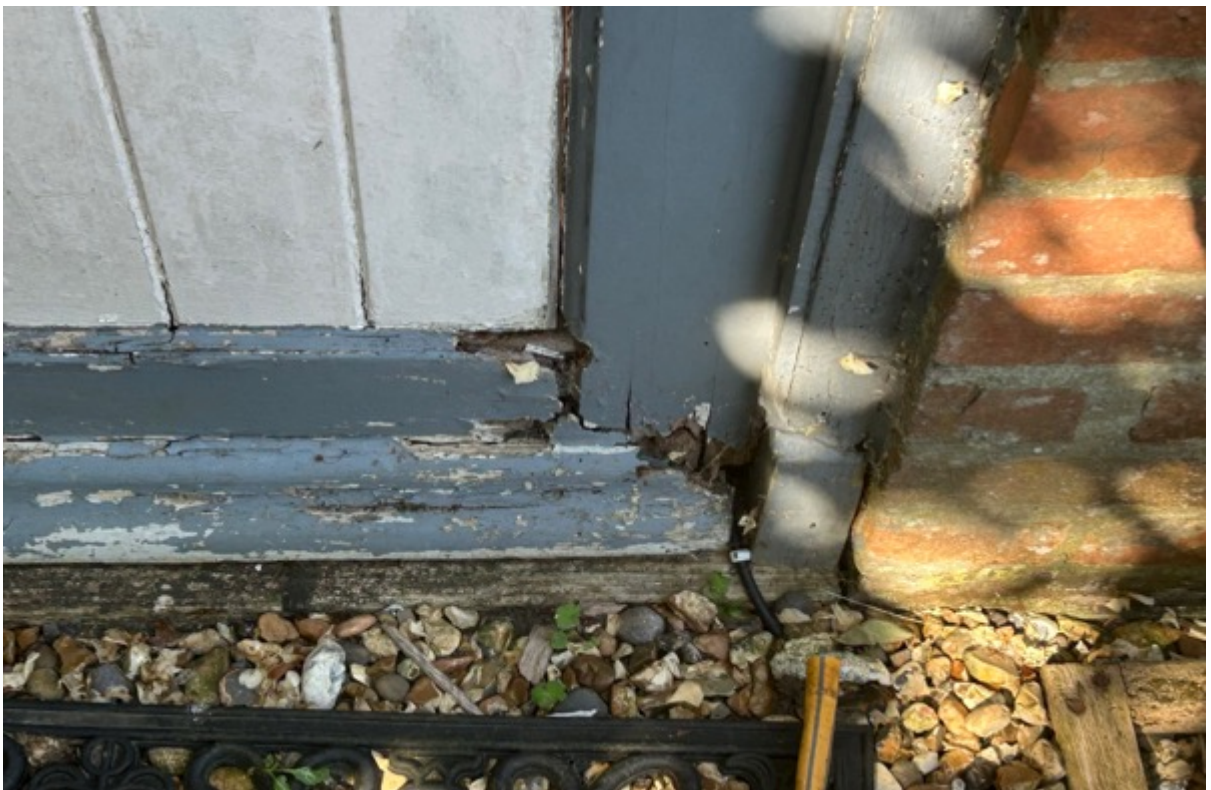
Severe timber decay to the right side door to the Perspex sheeted enclosed area to the rear of the property.

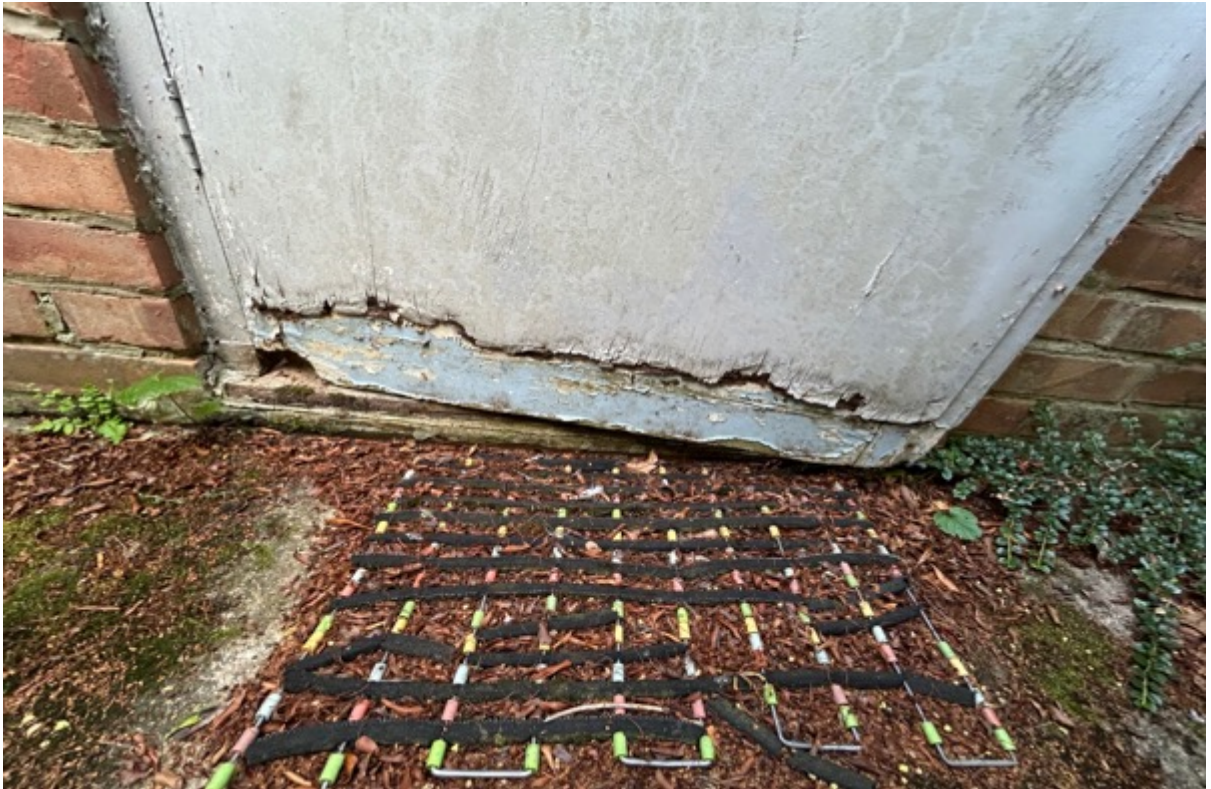
Severe timber decay to the second door to the Perspex sheeted enclosed area to the rear of the property.

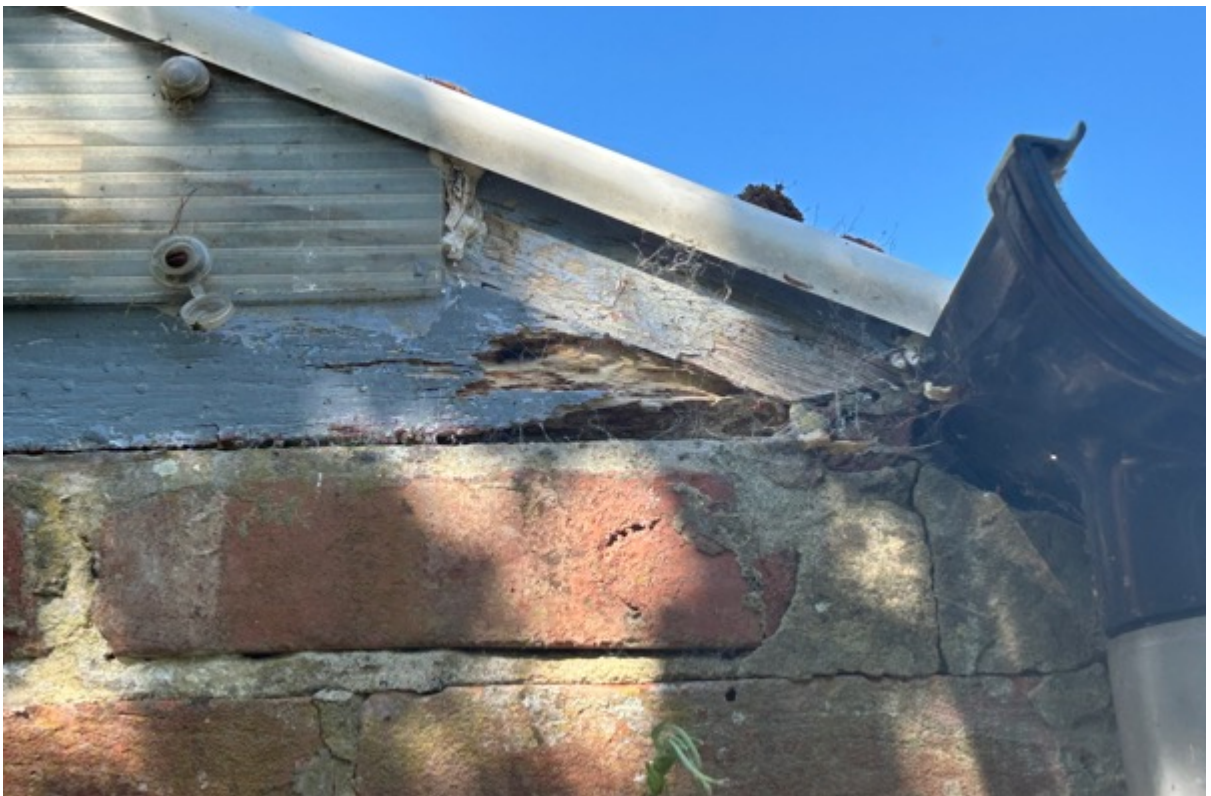
Significant timber decay to some of the upper timbers to the same roof.

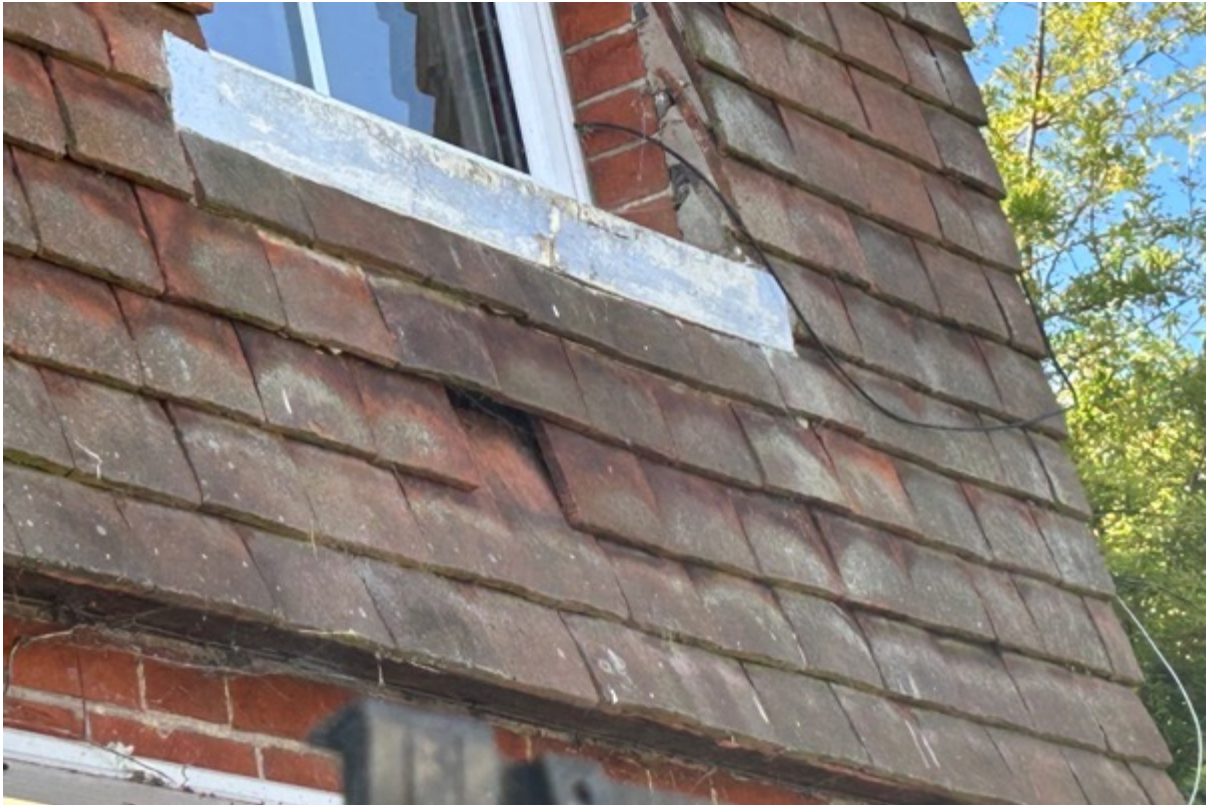
Missing tile to the vertical tile hanging to the rear of the property.
