Building Survey Report
on
Sunfield House, Townsend Road, Streatley
Berkshire RG8 9LH
for
Ms A White
as at
3 July 2025

James Ross & Co Limited
Chartered Building Surveyors

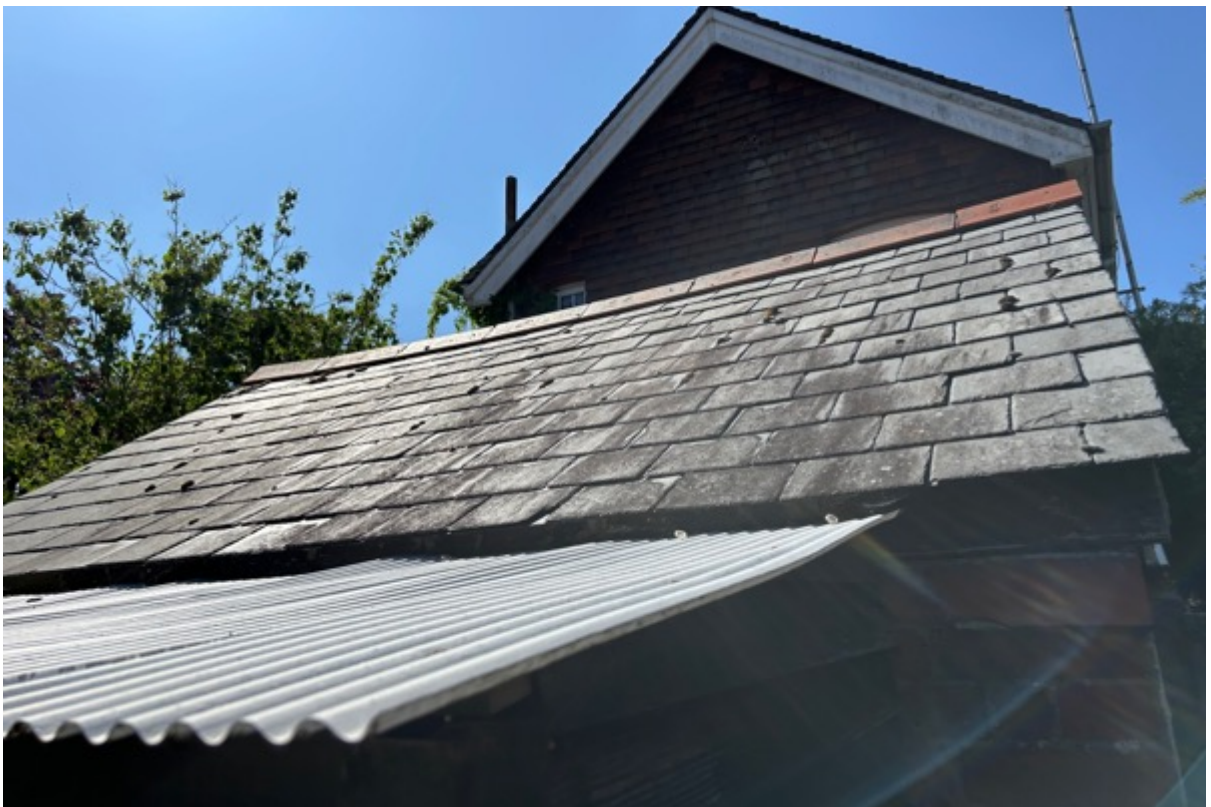
Rear slated slope to the rear outbuilding in fair condition.

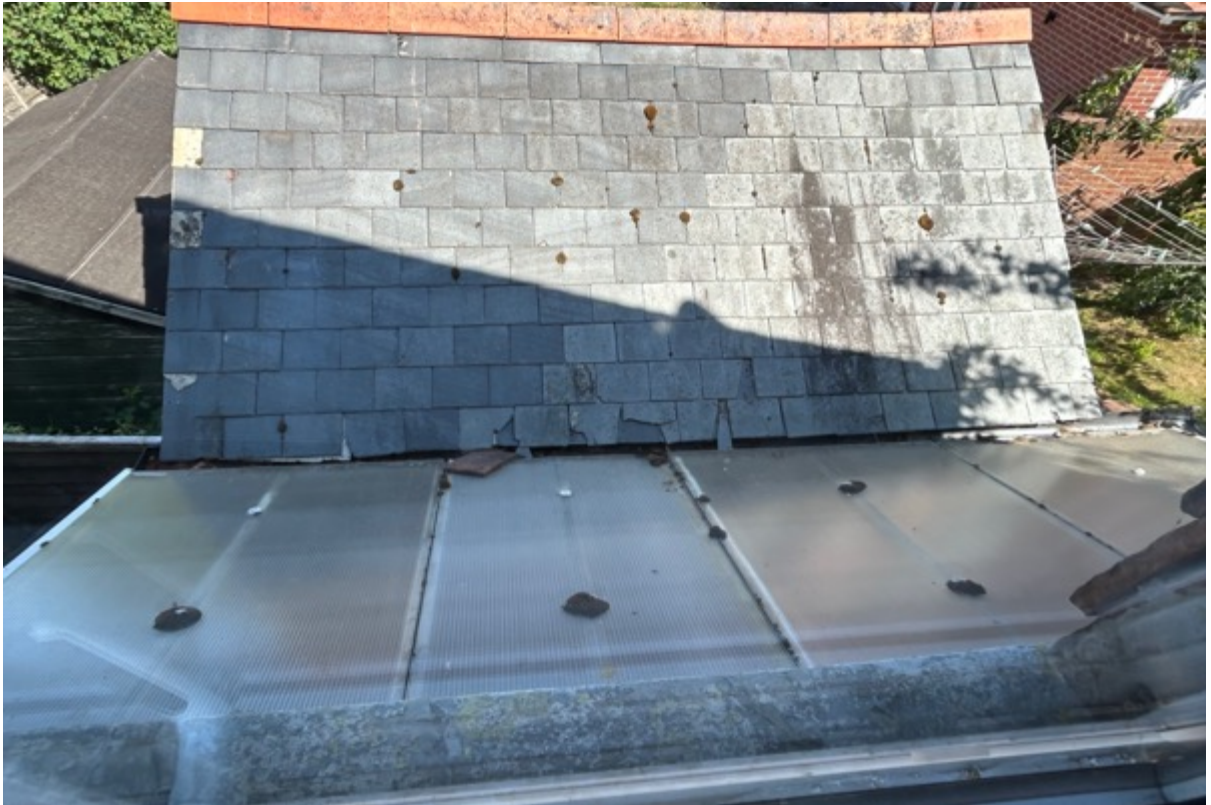
Front slated slope to the same outbuilding, with a number of the slates damaged.

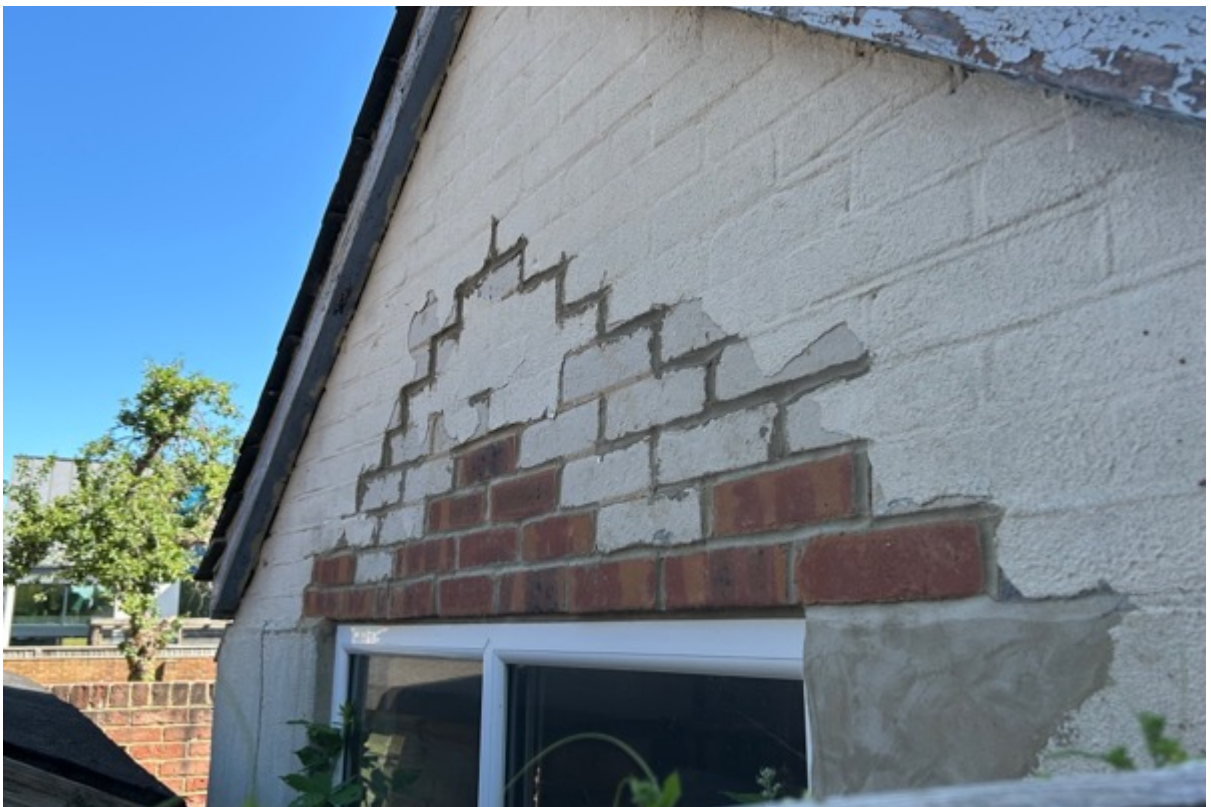
Inadequately supported brickwork above the left side window opening to the same rear shed.

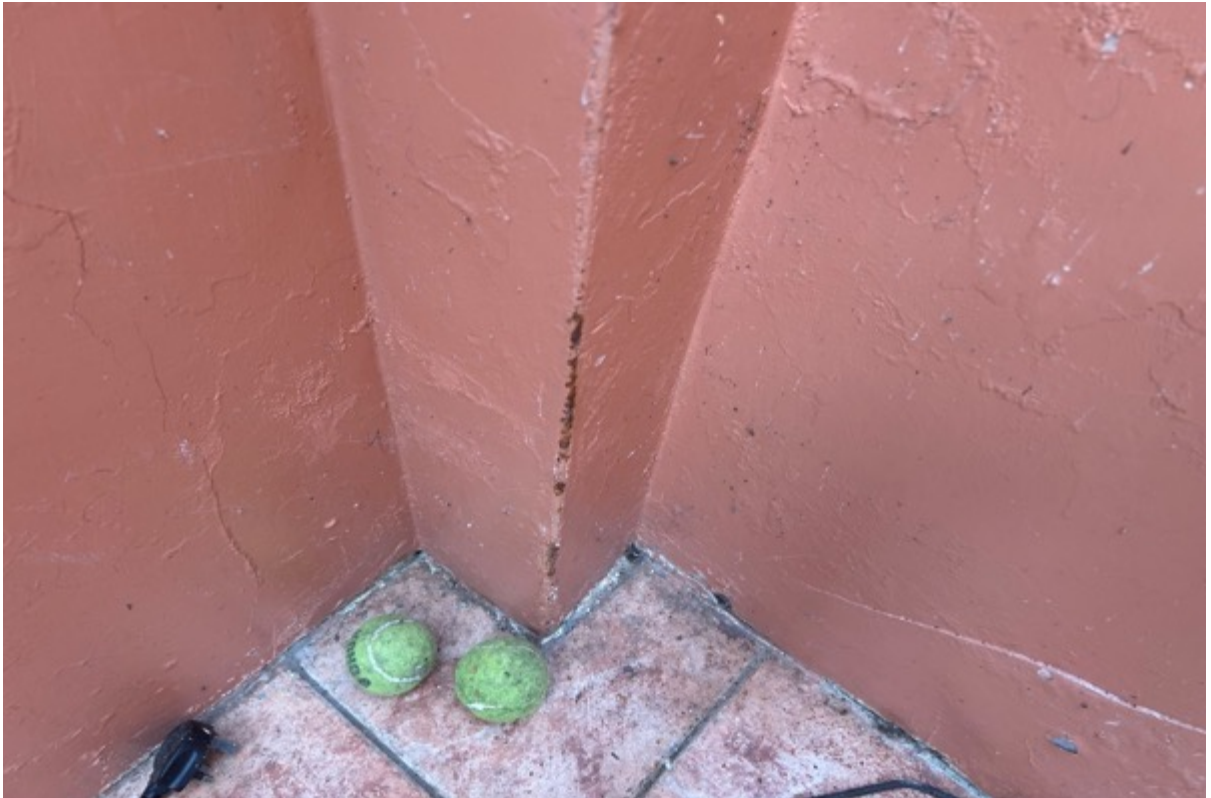
Clear evidence of rising damp within the enclosed area covered by corrugated plastic to the rear of the property.

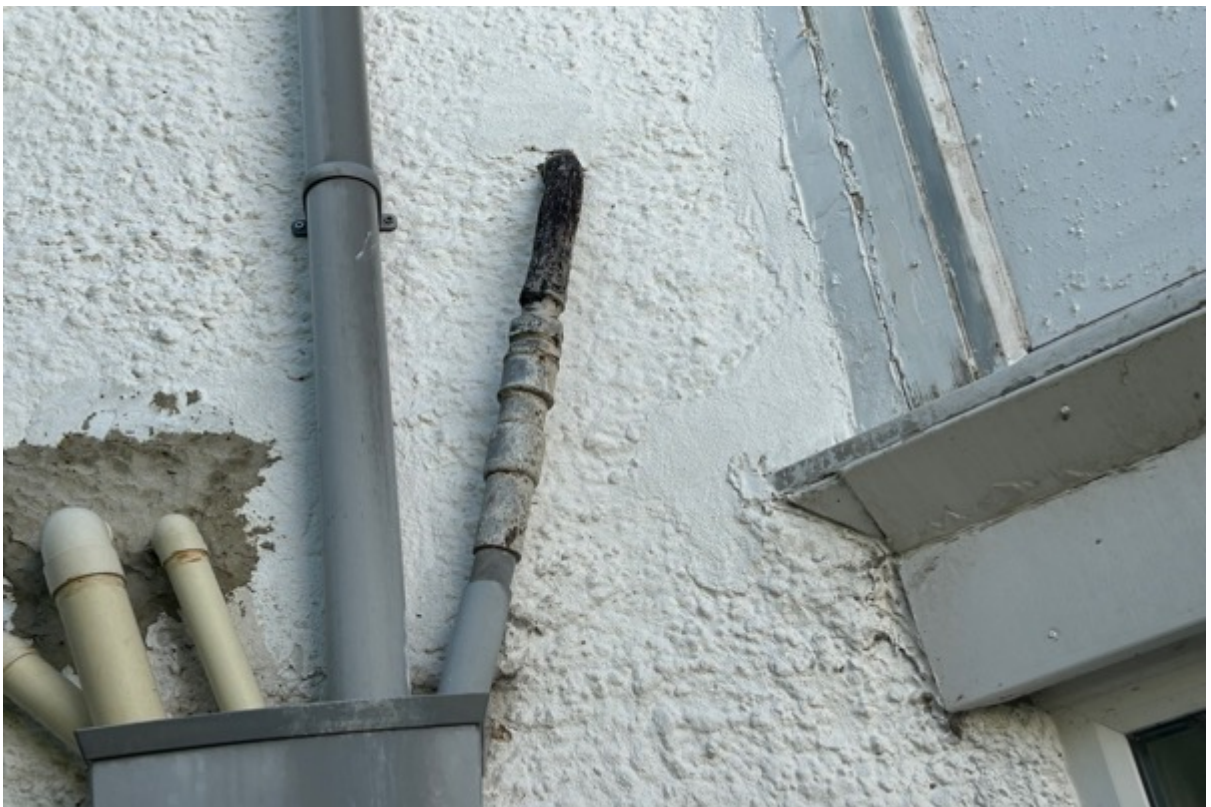
Example of an old, corroding waste pipe coming out through the render to the left flank elevation.

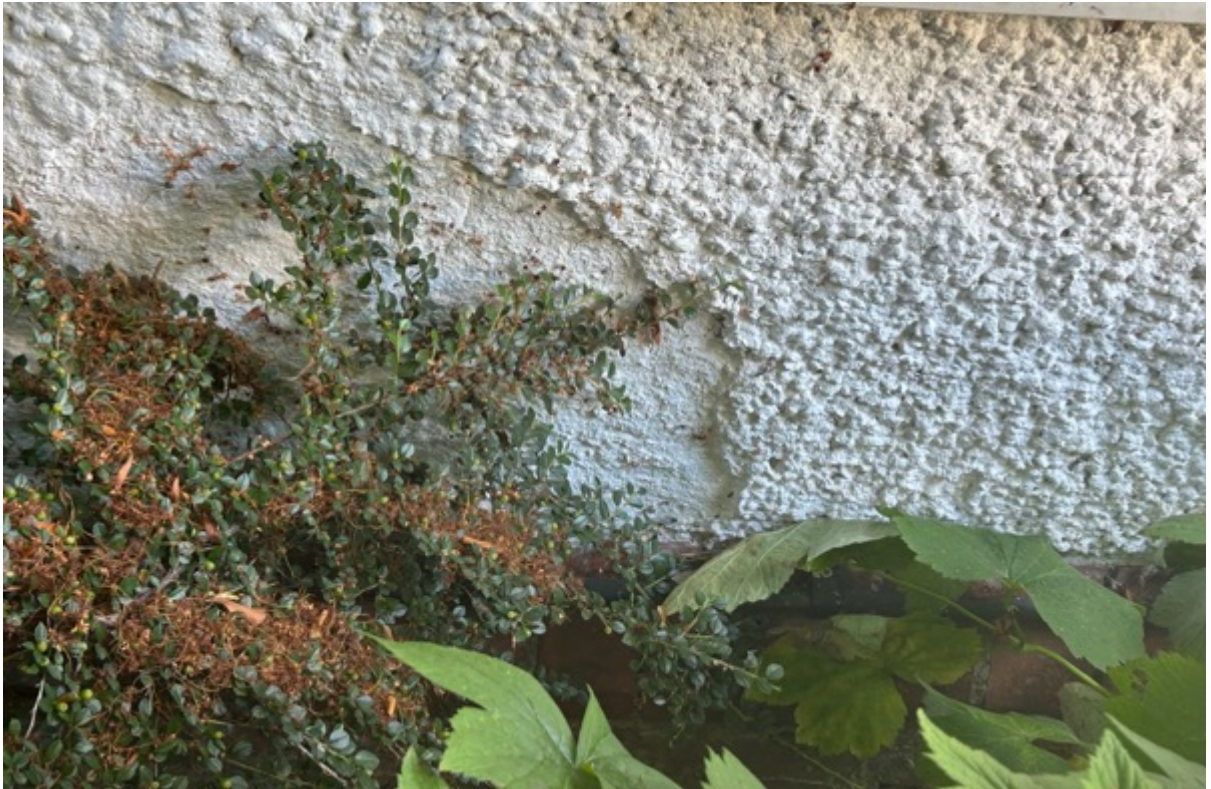
Area of missing roughcast render to the left flank elevation at low level.

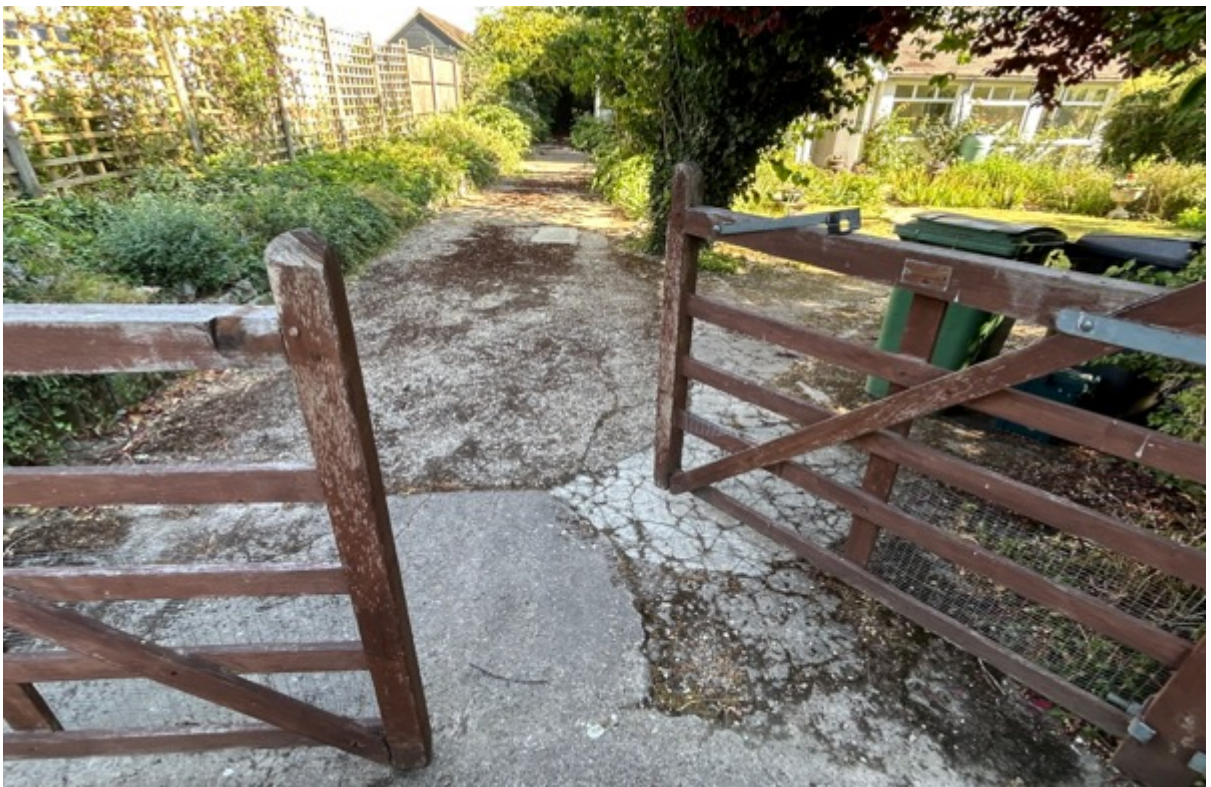
Front gates badly weathered and no longer meeting properly, with the concrete to the driveway beyond in poor condition.

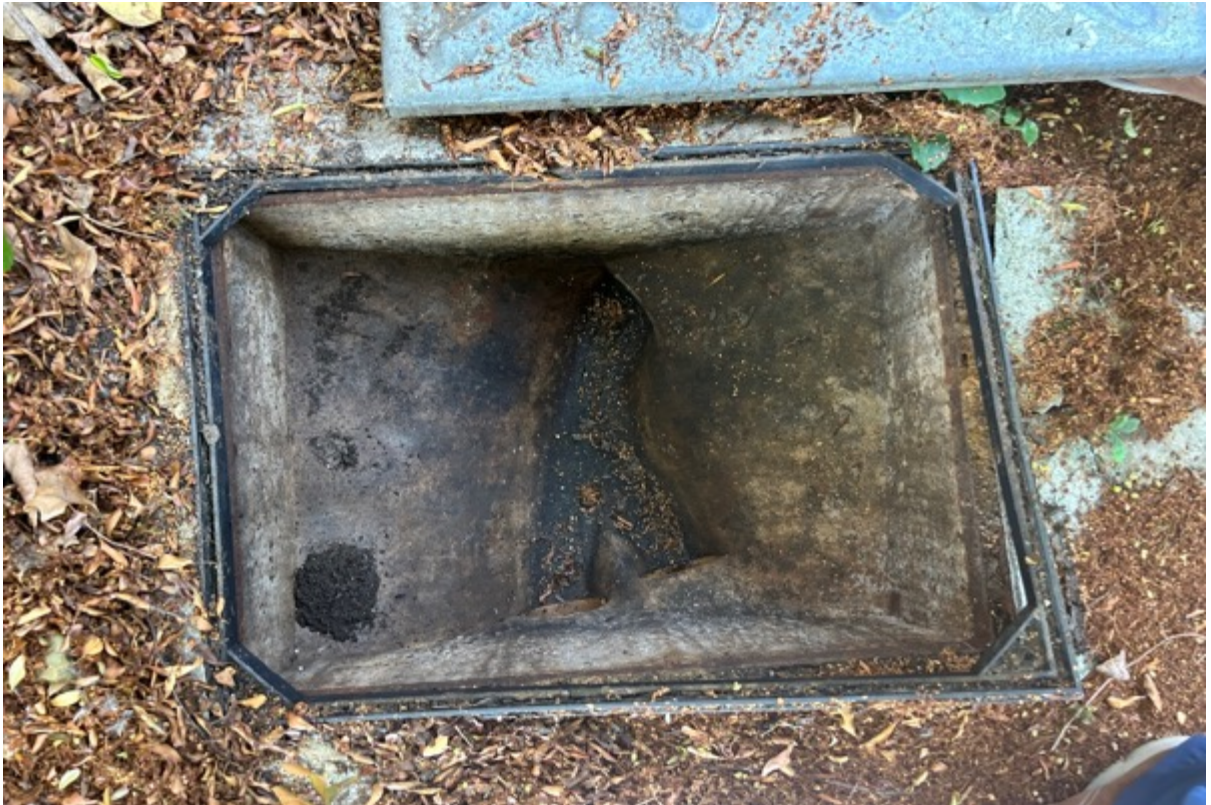
Interior of the inspection chamber to the left side of the property.

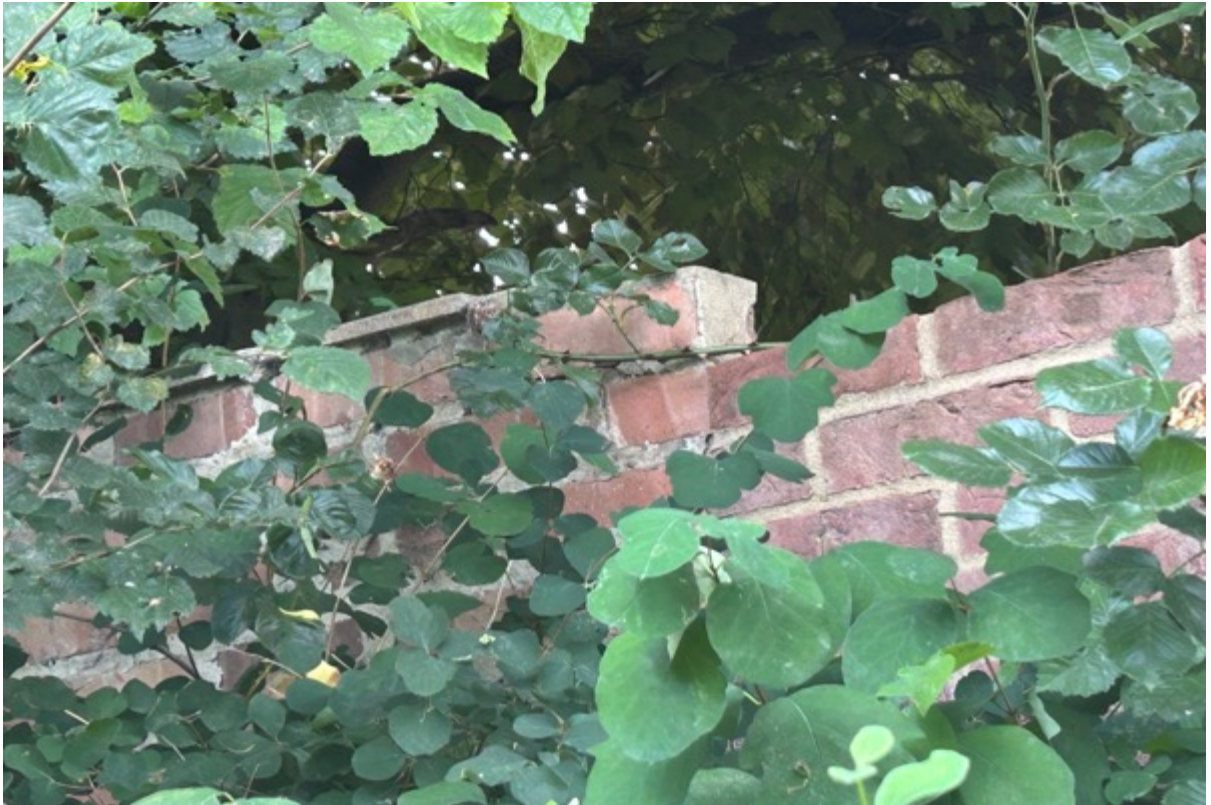
Damage to the boundary wall to the right side of the garden (1).

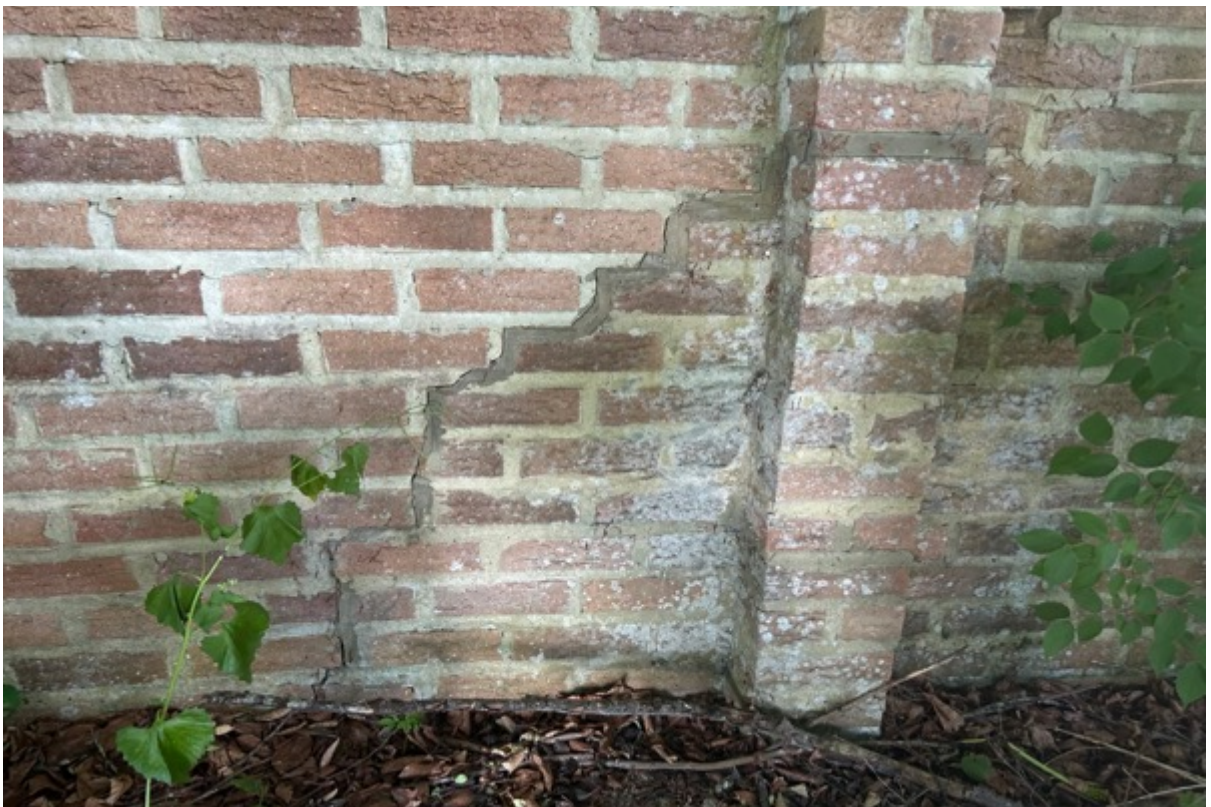
Damage to the boundary wall to the right side of the garden (2).

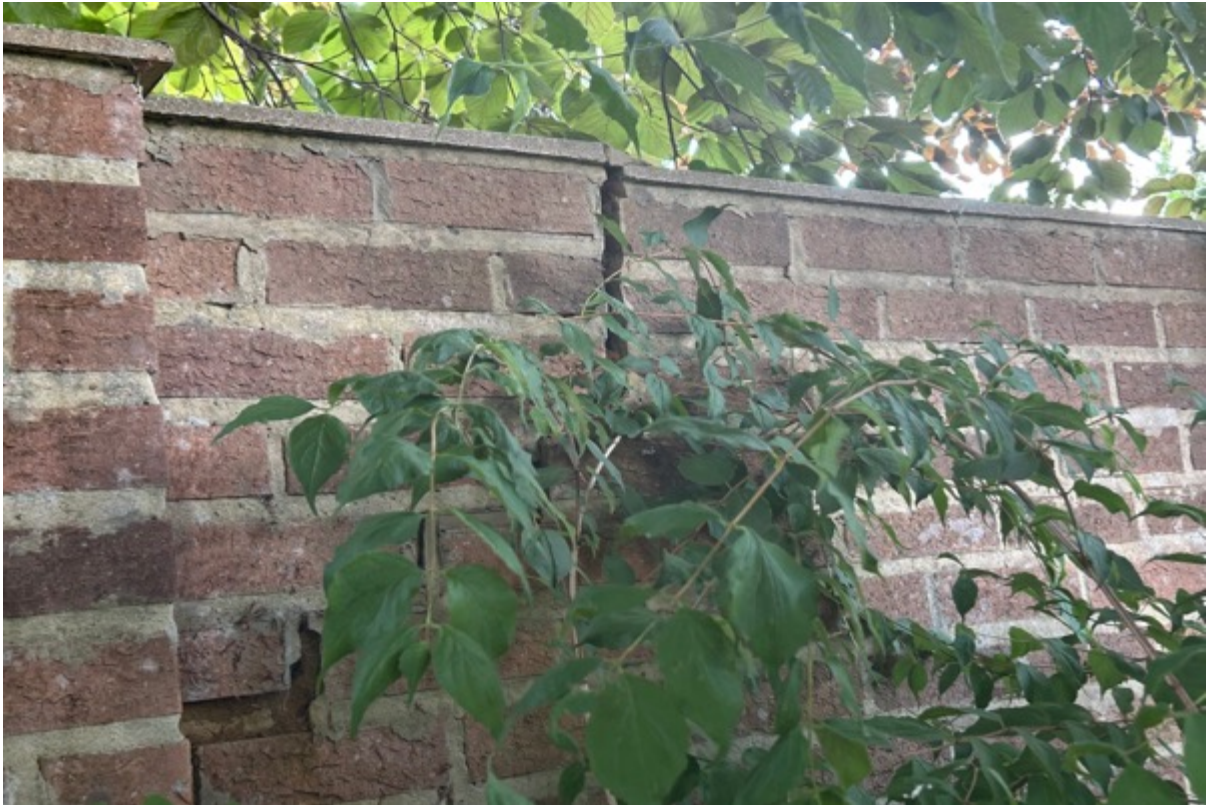
Damage to the boundary wall to the right side of the garden (3).

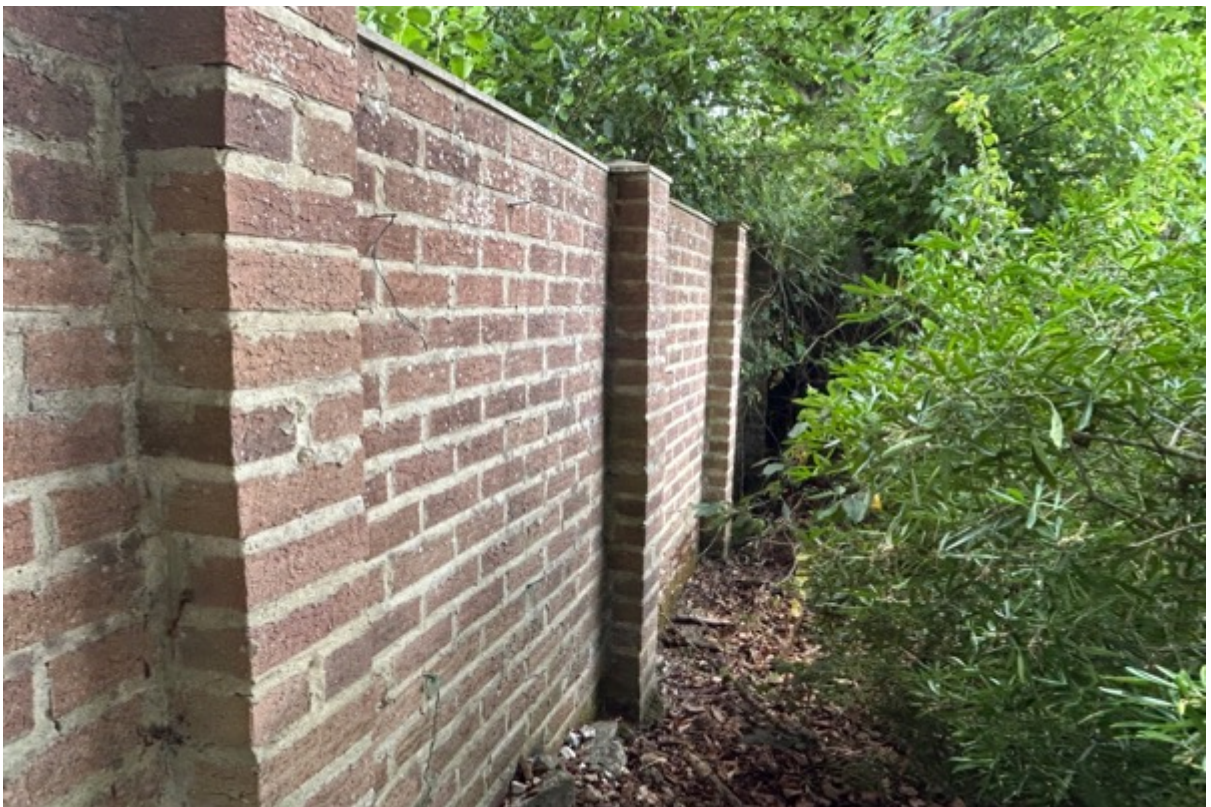
Right side boundary wall showing the first signs of leaning.

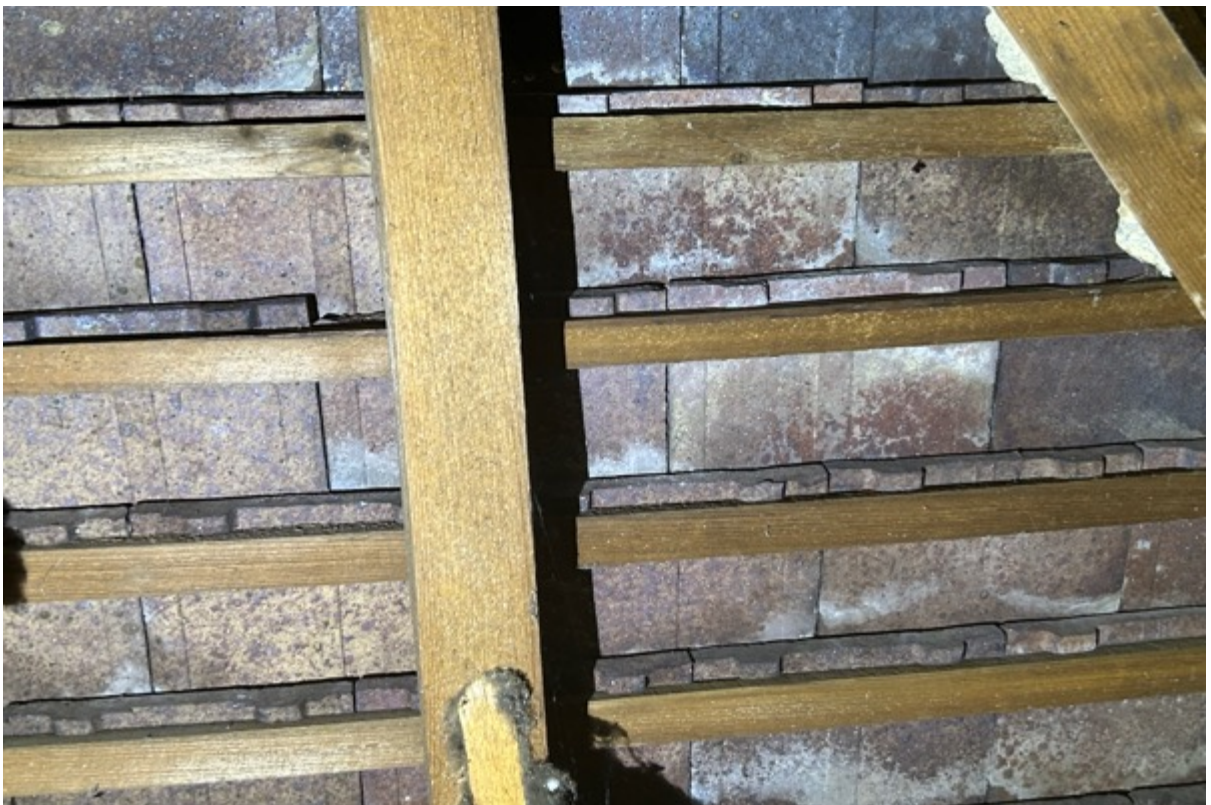
Close-up of the tiling, with the nibs holding the tiles to the roofing battens in good condition.

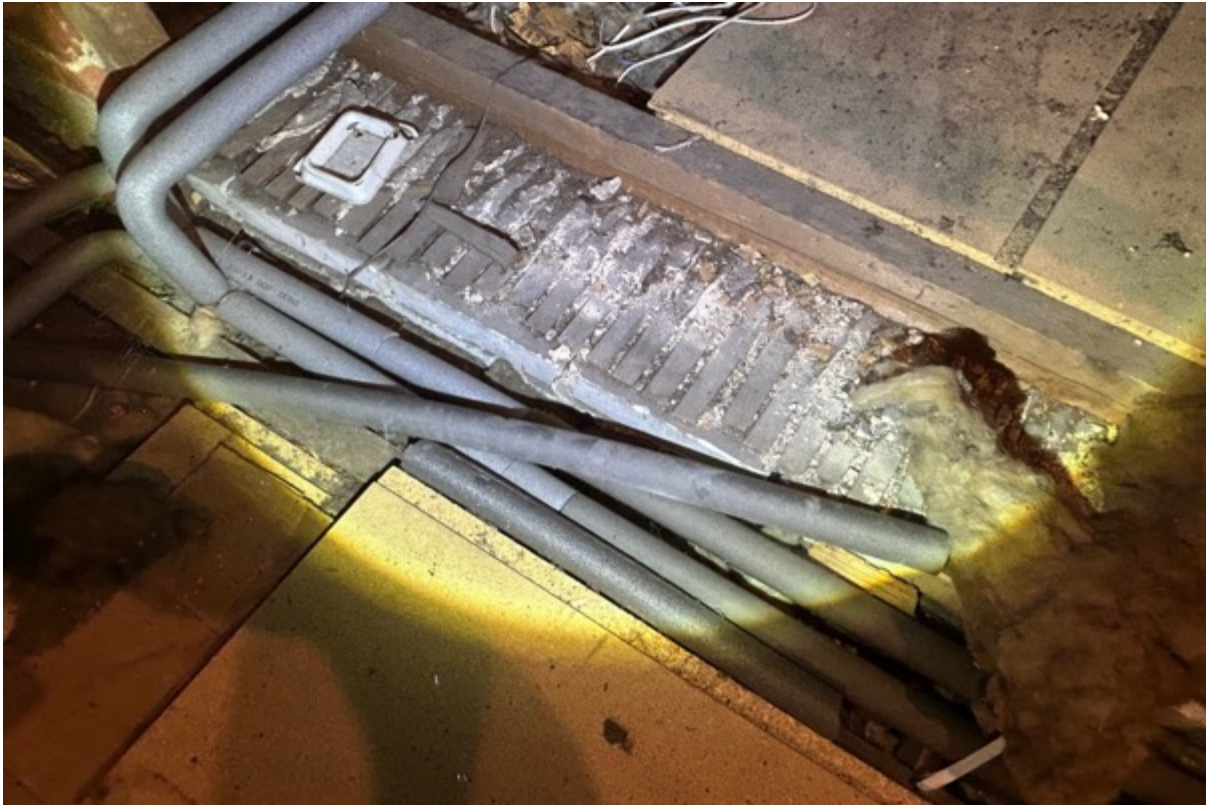
Confirmation that lath and plaster is still present throughout the property as the ceiling finish.

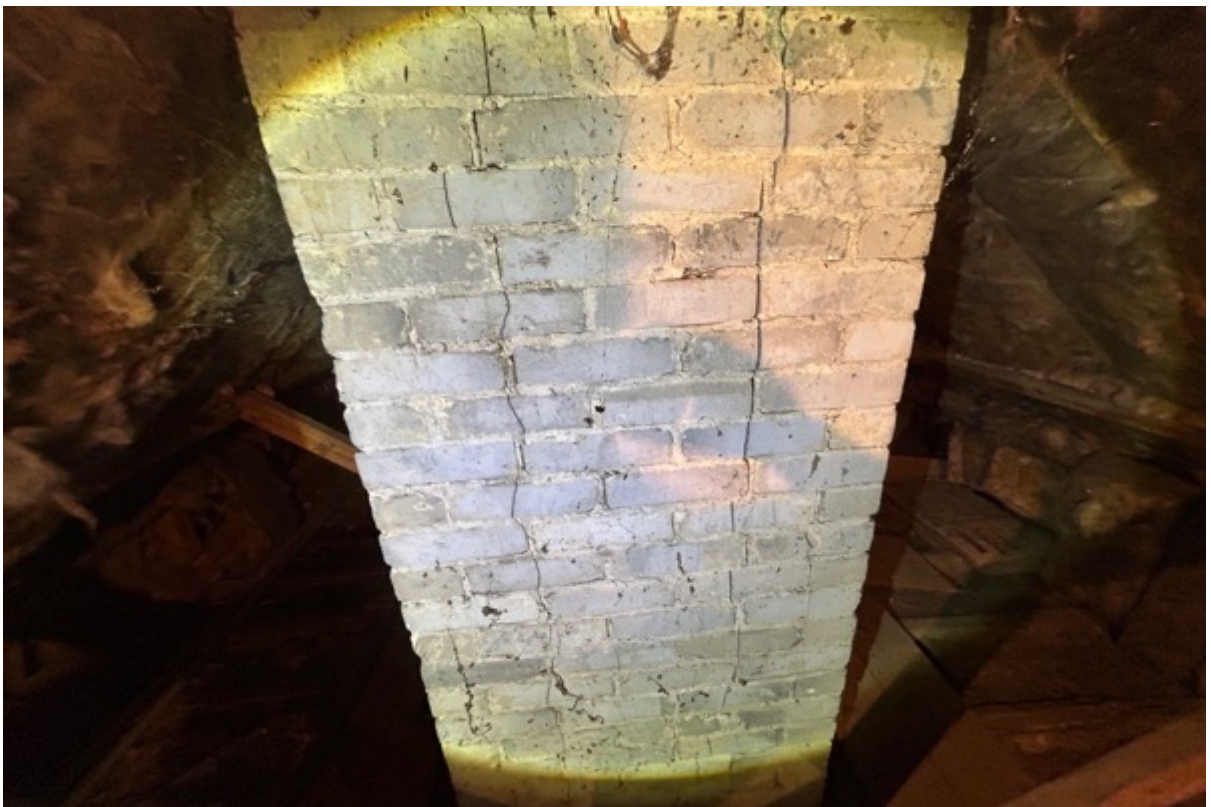
Hairline cracks to the roof space chimney breast.

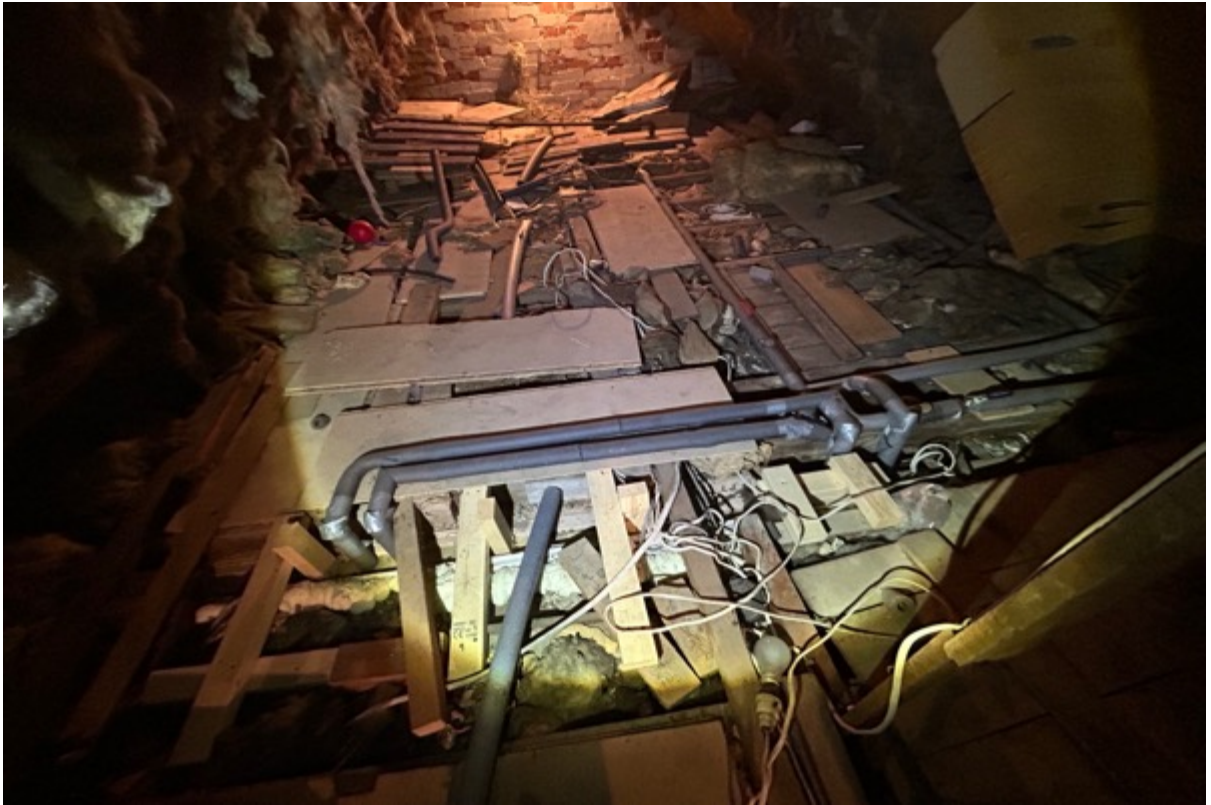
Rear of the main roof an utter mess (1).

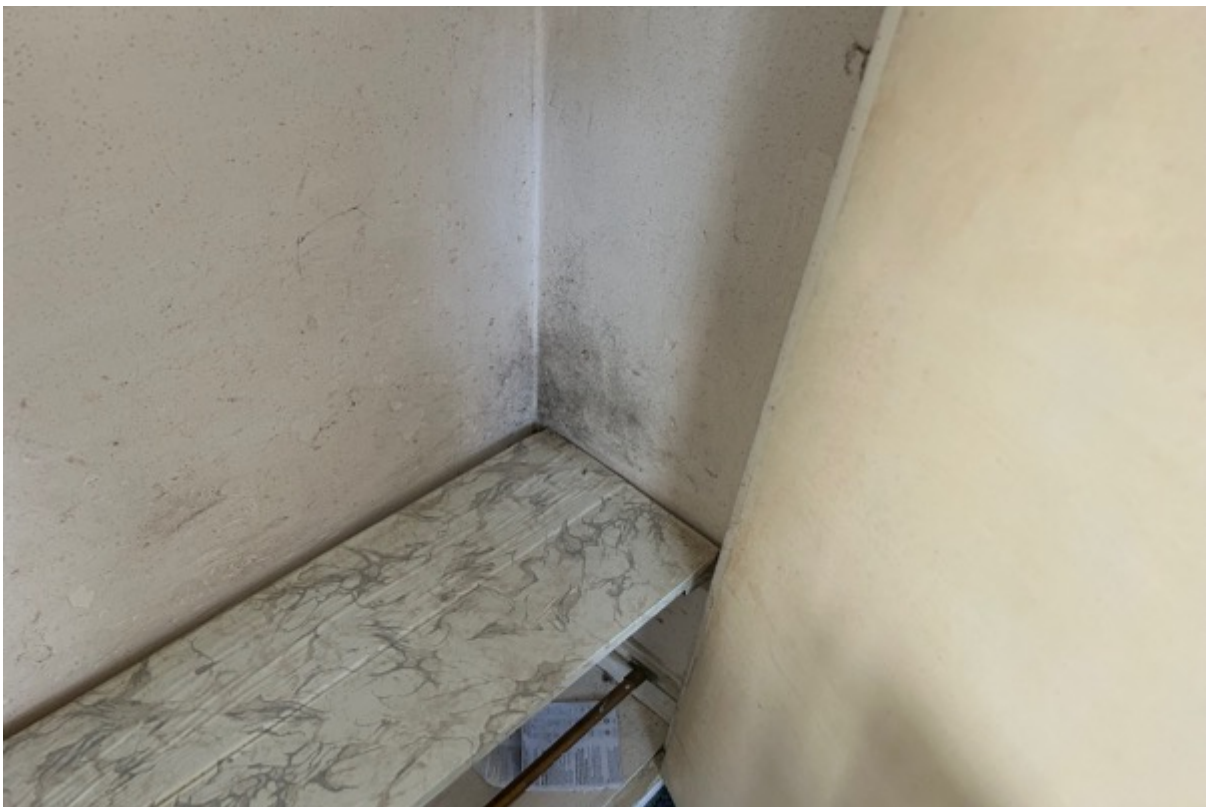
Example of mould staining to one of the built-in cupboards (1).

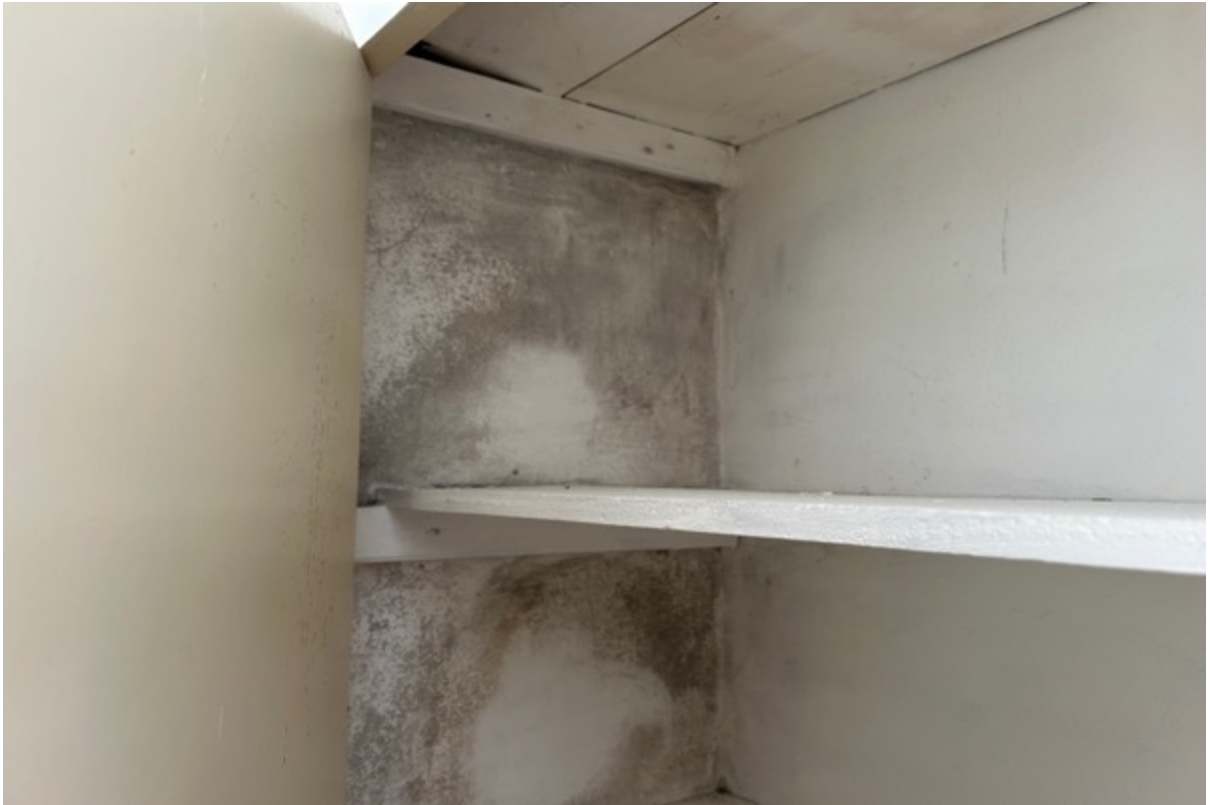
Example of mould staining to one of the built-in cupboards (2).

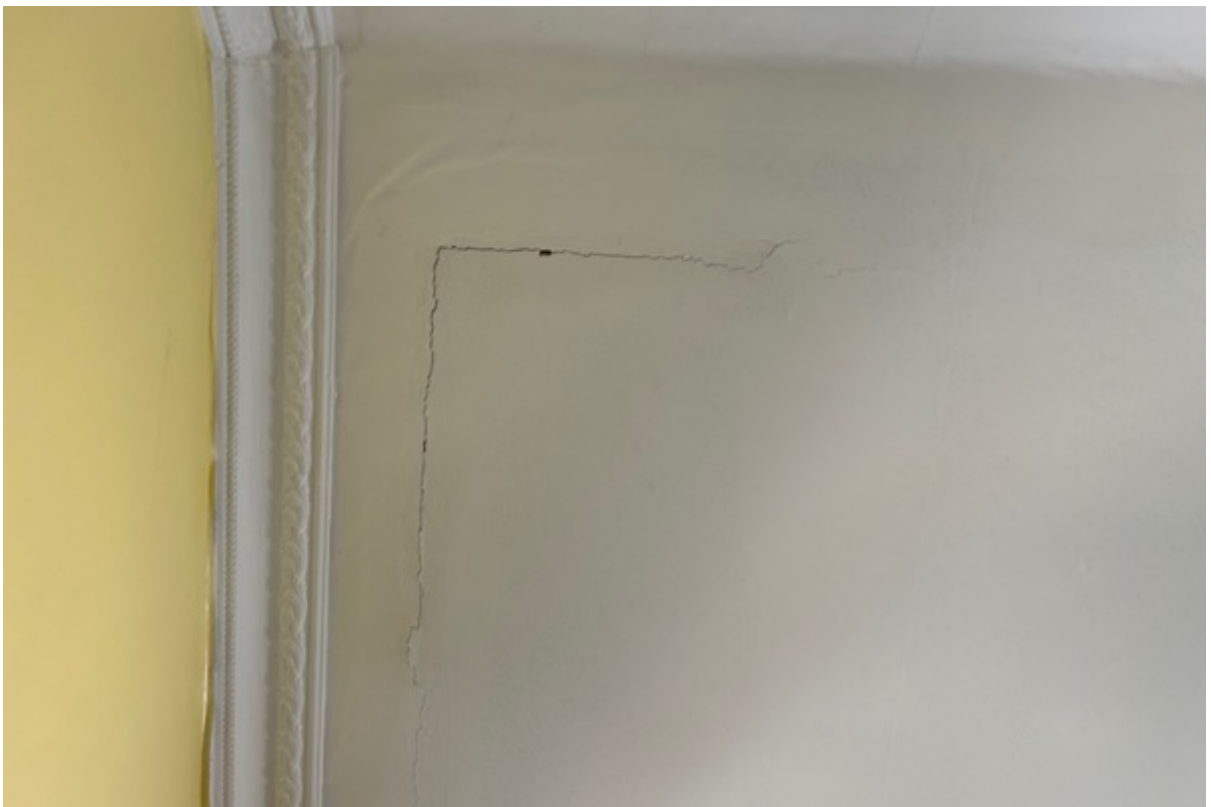
Non-structural cracking to one of the first floor ceilings.

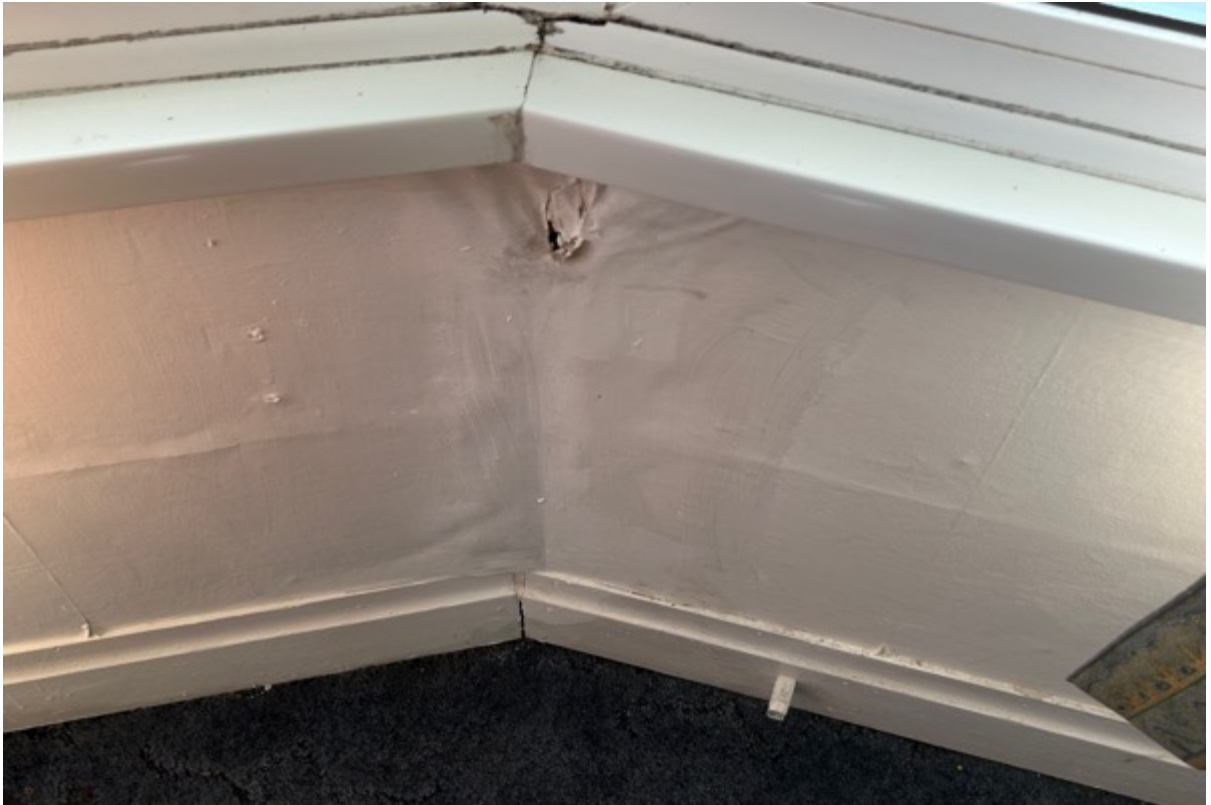
Trace movement to the first floor bay.

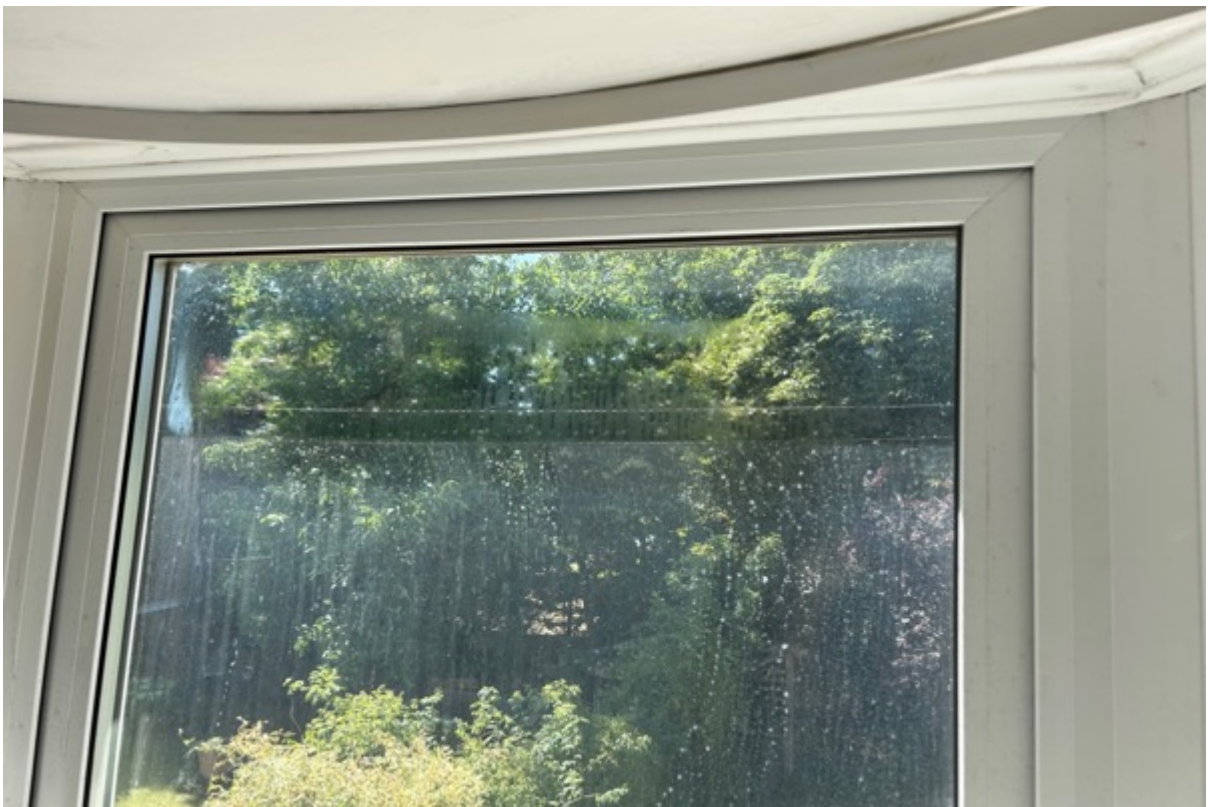
Failed hermetic seal to the front right bedroom window.

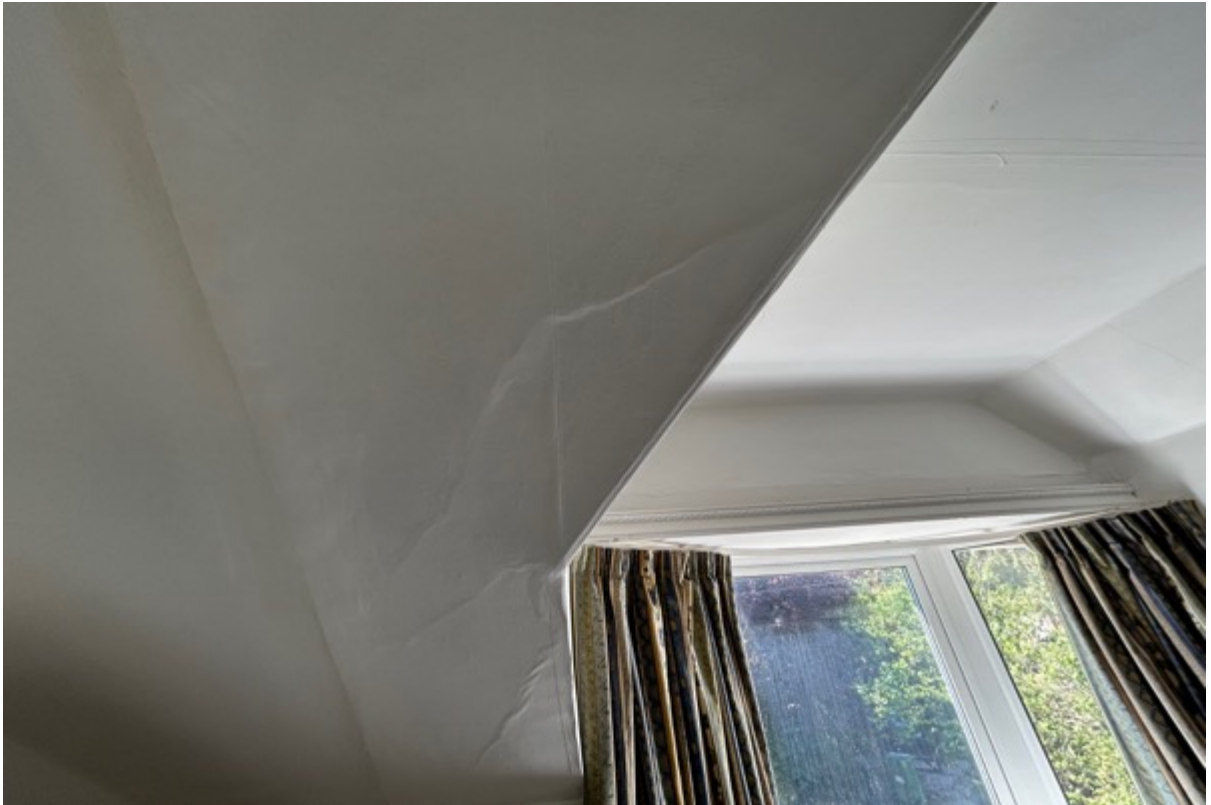
Example of cracking to the lath and plaster ceiling to the front right bedroom.

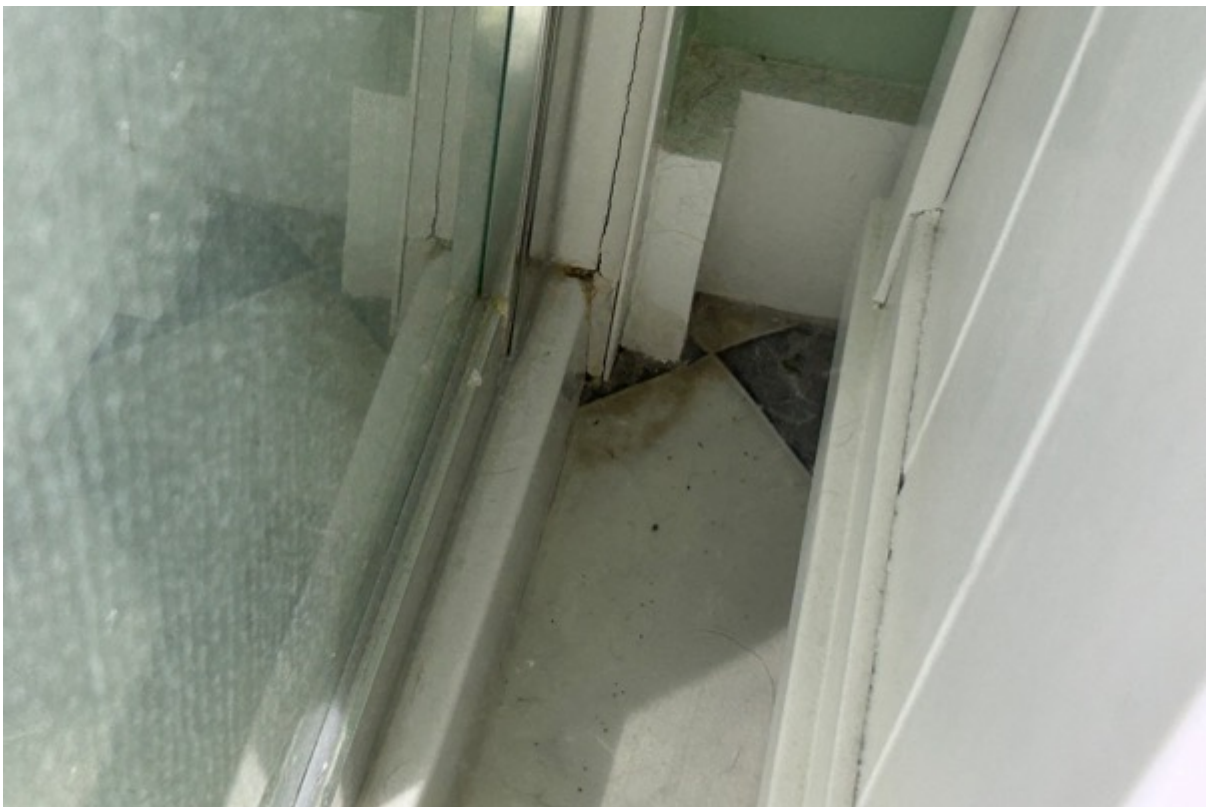
Clear leakage to the first floor bathroom shower enclosure.
