Building Survey Report
on
Sunfield House, Townsend Road, Streatley
Berkshire RG8 9LH
for
Ms A White
as at
3 July 2025

James Ross & Co Limited
Chartered Building Surveyors

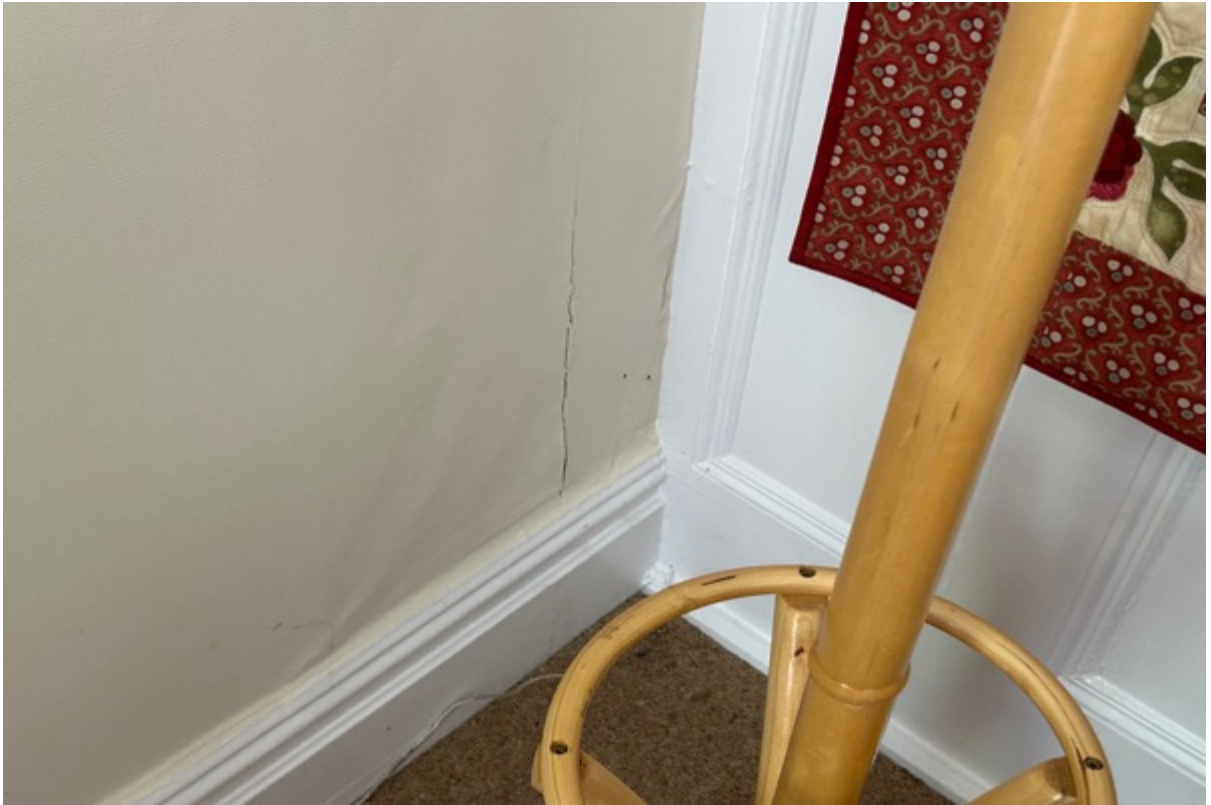
Area of rising damp to the rear left corner of the front lobby/reception room.

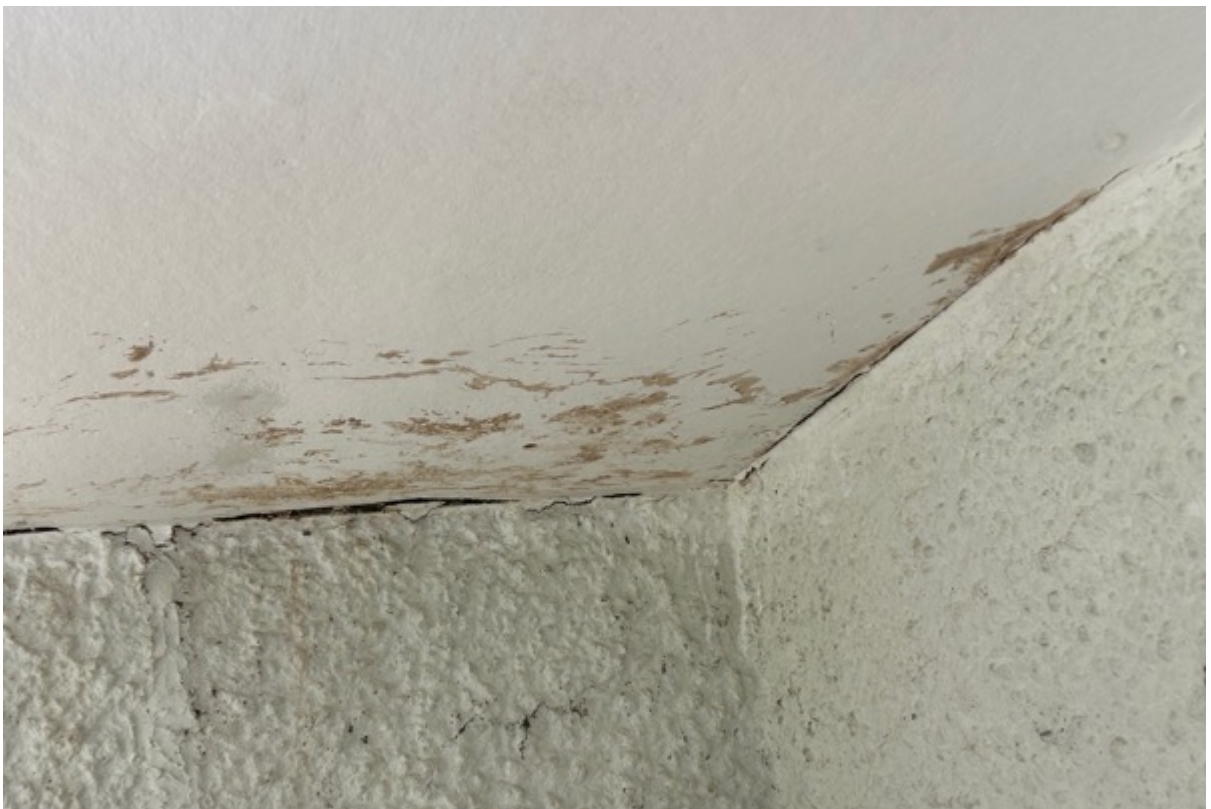
Severe damp staining to the ceiling to the garden room (1).

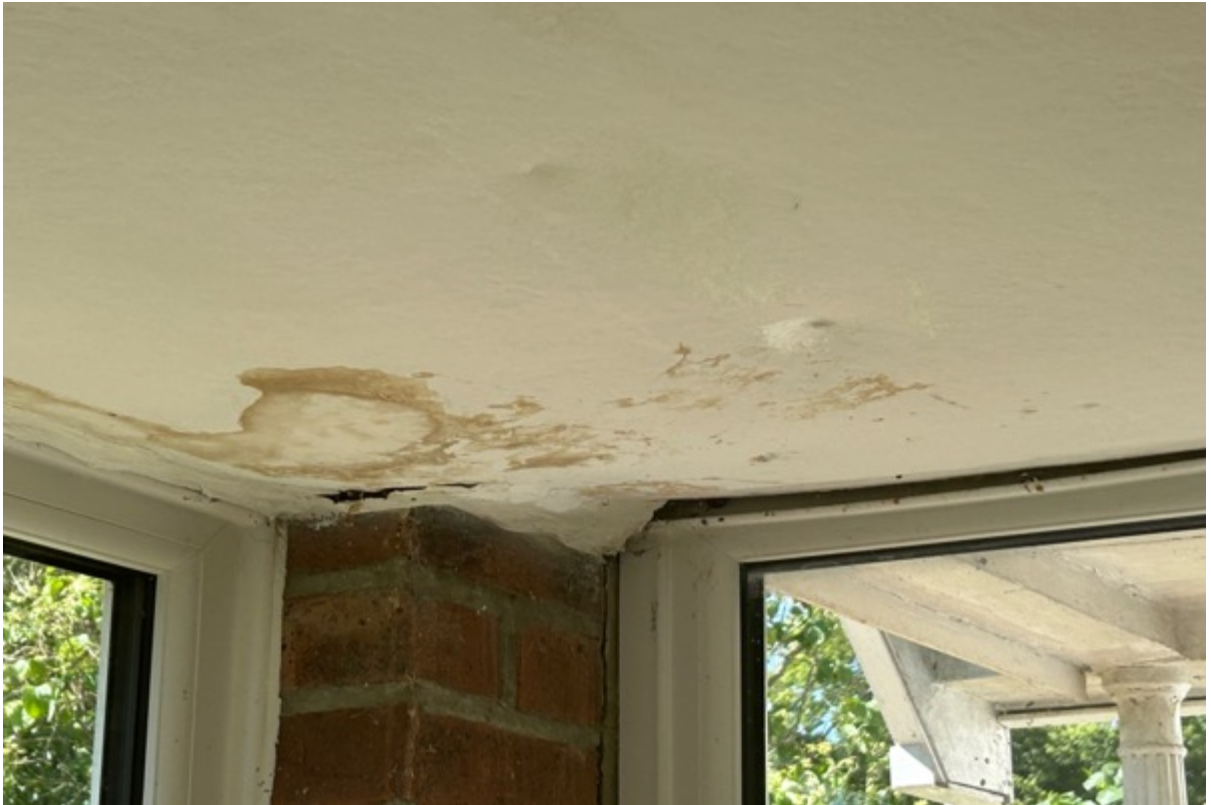
Severe damp staining to the ceiling to the garden room (2).

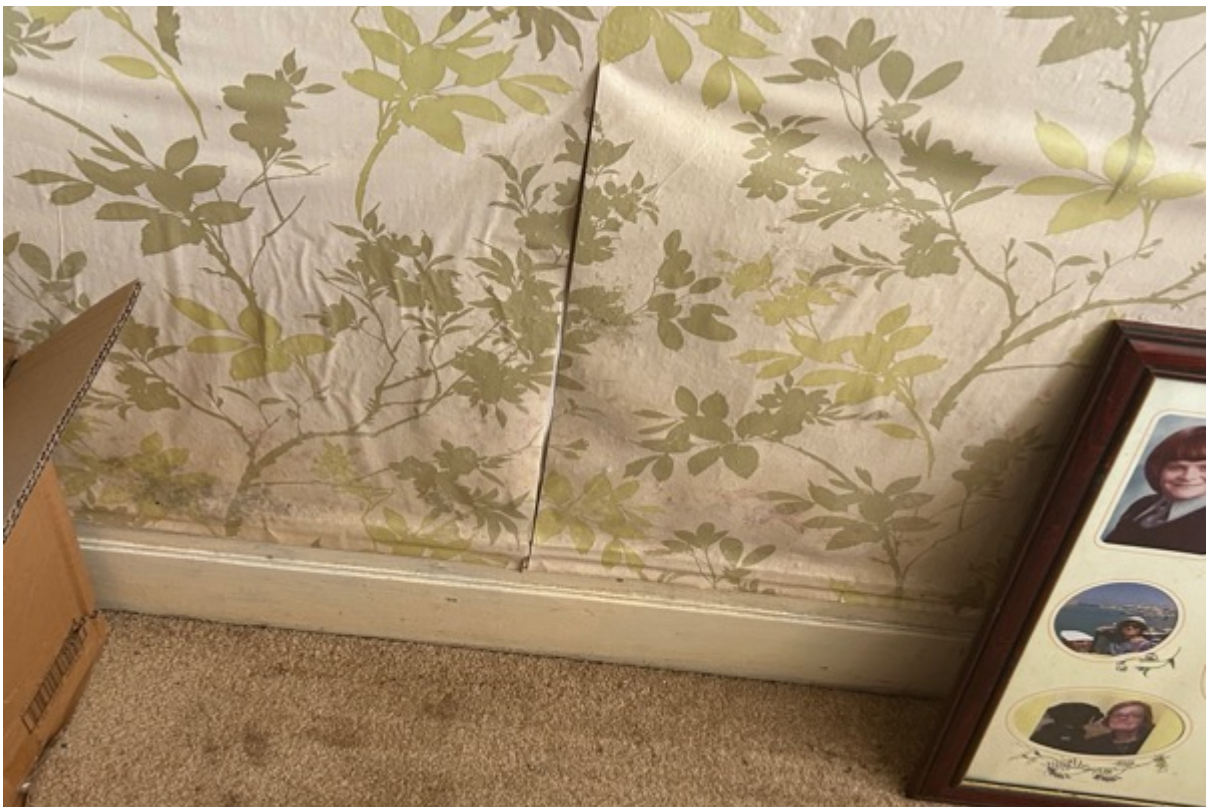
Severe rising damp to the rear wall of the main right side reception room (1).

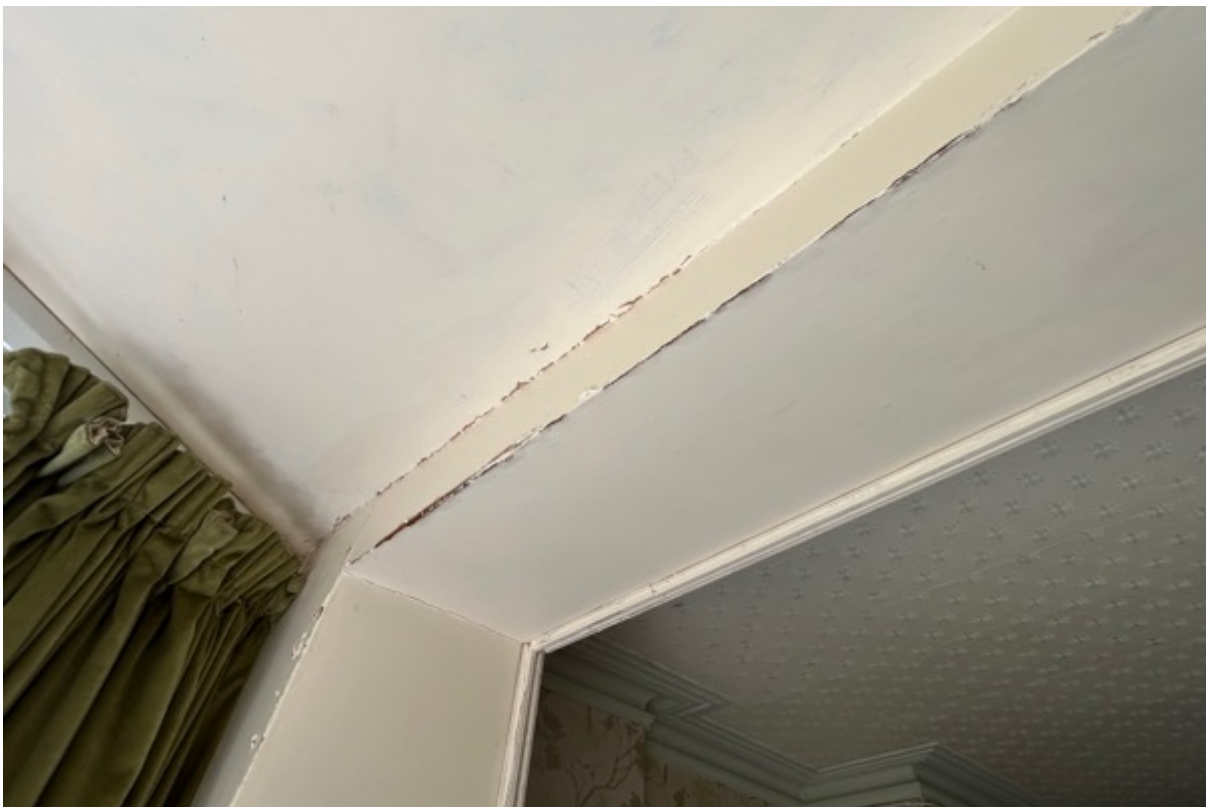
Damp staining to the ceiling of the bay to the main right side reception room.

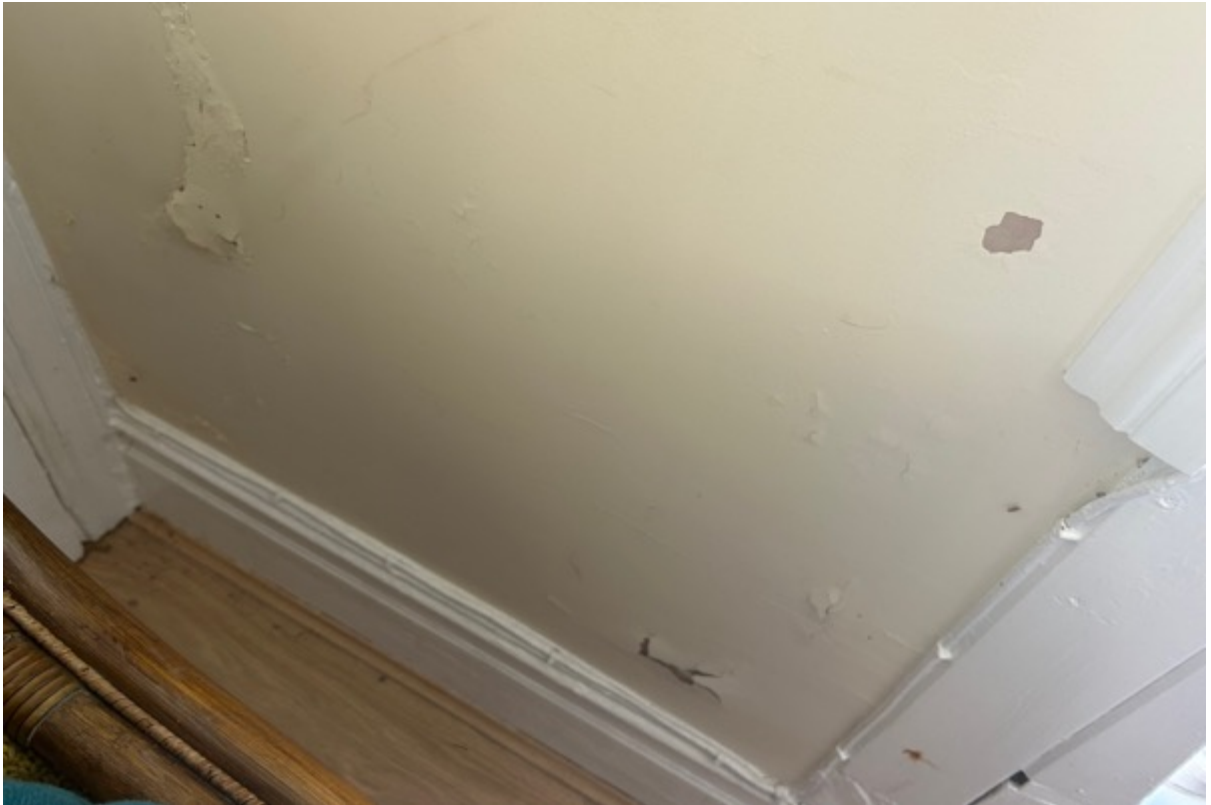
Rising damp to the front wall of the dining area.

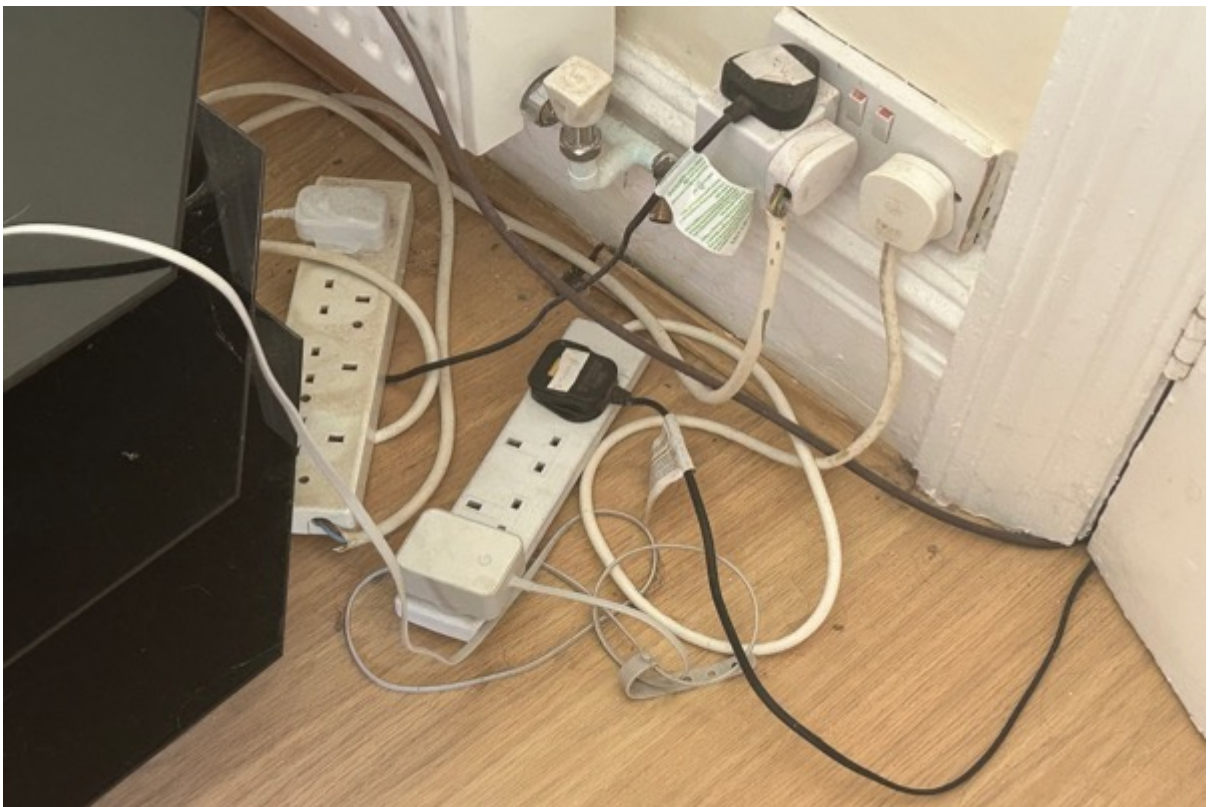
Confirmation that the property has an inadequate number of socket outlets.

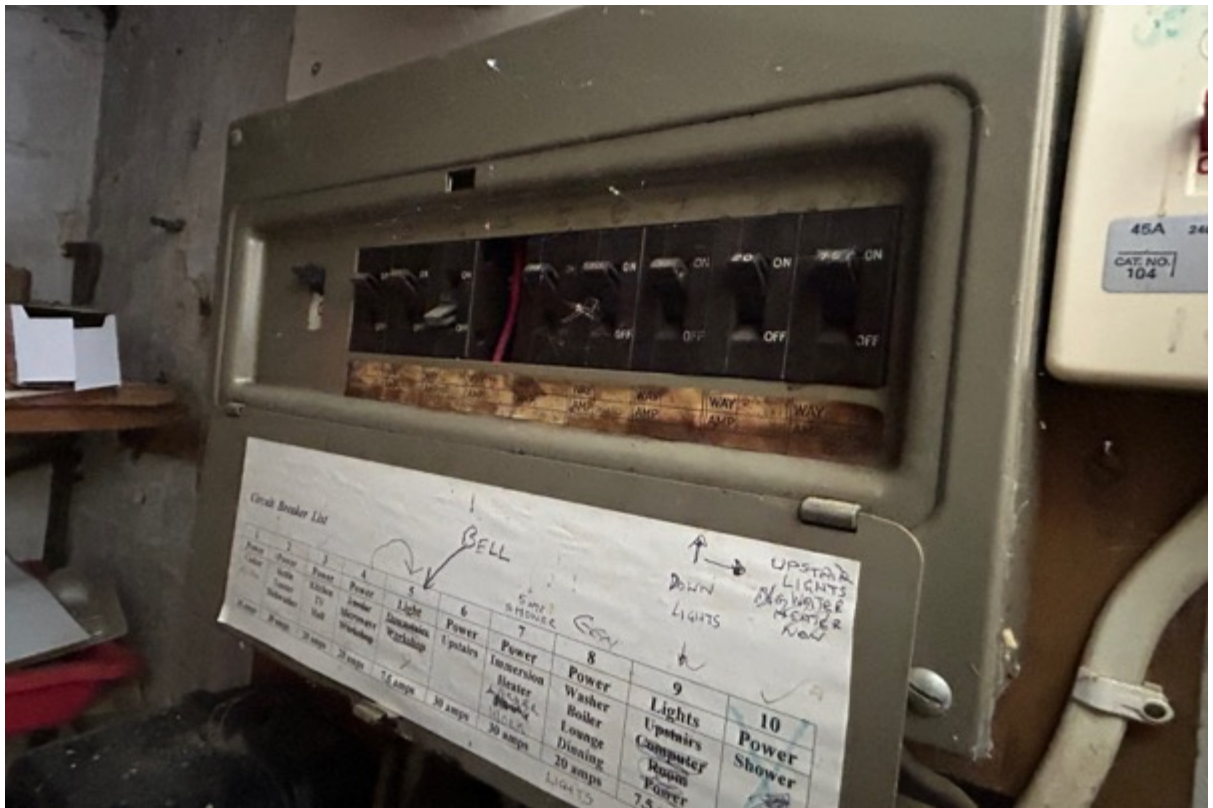
Ancient fuse box to the dining area cupboard.
