RICS  
**HomeBuyer** Report...

132 Astonville Street  
LONDON  
SW18 5AG

18 May 2016

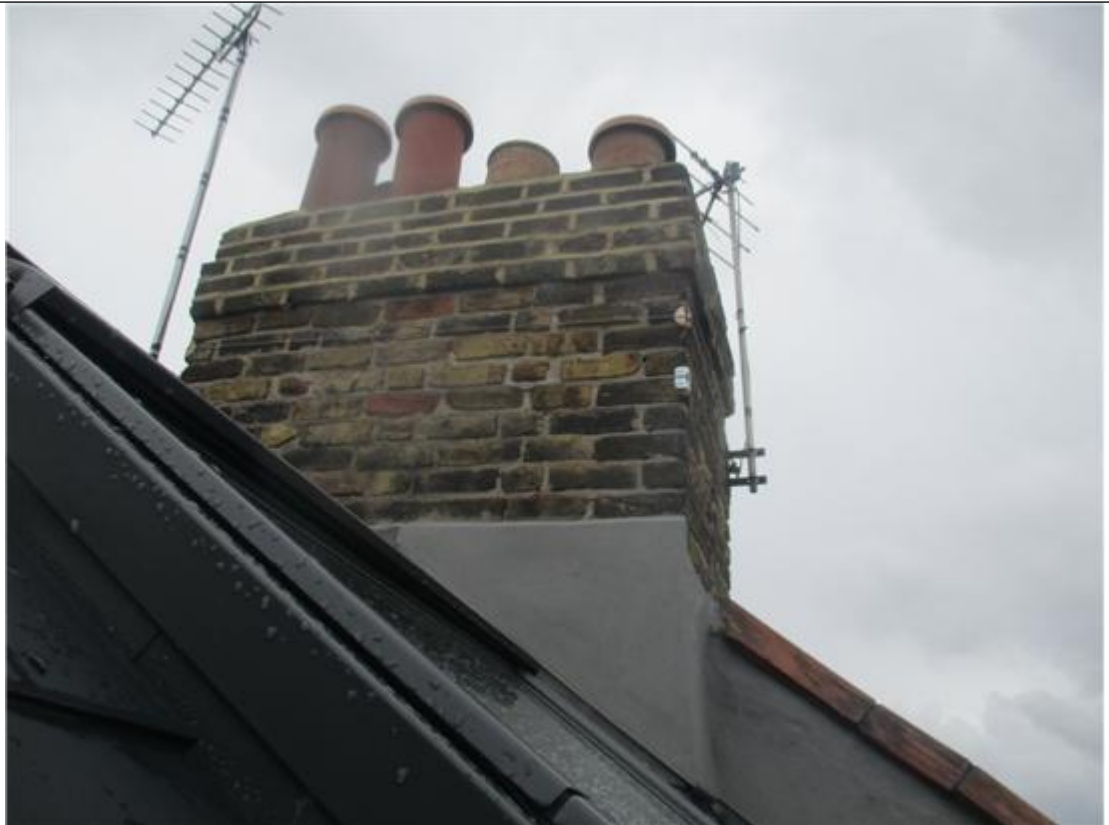
There is a chimney stack of traditional brick construction passing up through the main roof on the right side party line. The chimney stack is plumb, with no distortion from a vertical upright profile observed. 2

The brickwork to the stack is weathered, but not specifically defective, as viewed from ground level and from the adjacent roof lights. One brick is spalling at high level but this is not a material matter.

CHIMNEY STACK WITH NO SIGNIFICANT DEFECTS

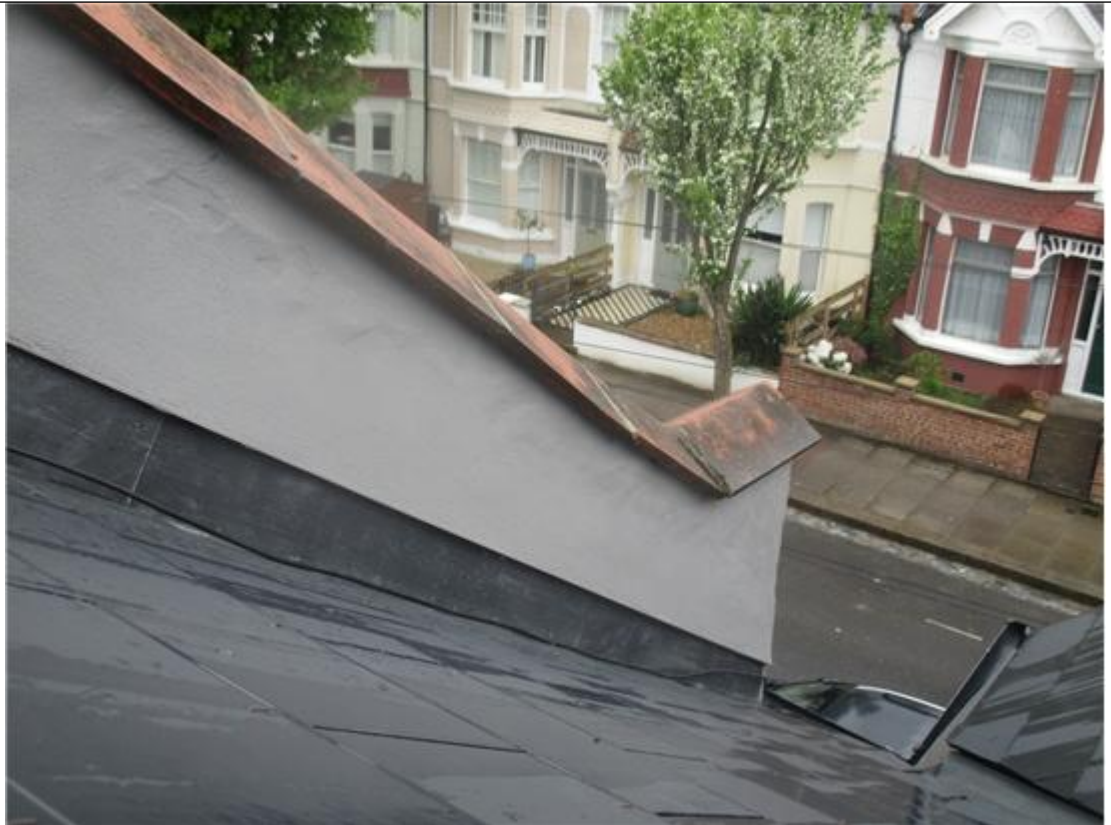
To the right/left sides of the front slope to the main roof, solid brick parapet walls covered with render are in position. No specific defects were noted to the render, although there is some general unevenness, which may be a reflection of some hollow patches. No specific repair works are required at the present time, but as time passes, some limited repair work to the render might be required.

INFERIOR CLAY RIDGE TILES AS THE CAPPING ON THE MAIN ROOF PARAPET WALLS

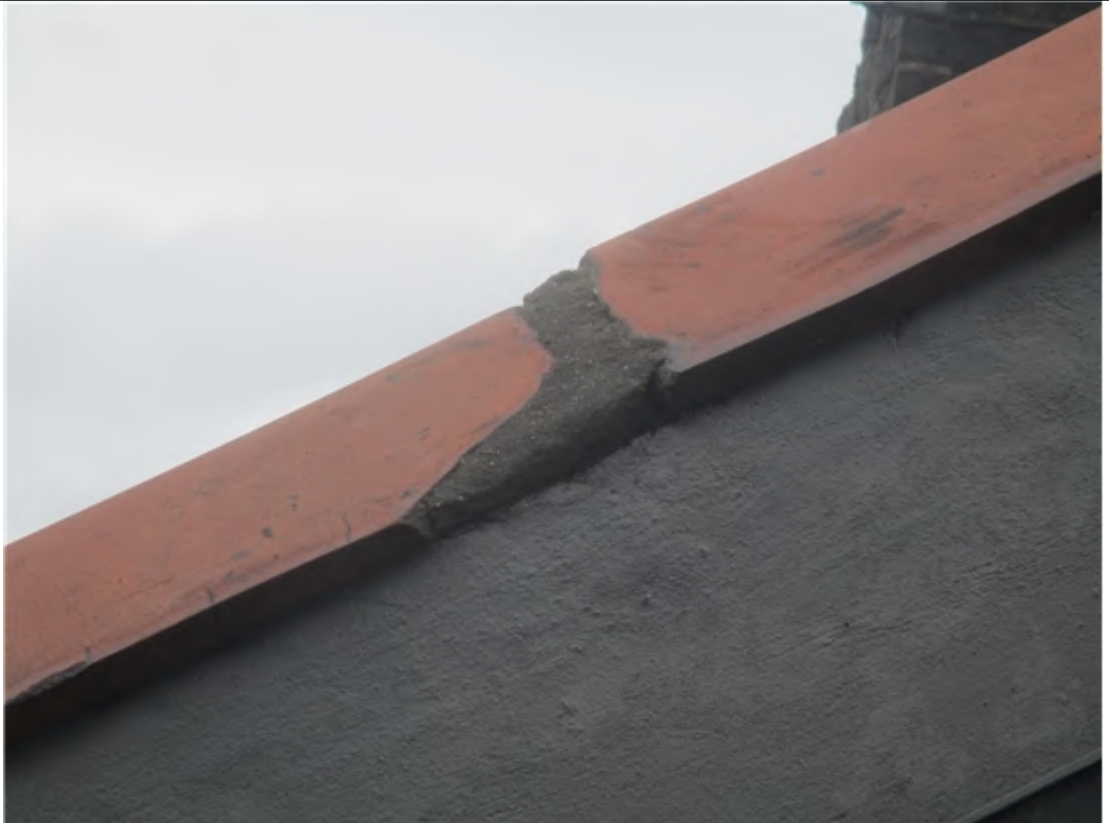
REPAIRED RIDGE TILE CAPPING ON TOP OF PARAPET WALL

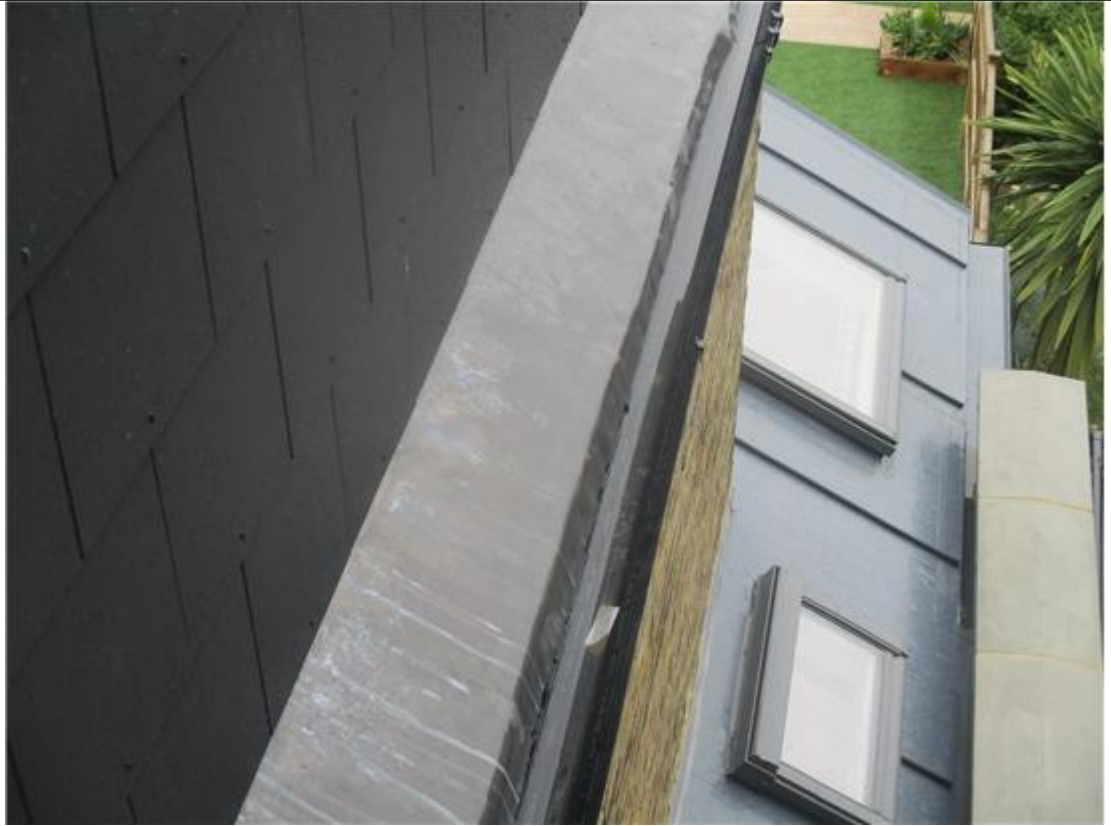
To the rear of the property, there are areas to both the main roof and the dormer construction, both vertical and sloping, which have been covered with sheet lead. The lead has been laid to a satisfactory standard, with no defects evident.

GOOD QUALITY LEADWORK COVERING FOOT OF DORMER

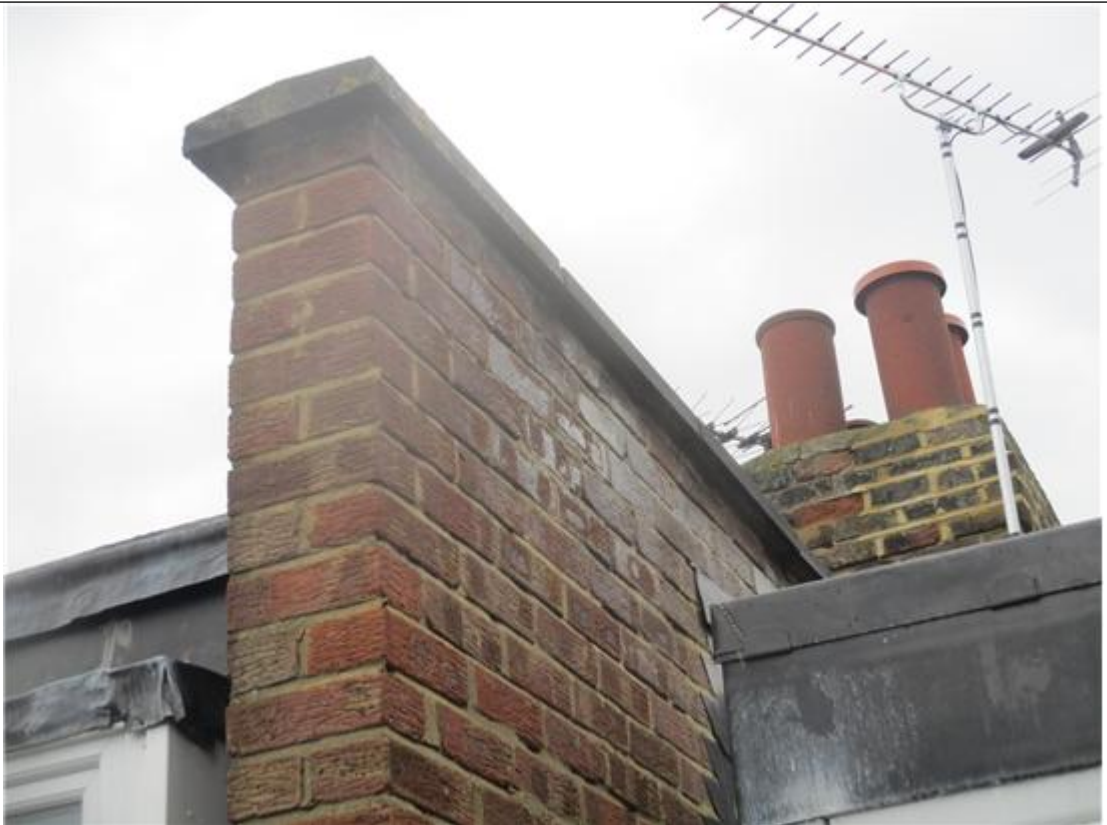
We were also able to view the parapet to the rear right corner of the roof from one of the first floor windows. The brickwork to the parapet wall is in satisfactory condition, but the capping detail on top is not wide enough, and at the time of our inspection, rain was driving directly into the brickwork beneath the coping stones. Ideally, the parapet wall should be covered with copings that are much wider, similar to those found on the party line to the right side of the rear subsidiary roof.

CONCRETE CAPPINGS TO REAR RIGHT PARAPET WALL OF INADEQUATE WIDTH

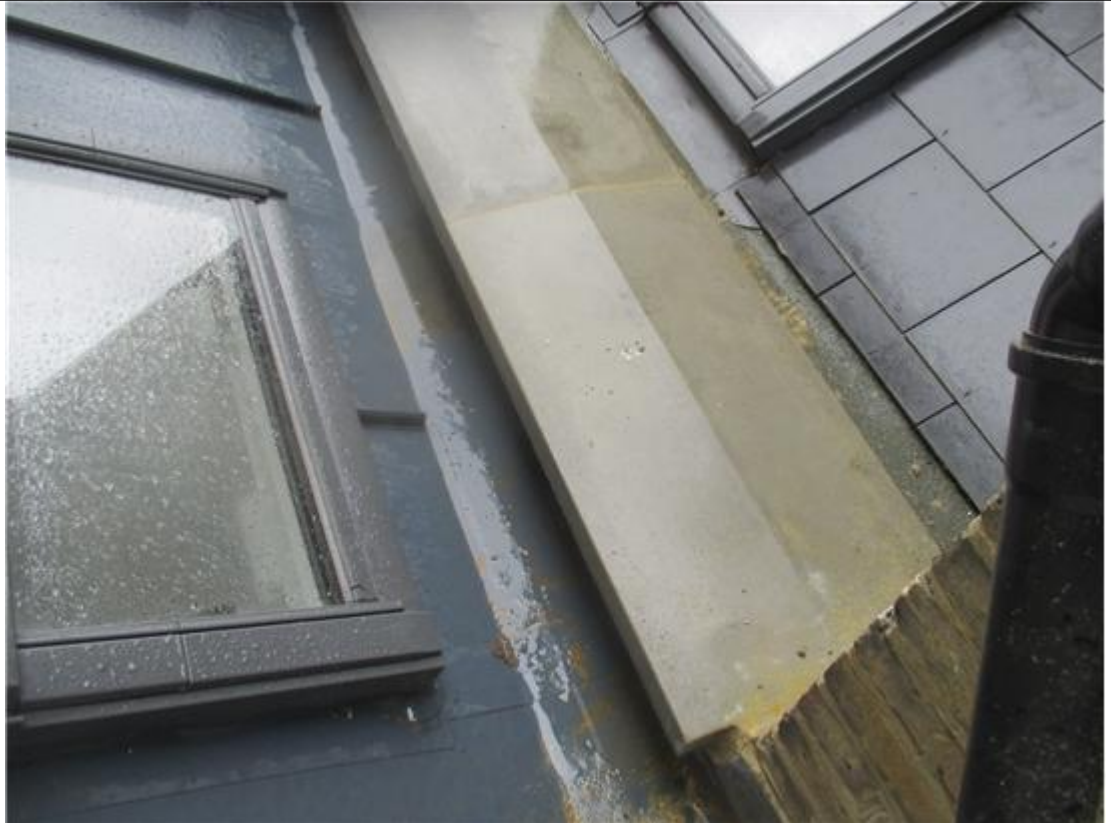
To the right side of this particular roof, on the party line, there is a dwarf parapet wall. The wall is surmounted by high quality, twice weathered concrete coping stones, which are in good condition and project out far enough on both sides to be able to perform their waterproofing function.

GOOD QUALITY/SIZE COPING STONES ON THE PARTY LINE TO THE RIGHT OF THE REAR SUBSIDIARY ROOF

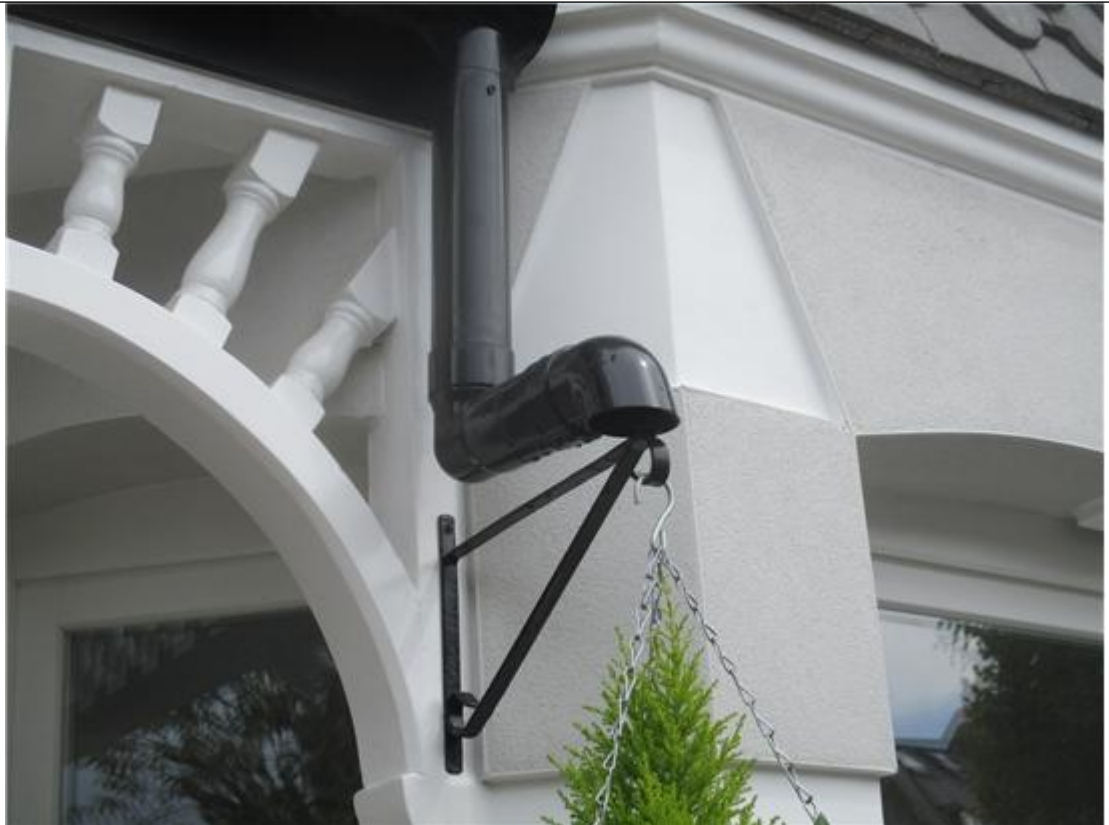
FRONT DOWNPIPE DISCHARGING INTO THIN AIR

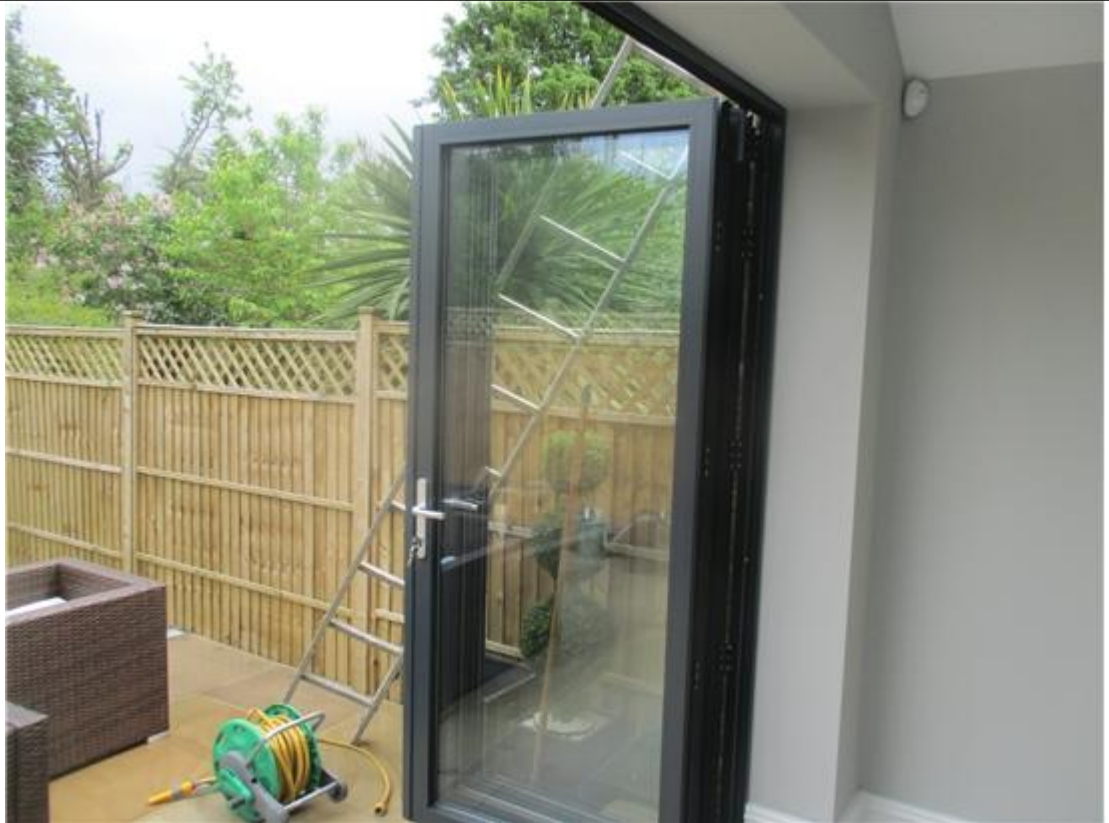
The folding doors to the rear of the property are of a double-glazed metal type. With this type of door, the tolerance in order for the doors to slide to the fully open position is very fine. However, we did open the doors fully and found that they were sliding smoothly within the frame.

REAR FOLDING DOORS OPEN TO THEIR FULLEST EXTENT

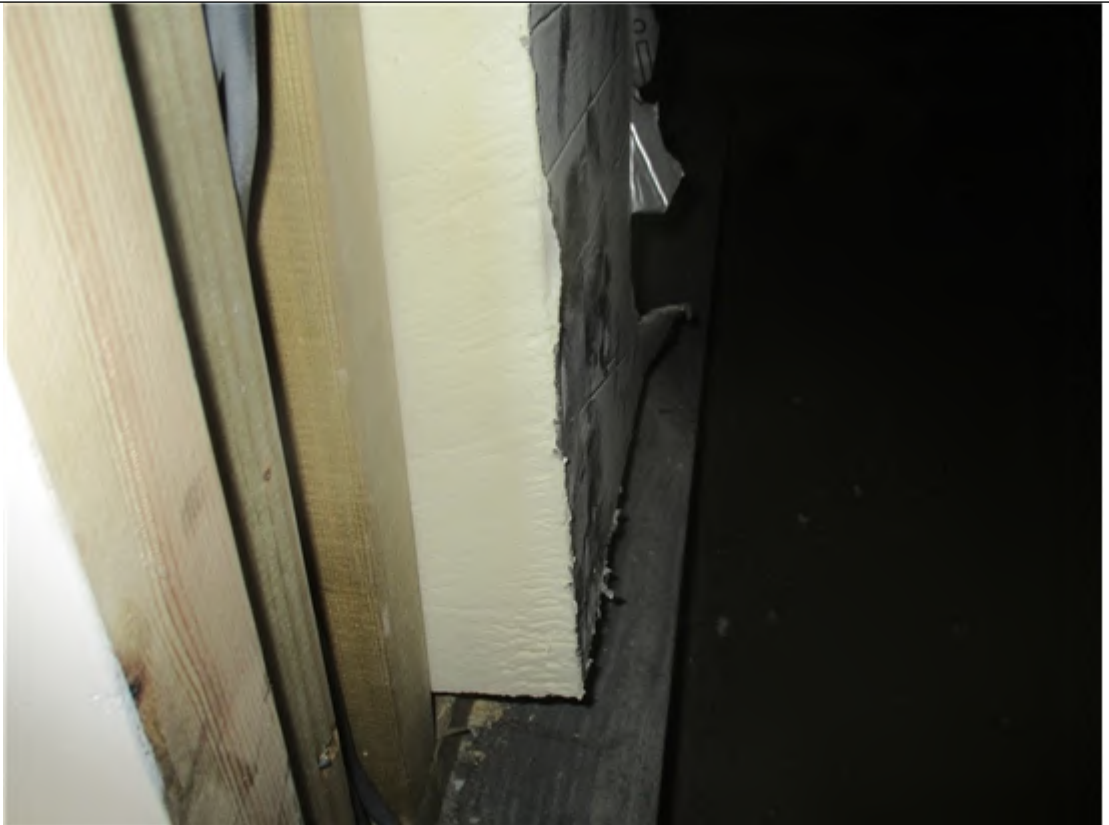
VERTICAL INSULATION BATTS OUT OF POSITION TO ROOF SPACE

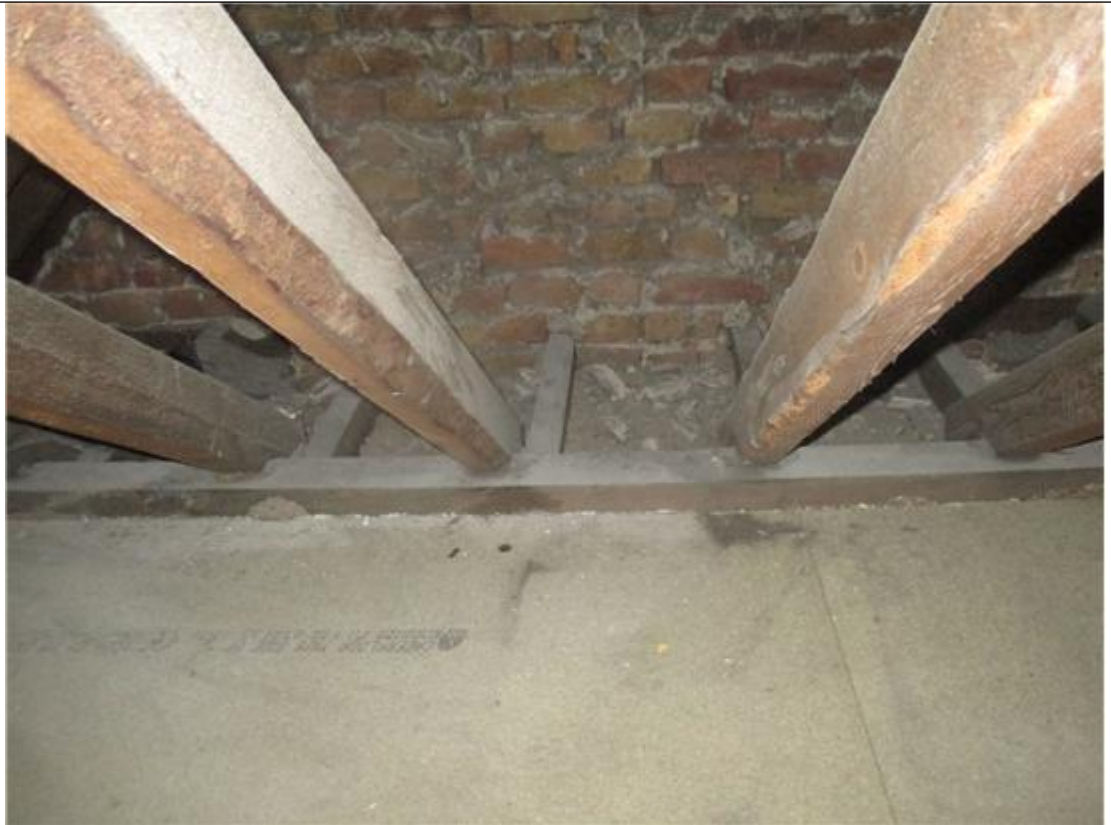
NO INSULATION BETWEEN JOISTS TO FRONT OF ROOF SPACE
